Home Inspection Report

Report Number: 121015-1
For The Property Located On:

Cary, North Carolina 27519

Date of Inspection: Thursday, December 10, 2015

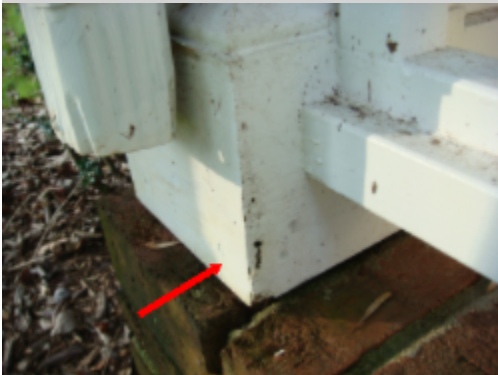
(A2 - 1.1) Porch

The Column located front porch right side has visible areas of decay at the base. The damage could jeopardize the strength of the column. The decay indicates a history of elevated moisture and or direct water penetration in or around the column area. A licensed general contractor should be consulted for further evaluation, to make necessary repairs, and determine the cause of the deterioration.

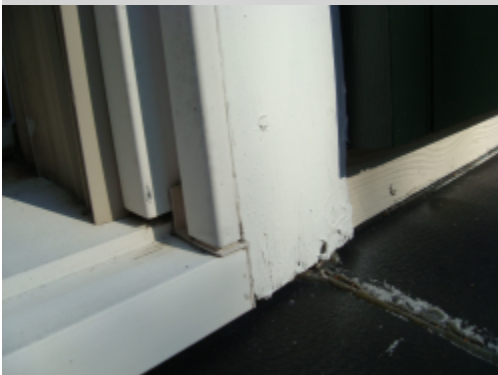
(B2 - 2.1) Windows ; Location: All Accessible

The front bedroom and master bathroom window(s) have soft and decayed wood in the trim area. Decay in the windows can result in leaking and water penetration and should be repaired as soon as possible. All windows should be inspected for similar damage as repairs are made. A licensed general contractor should be consulted to evaluate the extent of the damage and make necessary repairs.

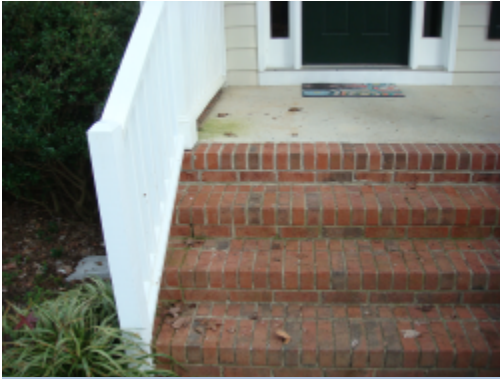
(B3 - 1.1) Porch ; Location: Main House Front

The handrails to the front porch are loose, and present a safety/fall hazard. A licensed general contractor should be consulted for evaluation of the handrail system and to make necessary repairs.

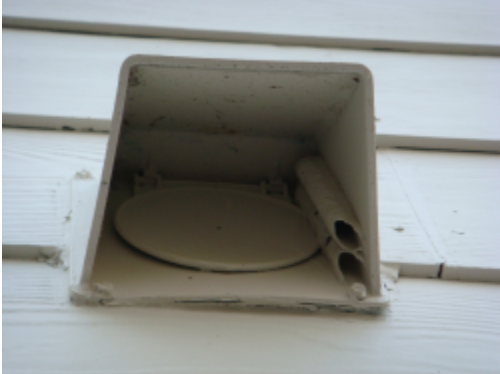
(B3 - 2.1) Deck ; Location: Main House Rear

The ventilation fan hood located above rear deck is not operable due to mud dauber tubes. The vent hood needs to be cleaned and inspected to ensure proper operation. A general repair person should be consulted. Owners disclosure is also recommended to identify the fan to which it is connected and proper operation is verified.

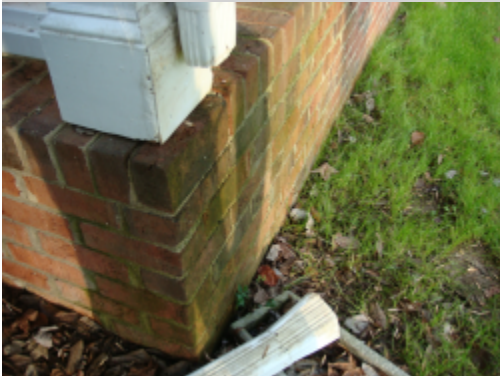
(C2 - 1.1) Main House; System Type: Gutter

The gutter downspouts are not extended or piped to direct roof drainage away from the foundation. Direct drainage from the gutter system can result in direct water penetration into the foundation area and foundation deterioration. A licensed general contractor should be consulted for a complete evaluation and to make necessary repairs.

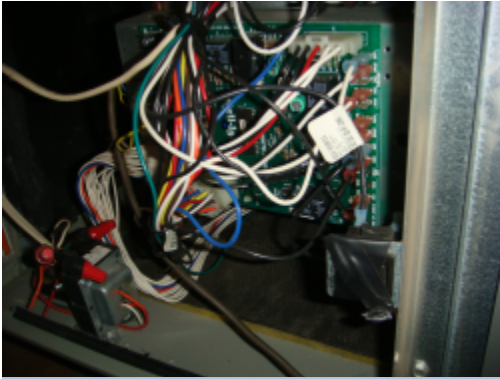
(F1 - 2.2) Heating Unit #2; Location: Exterior: Attic

The safety interlock switch located in the attic air handler has been bypassed. The switch is needed to prevent a safety hazards. A HVAC contractor should be consulted to evaluate the system and repair/replace as needed to ensure proper operation and safe installation.

The safety interlock switch located in the attic air handler has been bypassed. The switch is needed to prevent a safety hazards. A HVAC contractor should be consulted to evaluate the system and repair/ replace as needed to ensure proper operation and safe installation.

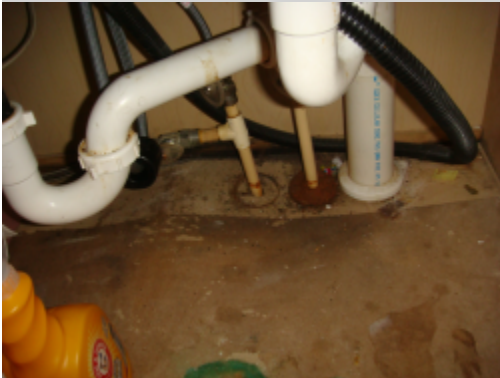
(H2 - 1.1) Kitchen

The sink cabinet has visible areas of water damage. The seller should be asked for disclosure related to the damage and history of flooding or leaks. The cabinet needs to be repaired/ replaced and the adjacent plumbing systems evaluated. A general repair specialist should be consulted for evaluation and repair. A licensed plumbing contractor should be consulted for evaluation and repair to ensure proper service.

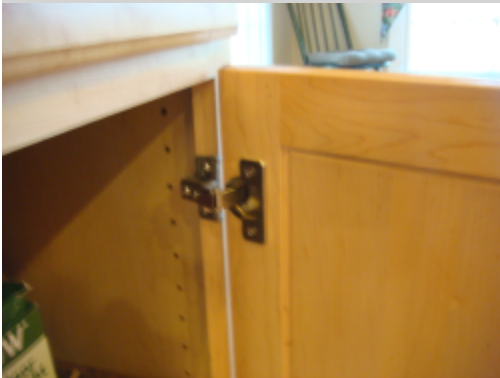
(H2 - 1.3) Kitchen

The cabinet hinge was note to be loose/ damaged and in need of repair to ensure proper operation of the cabinet doors. A general repair specialist or licensed general contractor should be consulted for evaluation and repair.

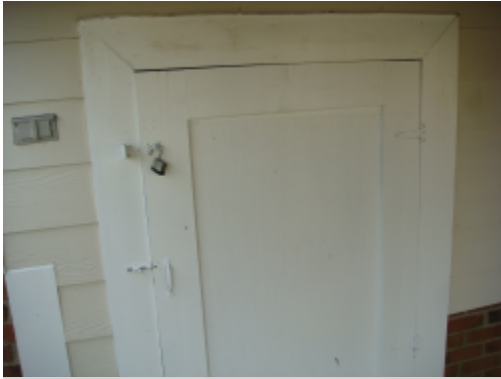
(I1 - 2.1) Crawl Space

The crawl space door drags and is difficult to open or close. This condition could indicate improper installation or framing movement. The door needs repair/replacement to ensure that the door closes securely and is weather tight. A general repair specialist or licensed general contractor should be consulted for evaluation and repair.

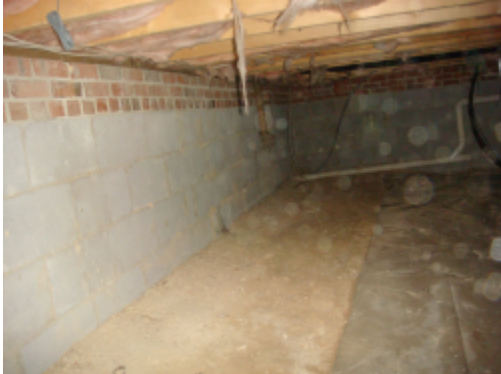
(I1 - 2.2) Crawl Space

The vapor barrier in the crawl space does not cover the ground completely. Improper installation could result in condensation and inadequate conditioning of the living areas. A licensed general contractor should be consulted for repair/ replacement.

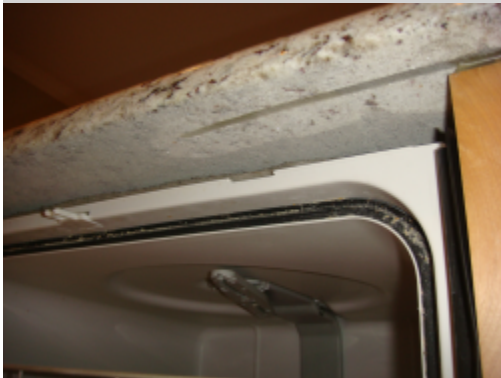
(J1 - 1.1) Dishwasher; Location: Kitchen

The dishwasher is not secure to the cabinet and it moves forward when the door is opened. The appliance needs to be secured to the cabinet to prevent damage to the unit or personal injury. An appliance repair person or general contractor should be consulted for repair.

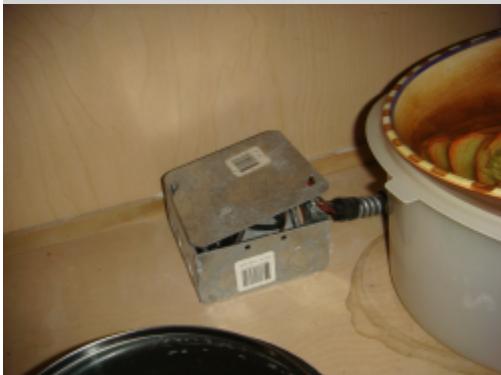
(J1 - 3.1) Range: Electric; Location: Kitchen

Electrical connections for the counter range top have been made in the cabinet without being properly protected in a covered junction box. The open junction leaves electrical conductors exposed and in a hazardous condition. Electrical concerns should be considered fire and safety issues and repaired as soon as possible. The electrical systems and components in the attic are in need of a complete evaluation and repair by a licensed electrical contractor.

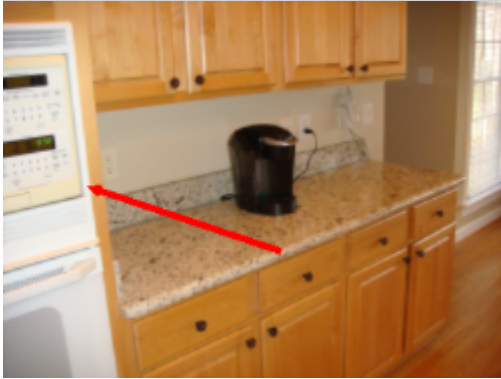
(J1 - 5.1) Microwave: Built In; Location: Kitchen

The microwave door did not operate. An appliance repair person should be consulted for further evaluation and repair to ensure proper operation of the appliance.
