# Home Inspection Report

Durham, North Carolina 27712

Date of Inspection: Friday, January 8, 2016

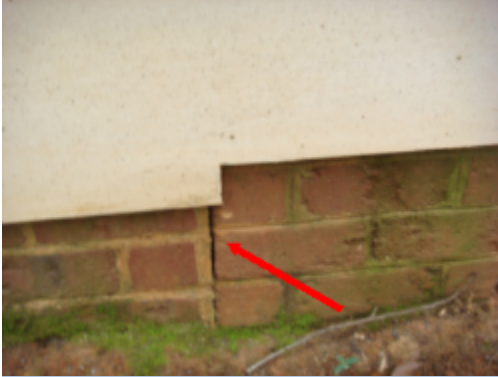
#### (A1 - 2.1 ) Main House

Open cracks were noted in the back porch foundation (left rear) of the home. Cracks in the foundation indicate a deficiency in the foundation, footing, or supporting soil that can change and worsen if it progresses over the life of the home. An engineer should be consulted to determine the significance /cause of the cracks and outline any necessary repairs.

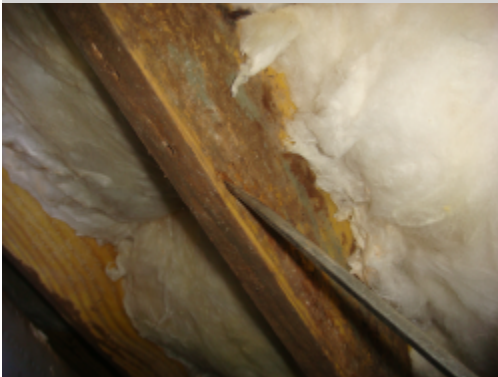
#### (A3 - 1.1 ) Main House

The wood framing components in the crawl space of this home are damaged from decay typical of fungal growths such as wood destroying fungi. The extensive amount of damage identified under the home indicates a long term history of elevated moisture and a wet crawl space environment. It is recommended that a licensed general contractor be consulted to perform an invasive inspection to determine the extent of the damage to the floor framing and to correct crawl space conditions to ensure the stability of the home and prevent additional damage.

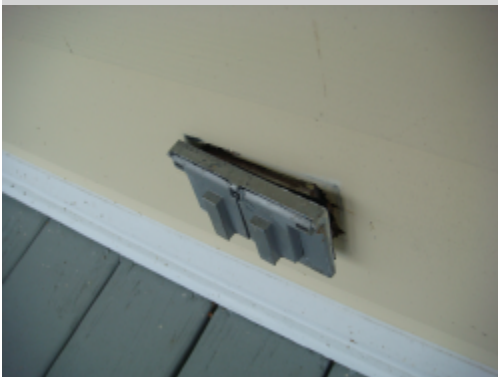
#### (B3 - 1.1 ) Porch ; Location: Main House Front

The receptacle located on front porch right is loose. Loose receptacles could result in electrical shock hazard or property damage. A licensed electrical contractor should be consulted for a complete evaluation to determine the significance of this concern and make necessary repairs to correct defects and prevent safety hazards.

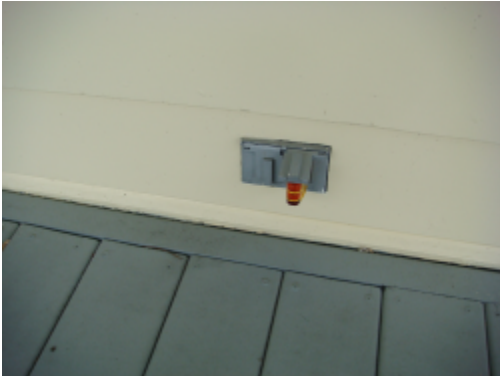
#### (B3 - 2.1 ) Balcony (front); Location: Main House Front

The receptacle(s) located front balcony had no power. This could indicate a damaged receptacle or branch wiring circuit. A licensed electrical contractor should be consulted for a complete evaluation to determine the significance of this concern and make necessary repairs to correct defects and prevent safety hazards.

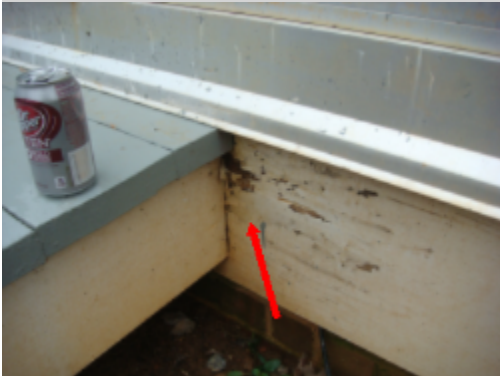
**(B3 - 3.1 ) Glass Enclosed Porch ; Location: Main House Rear**

The exterior steps going onto the rear enclosed porch have areas of decay. A licensed general contractor should be consulted for a complete evaluation of the exterior of the home to determine the extent of the damage to the siding, trim, and underlying components to ensure the weathertightness of the system.

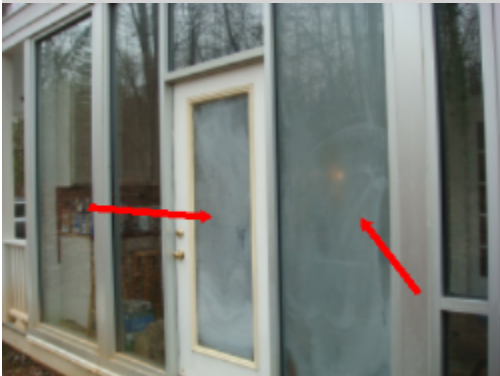
**(B3 - 3.2 ) Glass Enclosed Porch ; Location: Main House Rear**

The enclosed porch window and door have a cloudy or hazed appearance. The cloudy appearance indicates that the gas seal between the double glass panes has been jeopardized reducing the energy rating of the windows. The severity of the hazing varies with season and time of the day; therefore, all damaged windows may not have been visible at the time of the inspection. All windows should be evaluated as repairs are made. A licensed general contractor should be consulted to evaluate the extent of the concern and make necessary repairs.

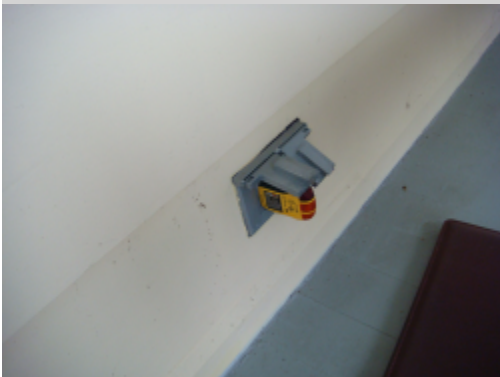
**(B3 - 4.1 ) Balcony (rear); Location: Main House Rear**

The receptacle(s) located on rear balcony had no power. This could indicate a damaged receptacle or branch wiring circuit. A licensed electrical contractor should be consulted for a complete evaluation to determine the significance of this concern and make necessary repairs to correct defects and prevent safety hazards.

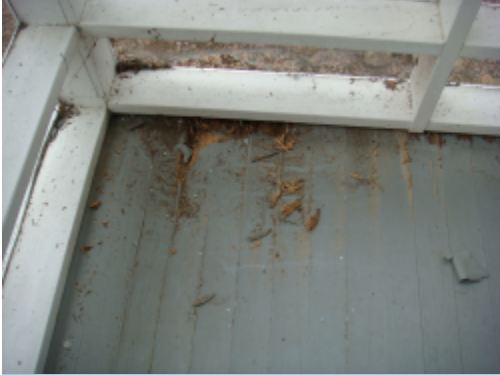
**(B3 - 4.2 ) Balcony (rear); Location: Main House Rear**

The wood deck was found to be in poor condition. Areas of soft wood were discovered. A licensed general contractor should be consulted for complete evaluation of the deck and to make necessary repairs or replacement as needed.

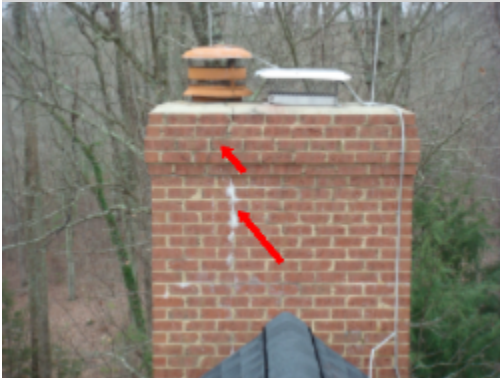
**(C4 - 1.1 ) Main House Left; Location: Chimney: Masonry**

The mortar is deteriorated and cracked. When the mortar cap is damaged water can enter between the chimney body and the flue liner resulting in leaks and deterioration. A masonry contractor should be consulted for a complete evaluation of the chimney, the flue liner and the masonry crown and to make necessary repairs.

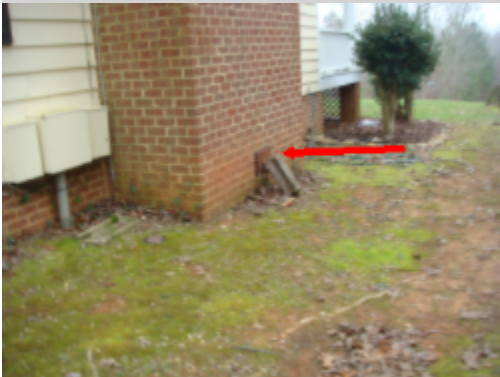
**(C4 - 1.2 ) Main House Left; Location: Chimney: Masonry**

The cleanout door is damaged and in need of repair/replacement. A chimney sweep and general contractors should be consulted for a complete evaluation of the chimney and to make necessary repairs to ensure that the chimney is safe and functional.

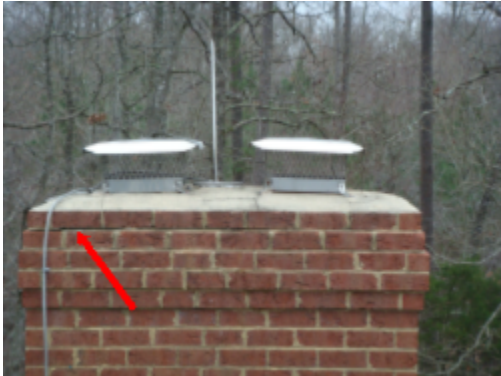
**(C4 - 2.1 ) Main House Right; Location: Chimney: Masonry**

The mortar is deteriorated and cracked. When the mortar cap is damaged water can enter between the chimney body and the flue liner resulting in leaks and deterioration. A masonry contractor should be consulted for a complete evaluation of the chimney, the flue liner and the masonry crown and to make necessary repairs.

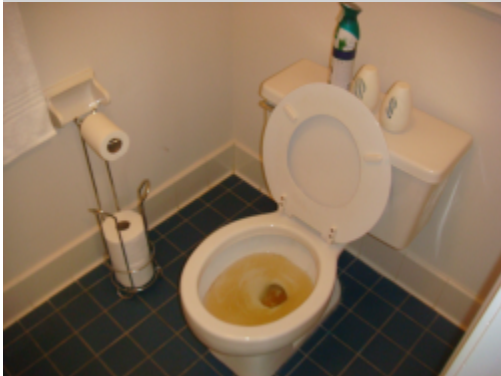
**(D1 - 1.1 ) All Accessible Areas**

The water in the toilet tanks, sink and tub was noted to be discolored. The discoloration indicates possible defect with the water supply system or distribution piping. The contamination could affect the quality and quantity of the water source for the home. The plumbing supply lines are original to the home. A licensed plumbing contractor should be consulted for complete evaluation of the water supply and distribution systems.

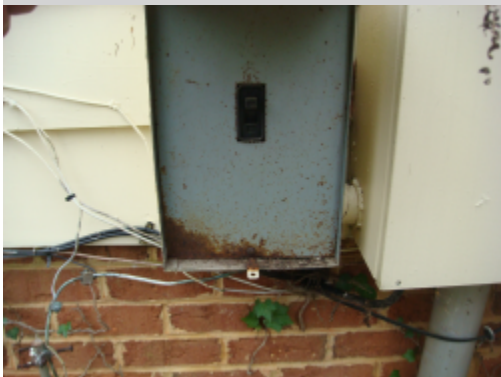
**(E2 - 1.1 ) Main Panel #1; Location: Exterior**

Evidence suggests that water has been entering the main electrical service panel. This condition presents a safety hazard that could result in interrupted service, property damage, and serious personal injury. The panel cover was not removed and the inspection was not completed. A licensed electrical contractor should be consulted for a complete inspection of the electrical system and for repair/replacement of the panel to ensure that it is safe and functioning properly.

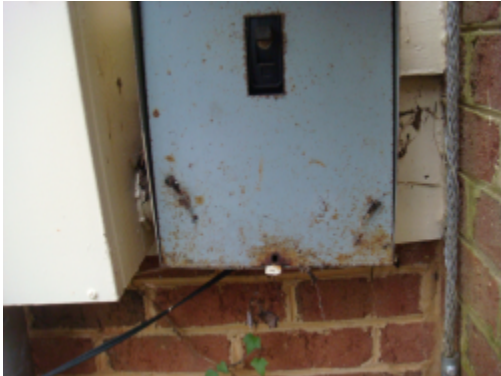
**(E2 - 2.1 ) Main Panel #2; Location: Exterior**

The main electrical service panel was noted to be rusted and deteriorated. The rust indicates deterioration and possible water penetration into the panel service area. This condition presents a safety hazard that could result in interrupted service, property damage, and serious personal injury. The electrical panel cover is missing a screw was not removed and the inspection was not completed. A licensed electrical contractor should be consulted for a complete inspection of the electrical system and for repair/replacement of the panel to ensure that it is safe and functioning properly.

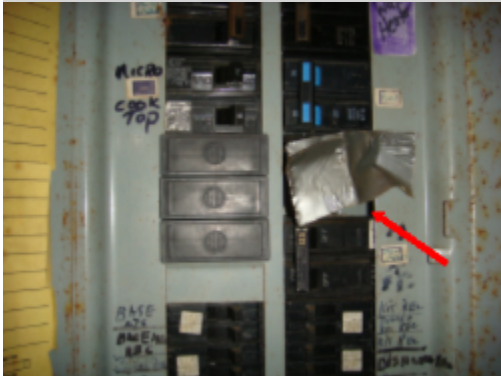
**(E3 - 1.1 ) Distribution Panel #1; Location: Basement**

The electrical service panel cover is missing knock out opening plugs. The covers or plugs prevent direct contact with hot electrical circuits. This condition presents a safety hazard that could result in interrupted service and serious personal injury /death from electrocution. A licensed electrical contractor should be consulted for a complete inspection of the electrical system and for repair/replacement of the panel to ensure that it is safe and functioning properly.

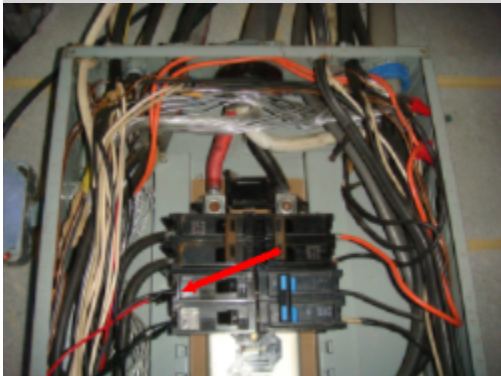
**(E3 - 1.2 ) Distribution Panel #1; Location: Basement**

Several breakers in the electrical panel has two conductors attached to the power screw. Typically breakers are not rated for double taps due to possible loose connections and circuit overloads. This condition presents a safety hazard that could result in interrupted service, property damage, and serious personal injury. A licensed electrical contractor should be consulted for further evaluation and repair.

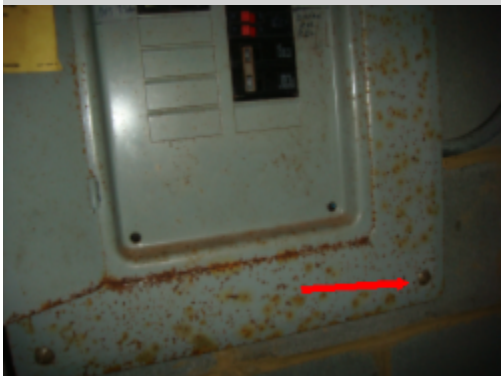
**(E3 - 1.3 ) Distribution Panel #1; Location: Basement**

The electrical service panel cover is installed with the wrong or worn out type of fasteners. The door/cover prevents direct contact with hot electrical circuits and contains the electrical energy of the electrical system in the event of a short or electrical explosion; therefore the cover must be secured with the correct type, size and number of fasteners. This condition presents a safety hazard that could result in serious personal injury or death. A licensed electrical contractor should be consulted for a complete inspection of the electrical system and for repair/replacement of the panel to ensure that it is safe and functioning properly.

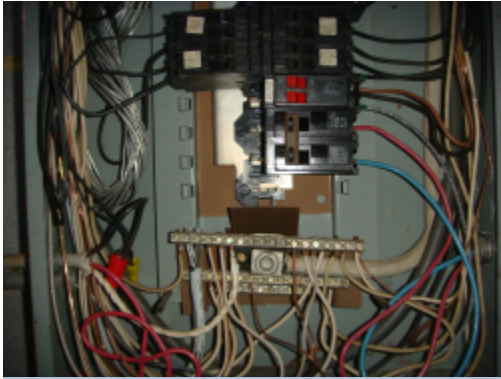
**(E3 - 1.5 ) Distribution Panel #1; Location: Basement**

The neutral bus bar of the panel is not isolated from the ground system. This condition presents a safety hazard that could result in interrupted service, property damage, and serious personal injury. A licensed electrical contractor should be consulted for repair and a complete evaluation of the electrical system.

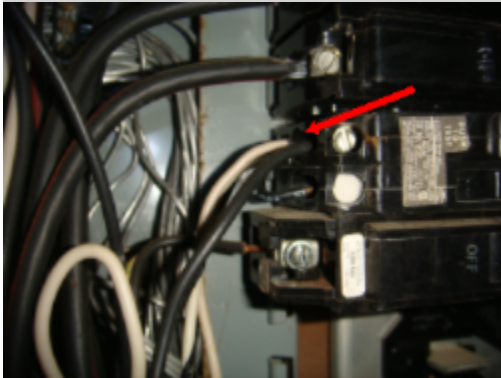
**(E3 - 2.1 ) Distribution Panel #2; Location: Basement**

The breaker located on the left side of the electrical panel has two conductors attached to the power screw. Typically breakers are not rated for double taps due to possible loose connections and circuit overloads. This condition presents a safety hazard that could result in interrupted service, property damage, and serious personal injury. A licensed electrical contractor should be consulted for further evaluation and repair.

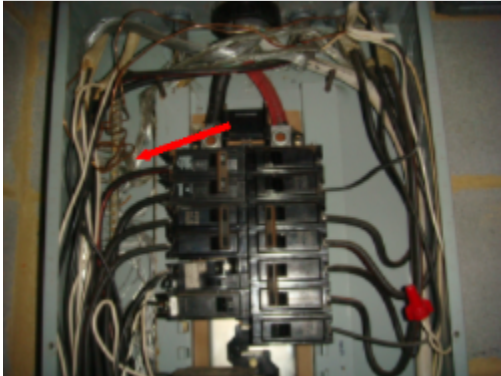
**(E3 - 2.3 ) Distribution Panel #2; Location: Basement**

The neutral bus bar located on the left side of the panel is not isolated from the ground system. This condition presents a safety hazard that could result in interrupted service, property damage, and serious personal injury. A licensed electrical contractor should be consulted for repair and a complete evaluation of the electrical system.

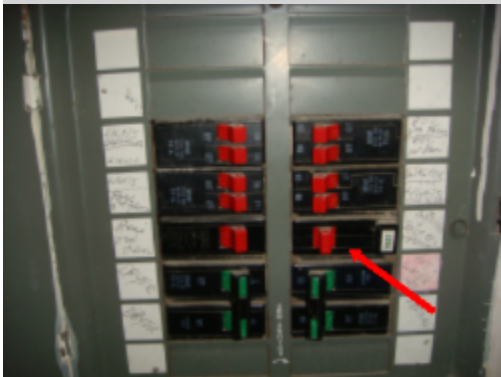
**(E3 - 3.1 ) Distribution Panel #3; Location: Laundry**

The breaker labeled for bathrooms in the panel was noted to be in the tripped position at the time of the inspection. A tripped breaker indicates a problem with the branch circuit or the appliance. This condition presents a safety hazard that could result in interrupted service, property damage, and serious personal injury. A licensed electrical contractor should be consulted for further evaluation and repair.

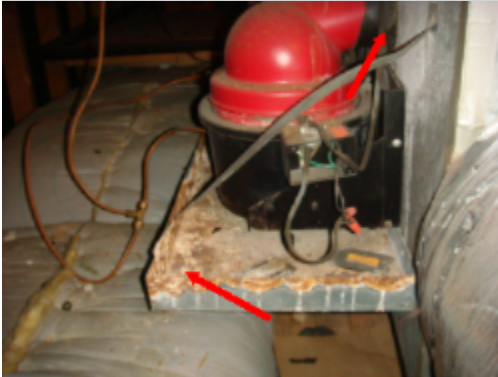
**(Defects, Comments, and Concerns):****(F1 - 1.1 ) Heating Unit #1; Location: Attic**

The humidifier system drain pan is in poor condition and in need of replacement. This condition indicates a history of improper drainage of the system condensate water. Improper drainage of the condensate water can result in system and property damage. A HVAC contractor should be consulted for a complete evaluation and to make necessary repairs to ensure safe, reliable, and proper operation of the HVAC system. In addition the connection from the humidifier to the duct was not sealed and it was also noted the water supply pipe for the humidifier was disconnected. Owner disclosure is recommended.

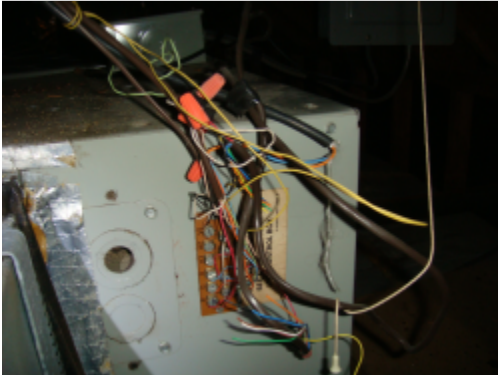
**(F1 - 1.2 ) Heating Unit #1; Location: Attic**

The attic air handler electrical systems and components in the attic are in need of a complete evaluation and repair by a licensed electrical contractor. The following electrical concerns were noted: Junction Boxes no cover; Junctions no boxes; Service cables not supported.

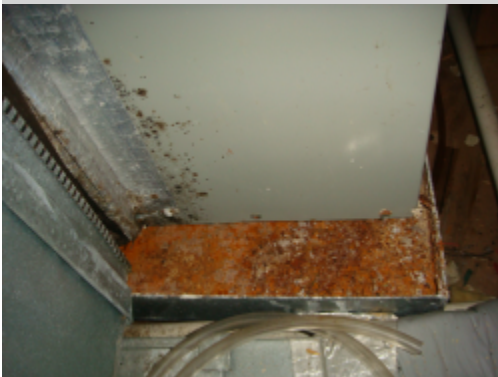
**(G1 - 1 ) Summary - Cooling: Equipment  
(Defects, Comments, and Concerns):****(G1 - 1.1 ) Cooling Unit #1; Location: Attic**

The AC system auxiliary drain pan is in poor condition and in need of replacement. This condition indicates a history of improper drainage of the system condensate water. Improper drainage of the condensate water can result in system and property damage. A HVAC contractor should be consulted for a complete evaluation and to make necessary repairs to ensure safe, reliable, and proper operation of the HVAC system.

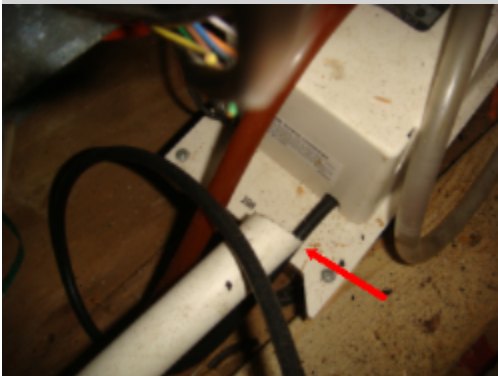
**(G1 - 1.2 ) Cooling Unit #1; Location: Attic**

The condensate drain lines are not properly installed with a trap to ensure proper drainage. Improper drainage of the condensate water can result in system and property damage. A HVAC contractor should be consulted for a complete evaluation and repair of the system to ensure reliable and proper operation of the HVAC system.

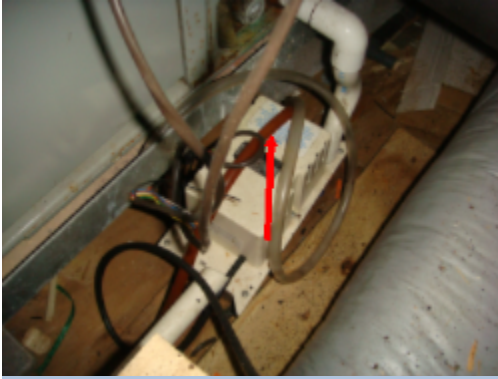
**(G1 - 1.3) Cooling Unit #1; Location: Attic**

The drainage of the condensate water from the AC system is controlled by a condensate pump. The condensate pump exit drain is contaminated. Improper drainage of the condensate water can result in system and property damage. A HVAC contractor should be consulted for a complete evaluation and repair of the system to ensure safe, reliable, and proper operation of the HVAC system.

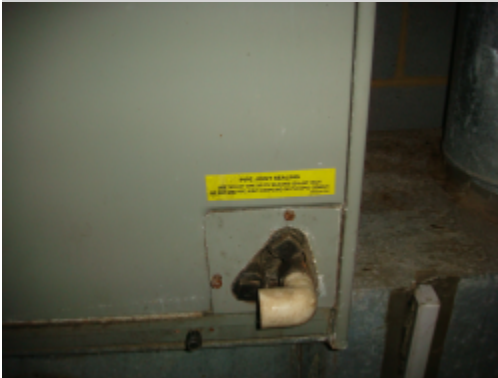
**(G1 - 2) Summary - Cooling: Equipment  
(Defects, Comments, and Concerns):****(G1 - 2.1) Cooling Unit #2; Location: Basement**

The condensate drain lines are not properly installed with a trap to ensure proper drainage. Improper drainage of the condensate water can result in system and property damage. A HVAC contractor should be consulted for a complete evaluation and repair of the system to ensure reliable and proper operation of the HVAC system.

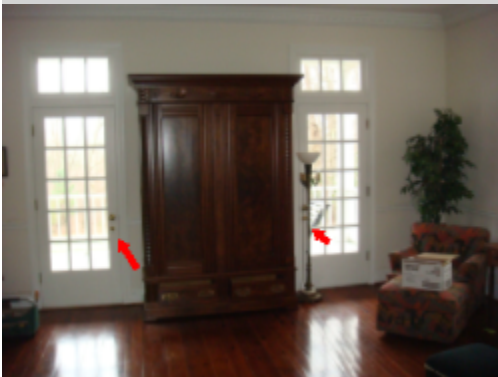
**(H1 - 2) Summary - Interiors: General Rooms  
(Defects, Comments, and Concerns):****(H1 - 2.2) Living Room**

The entrance door to the home has a double key deadbolt lock. This type of lock cannot be unlocked from the interior of the home without the key and is not recommended for main egress doors. In the event of an emergency, the key may not be available resulting in a person not being able to exit the home. Replacement is recommended.

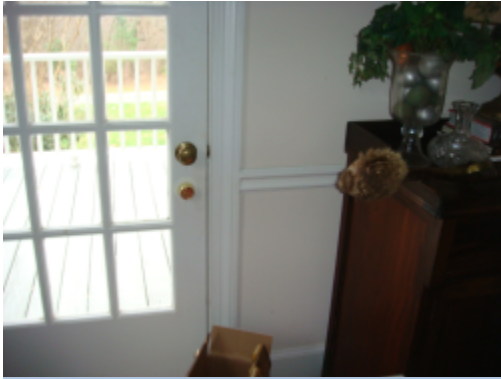
**(H1 - 3) Summary - Interiors: General Rooms  
(Defects, Comments, and Concerns):****(H1 - 3.1) Library**

The entrance door to the home has a double key deadbolt lock. This type of lock cannot be unlocked from the interior of the home without the key and is not recommended for main egress doors. In the event of an emergency, the key may not be available resulting in a person not being able to exit the home. Replacement is recommended.

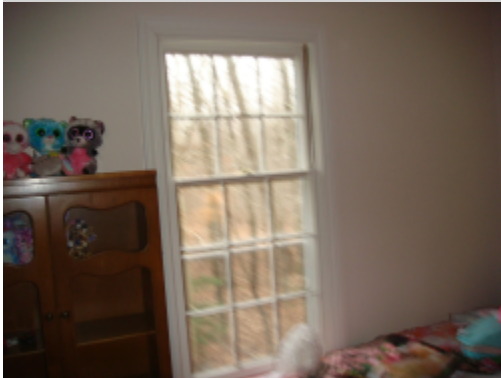
**(H1 - 5.1 ) Bedroom (rear left)**

The window in left rear bedroom needs repair to ensure proper operation. The window could not be closed/ latched. A licensed general contractor should be consulted for evaluation and repair.

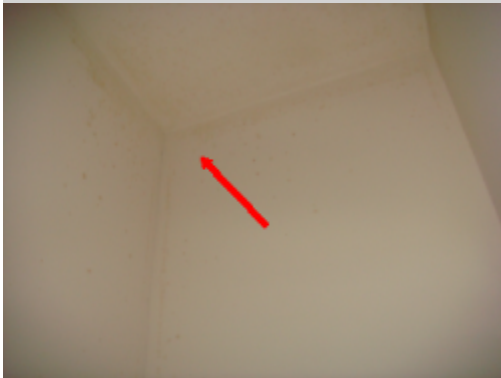
**(H1 - 5.2 ) Bedroom (rear left)**

Stains on the ceilings in the right closet indicate a history of a leak. At the time of the inspection it was not possible to determine if the condition was due to an active or past occurrence. Further investigation by a repair specialist and/or owner disclosure is recommended.

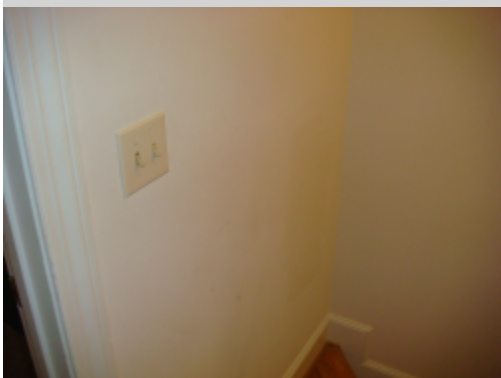
The 3-way light switch used to control the light fixture located in the third floor stairway was broken and did not operate correctly. A licensed electrical contractor should be consulted for a complete evaluation to determine the significance of this concern and make necessary repairs to correct defects and prevent safety hazards.

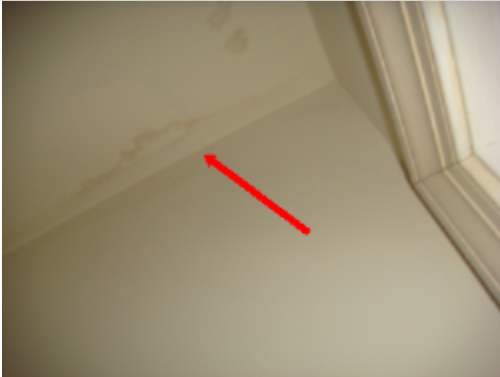
Stains on the ceilings indicate a history of a leak. At the time of the inspection it was not possible to determine if the condition was due to an active or past occurrence. Further investigation by a repair specialist and owner disclosure is recommended.

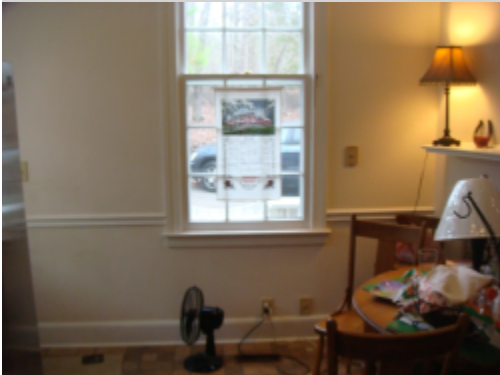
The window in the kitchen needs repair to ensure proper operation. The window could not be opened. A licensed general contractor should be consulted for evaluation and repair.

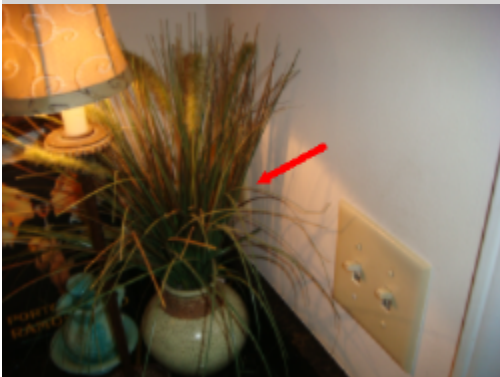
The receptacle located first floor bathroom is not GFCI protected. Receptacles located in hazardous or wet locations should be GFCI protected to reduce shock in hazardous locations. A licensed electrical contractor should be consulted for further evaluation and repair.

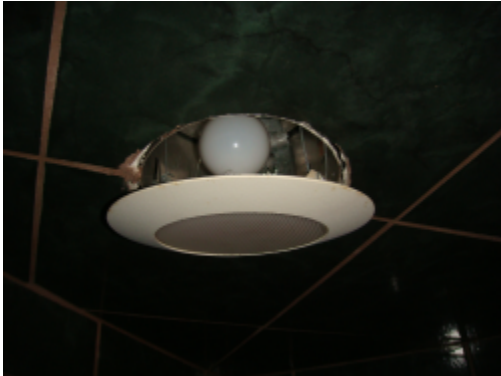
The light fixture located in the shower is not a sealed unit. The light fixture should be verified to be rated for installation in a wet environment. A licensed electrical contractor should be consulted for evaluation and repair to ensure safe and proper service.

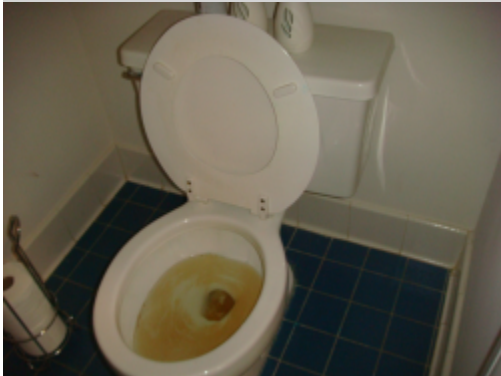
The toilet did not flush completely. The slow flush could be related to a defective flush valve, clogged toilet, or defective toilet. A licensed plumbing contractor should be consulted for evaluation and repair. In addition the door to the toilet room needs repair to ensure proper operation and privacy. The door did not properly close.

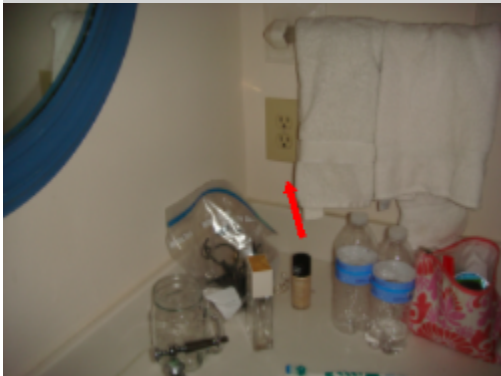
The receptacle(s) located in the master bathroom by sink had no power. This could indicate a damaged receptacle or branch wiring circuit. A licensed electrical contractor should be consulted for further evaluation and repair.

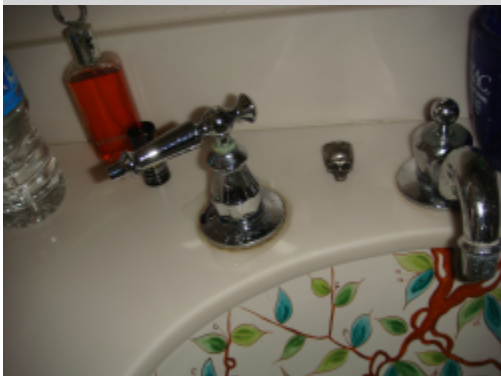
The sink faucet left sink hot faucet leaks at the handle base area when turned on. The leaks could result in damage to the sink and cabinet and should be repaired as soon as possible. A licensed plumbing contractor should be consulted for a complete evaluation to determine the significance of this concern and make necessary repairs to prevent leaks and ensure sanitary conditions.

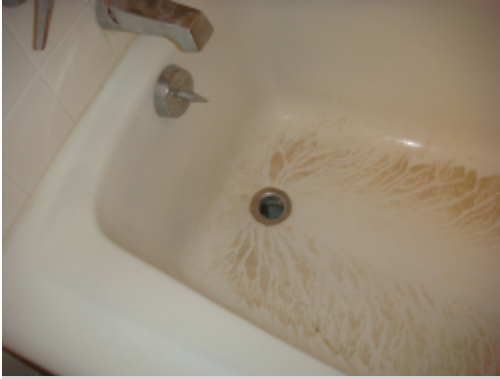
The linkage for the tub drainage stopper is not functioning properly. The stopper needs repair to ensure that the tub can be filled and easily drained. A licensed plumber should be consulted for repair.

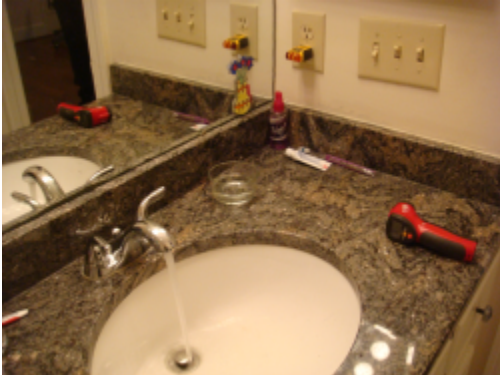
The receptacle had no power. This could indicate a damaged receptacle or branch wiring circuit. A licensed electrical contractor should be consulted for further evaluation and repair.

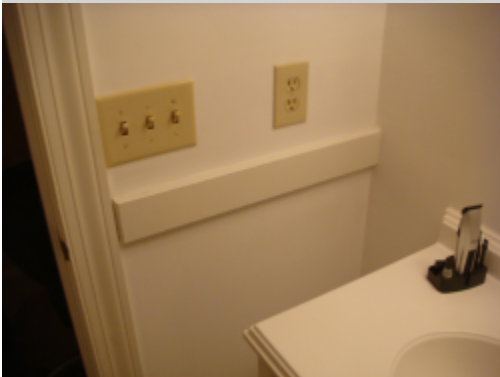
The receptacle had no power or tested as not hot. This could indicate a damaged receptacle or branch wiring circuit. A licensed electrical contractor should be consulted for further evaluation and repair.

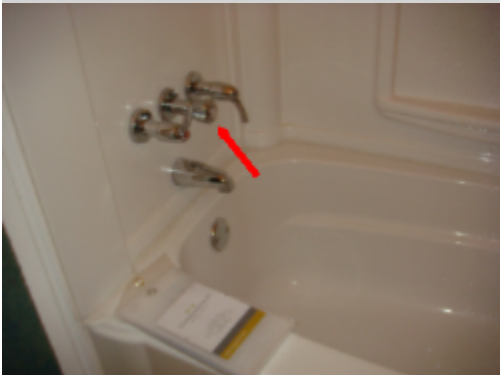
The shower/ diverter valve did not function properly. A licensed plumbing contractor should be consulted for evaluation and repair to ensure proper service.

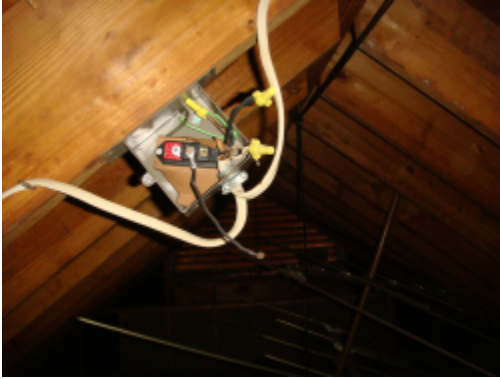
Electrical connections have been made in the top attic area without being properly protected in a covered junction box. The open junction leaves electrical conductors exposed and in a hazardous condition. Electrical concerns should be considered fire and safety issues and repaired as soon as possible. The electrical systems and components in the attic are in need of a complete evaluation and repair by a licensed electrical contractor.
