Home Inspection Report

Report Number: 71615-1
For The Property Located On:

Franklinton, North Carolina 27525

Date of Inspection: Thursday, July 16, 2015

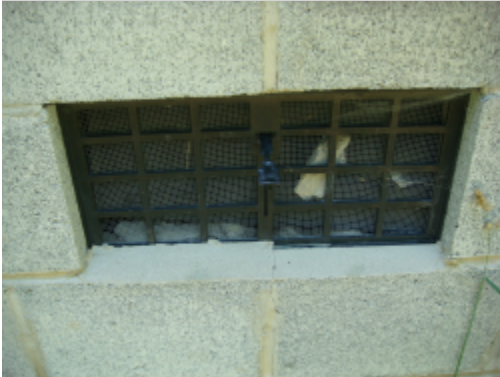
(A1 - 1.1) Main House

The foundation vents on right side of house are not operating properly. Improper ventilation could result in condensation and elevated moisture levels in building components. A licensed general contractor should be consulted for a complete evaluation of the crawl space to determine the significance of the concern and make necessary repairs. Refer to the foundation section of the report.

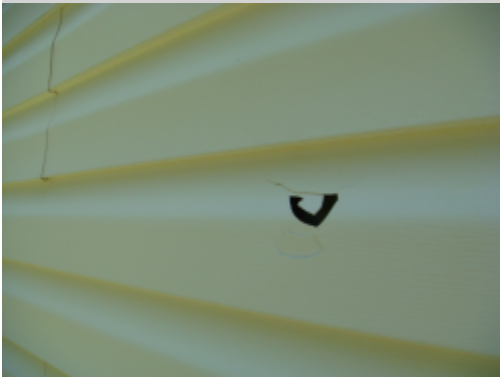
(B1 - 1.1) Main House

On the left side of the home, a damaged or cracked piece of siding is in need of replacement. A siding installation company or general contractor should be consulted to evaluate and repair the siding to ensure the integrity of the cladding system.

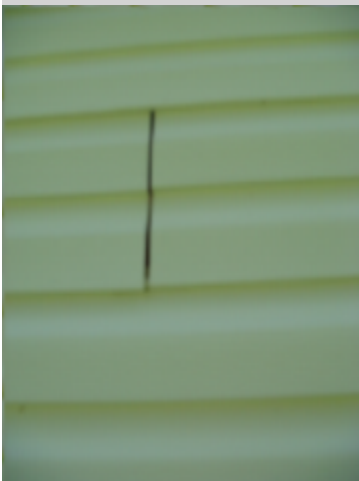
(B1 - 1.2) Main House

on the rear of the house, short pieces of siding were noted. The short pieces are loose and leave the wall sheathing/house wrap exposed. The siding needs to be installed to create a complete cladding system covering all underlying wall components. A siding installation company or general contractor should be consulted to evaluate and repair the siding to ensure the integrity of the cladding system.

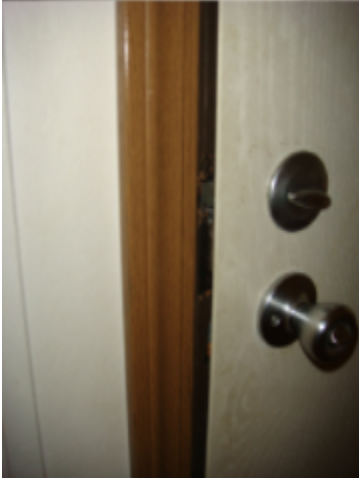
(B2 - 2.1) Doors ; Location: Main House Front

The door lock assembly is not aligned with the striker in the jamb area. The deadbolt could not be engaged to secure the door. The door/lock needs repair/replacement to ensure that the door closes securely. A general repair specialist or licensed general contractor should be consulted for evaluation and repair.

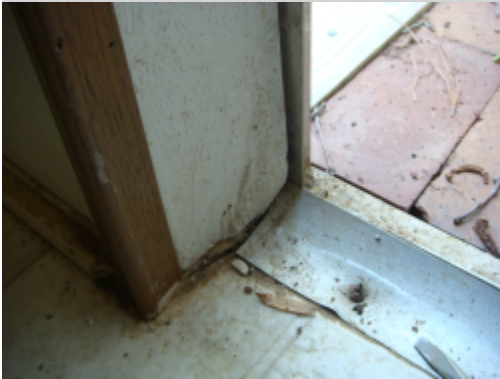
(B2 - 3.1) Doors ; Location: Main House Rear

The exterior rear door trim has soft and decayed wood in the frame area bottom left. Decay in the door frames can result in leaking and water penetration and should be repaired as soon as possible. All doors should be inspected for similar damage as repairs are made. A general repair specialist or licensed general contractor should be consulted for evaluation and repair.

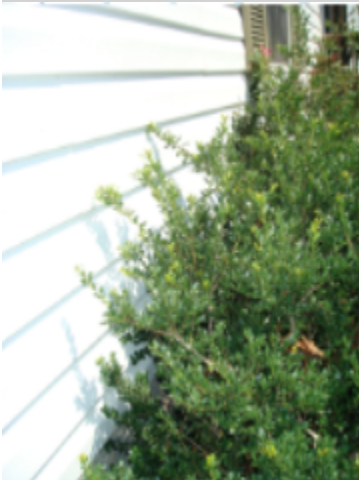
(B5 - 1.2) Vegetation; Location: Main House

Additional Photograph: This a photograph of vegetation

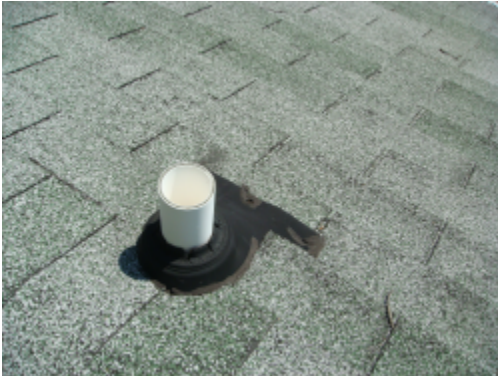
(C3 - 1.1) Main House; Location: Plumbing Vent

The vent boot located left and middle of roof acts as a flashing to prevent water penetration around the plumbing vent pipe is split, cracked. A licensed roofing contractor should be consulted for evaluation and repair to ensure the weather-tightness of the roof covering system.

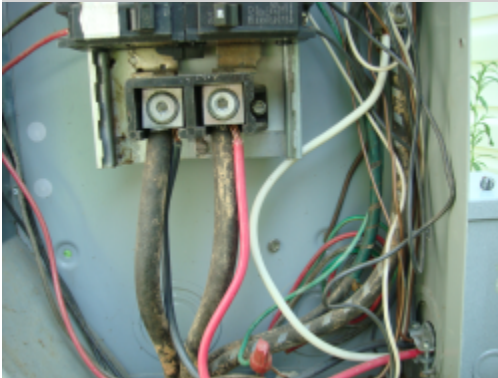
(E2 - 1.1) Main Panel #1; Location: Exterior

A set of conductors for the external generator plug have been inserted in the main lugs with the main service cables. This double tap leaves the added conductors and branch circuit that is being power unprotected and unsafe. This condition presents a safety hazard that could result in interrupted service, property damage, and serious personal injury. A licensed electrical contractor should be consulted for repair and a complete evaluation of the electrical system.

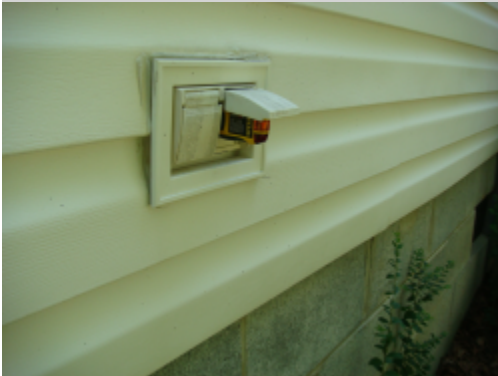
(E5 - 1.1) Exterior

The receptacle located main house rear had no power. This could indicate a damaged receptacle or branch wiring circuit. A licensed electrical contractor should be consulted for a complete evaluation to determine the significance of this concern and make necessary repairs to correct defects and prevent safety hazards.

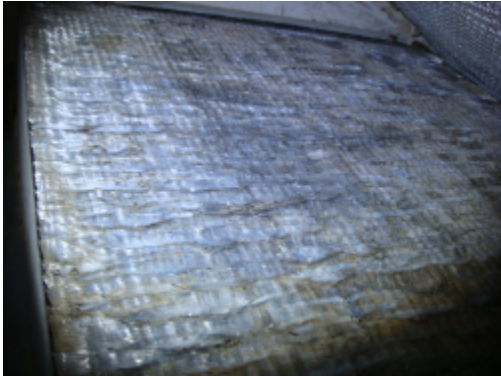
(G1 - 1.1) Cooling Unit #1; Location: Closet: Hall

The evaporator coil unit for the heat pump/AC system has visible damage to the coil fins. A damaged coil can result in leaking refrigerant and poor system performance. A HVAC contractor should be consulted for a complete evaluation and repair of the system to ensure reliable and proper operation of the HVAC system.

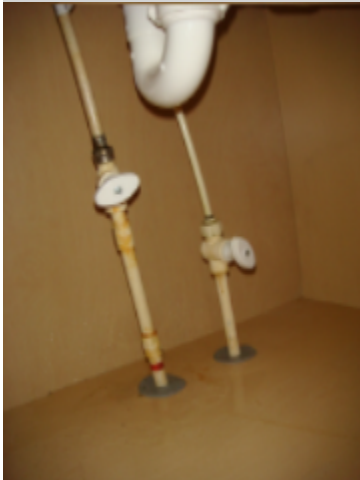
(H3 - 1.1) Bathroom: Master

The sink faucet leaks into the cabinet area when turned on. The leaks could result in damage to the sink and cabinet and should be repaired as soon as possible. A licensed plumbing contractor should be consulted for a complete evaluation to determine the significance of this concern and make necessary repairs to prevent leaks and ensure sanitary conditions.

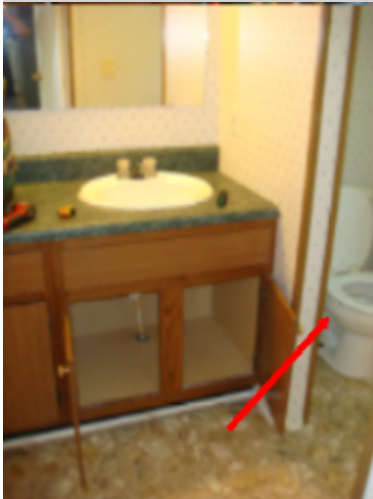
(H3 - 1.2) Bathroom: Master

The water flow to the toilet is low. Low water flow in the bathroom can indicate an underlying problem with the plumbing systems/components and reduce the effectiveness and function of the fixtures. A licensed plumbing contractor should be consulted for evaluation and repair.

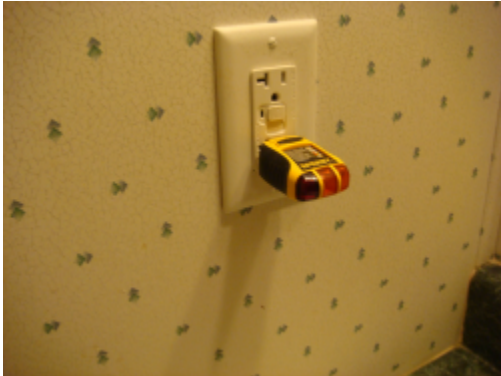
(H3 - 2.1) Bathroom #1

The receptacle located in bathroom #1 had no power. This could indicate a damaged receptacle or branch wiring circuit. A licensed electrical contractor should be consulted for a complete evaluation to determine the significance of this concern and make necessary repairs to correct defects and prevent safety hazards.

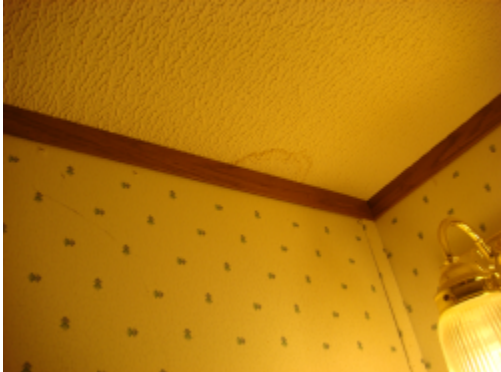
(H3 - 2.2) Bathroom #1

Stains on the ceilings indicate a history of a leak. At the time of the inspection it was not possible to determine if the condition was due to an active or past occurrence. Further investigation by a repair specialist and owner disclosure is recommended.

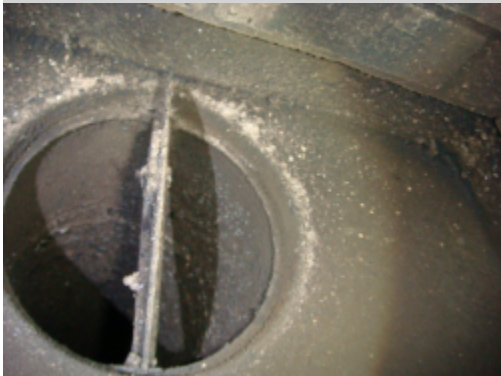
(H6 - 1.1) Fireplace: Pre-Manufactured: Metal: Box: ; Location: Living Room

From the fireplace opening, heavy build of soot was noted. Soot build-up can result in improper function of the fireplace and high potential for fire. A chimney sweep and general contractors should be consulted for a complete evaluation of the chimney and to make necessary repairs to ensure that the chimney is safe and functional.

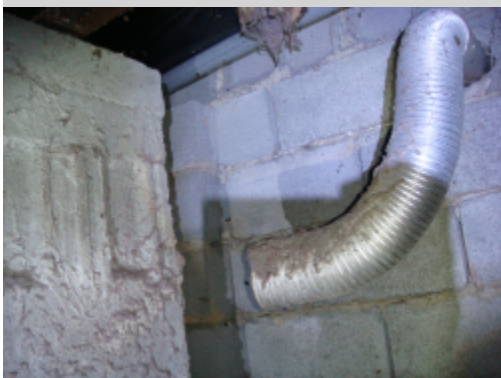
(J1 - 3.1) Vent: Dryer; Location: crawl space

The exhaust duct for the clothes dryer is disconnected in the crawl space and does not have proper termination at the floor level inside the home. The dryer duct should be kept in good working order to prevent fire hazards and properly distribute moisture to the exterior of the home. Note: the dryer duct for this home is a flexible plastic duct, most new dryers require a solid pipe metal duct. A HVAC contractor should be requested to upgrade this duct for safest operation.
