Home Inspection Report

Report Number: 73115-1
For The Property Located On:

Hillsborough, North Carolina 27278

Date of Inspection: Friday, July 31, 2015

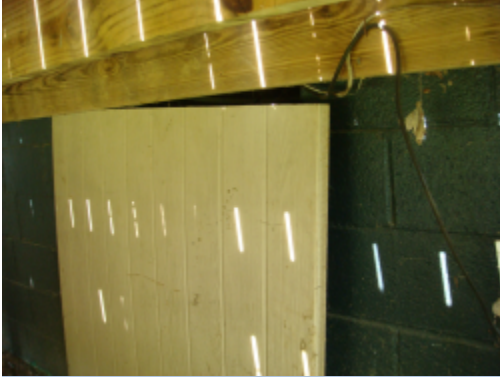
(A1 - 1.1) Main House

Access to the crawl space under the back deck is not secure, and can allow unwanted animals access. A general contractor should be consulted for further evaluation and to make necessary repairs.

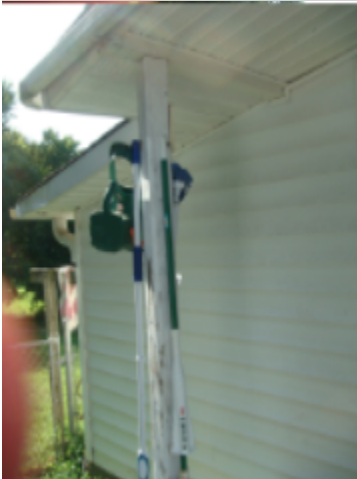
(A2 - 1.1) Main House rear, left

The column is weathered and starting to split. Repair and painting is needed to prevent further damage and decay. A general repair person should be consulted.

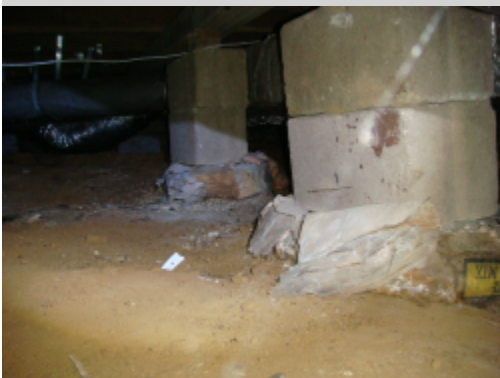
(A2 - 2.1) Main House

The foundation and pier system are in need of repair. This foundation was constructed without a concrete footing, over time the soil under the foundation area has eroded and degraded leaving the foundation poorly supported. A licensed general contractor should be consulted for further evaluation and repair. If the repair is beyond the scope of the Building code, a professional engineer should be consulted to outline the repair.

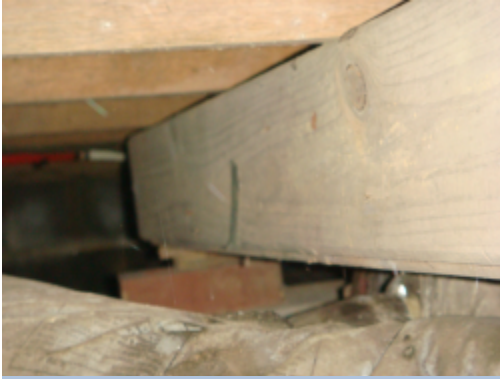
(A2 - 2.2) Main House

Additional Photograph: This a photograph of crawl space column

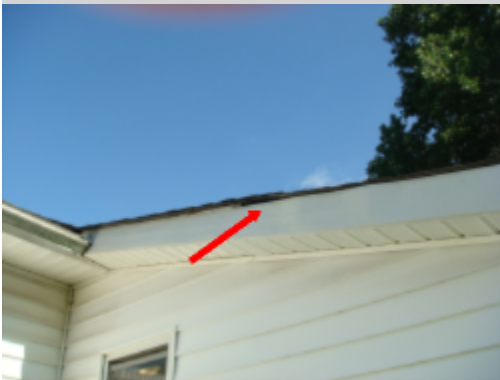
(A6 - 2.1) addition

The additions roof slopes to one side and the roof sheathing edges are not supported parallel to the rafter in the roof valley area. The edges of the roof sheathing need to be supported along the long seams parallel to the rafters and beams to prevent movement and damage to the roof covering. A licensed general contractor should be consulted for further evaluation and to make necessary repairs.

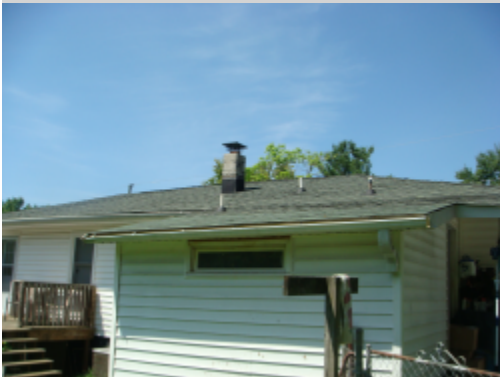
(A6 - 2.2) addition

Additional Photograph: This is a photograph of addition roof

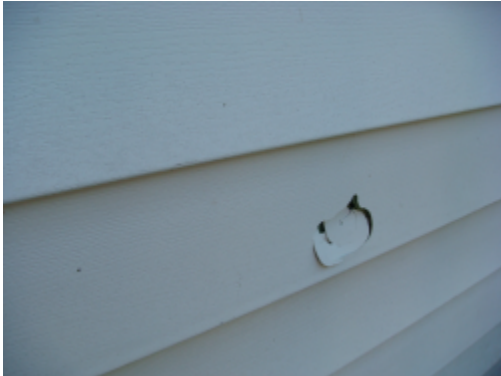
(B1 - 1.1) Main House

The siding for this home is a vinyl material. The siding on this home has several visible areas of damaged pieces. A licensed general contractor should be consulted for complete evaluation to locate and repair all areas of damage.

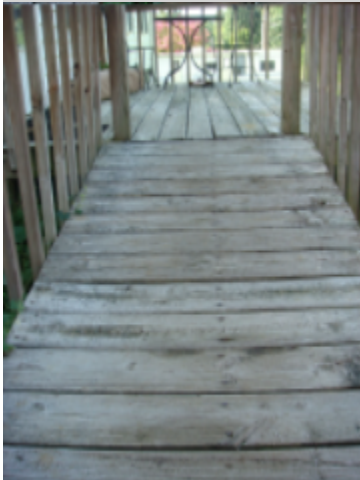
(B3 - 1.1) Porch ; Location: Main House Front

The front porch surface boards are cupped and splintered. Splintering boards can result in injury such as puncture wounds and should be considered hazardous for children. A licensed general contractor should be consulted for evaluation and to make necessary repairs.

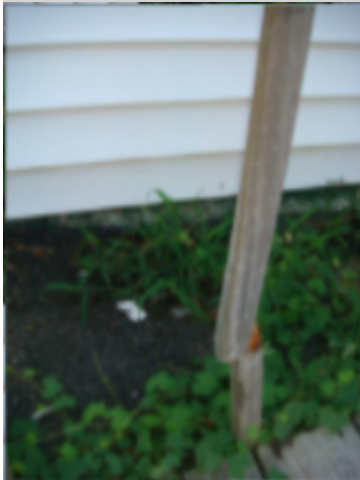
(B3 - 1.2) Porch ; Location: Main House Front

Incorrect baluster spacing and several balusters were noted to be loose or damaged and in need of repair or replacement to ensure safe and functional use of the deck/porch. A licensed general contractor should be consulted for a complete evaluation and to make necessary repairs.

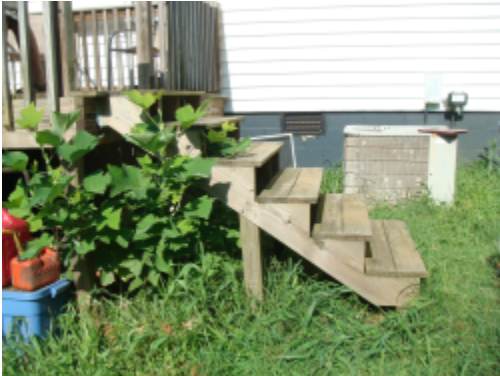
(B3 - 2.1) Deck ; Location: Main House Rear

The deck steps do not have handrails to prevent accidentally falling or stepping off the floor surface. It is recommended that handrails be installed to ensure safe and functional use of the deck. A licensed general contractor should be consulted for a complete evaluation and to make necessary repairs.

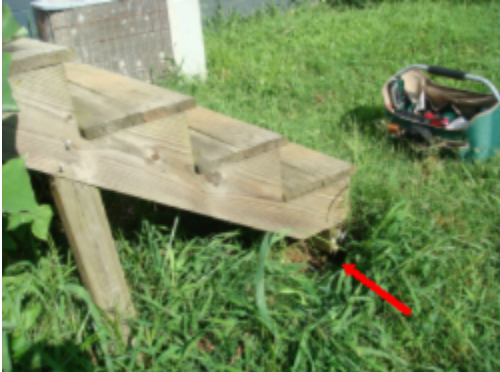
(B3 - 2.2) Deck ; Location: Main House Rear

The wood steps for the rear deck are in need of repair. The steps should be repaired to ensure safe entry and egress for the home. The following concerns were noted at the time of the inspection: Step stringer base is not properly supported; A licensed general contractor should be consulted for a complete evaluation and to make necessary repairs.

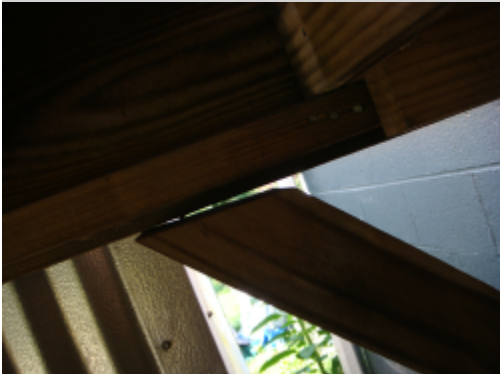
(B3 - 2.3) Deck ; Location: Main House Rear

The deck bracing was loose. Loose bracing can cause lateral movement of the deck. Improper deck construction can result in unsafe conditions and possible deck failure. A licensed general contractor should be consulted for complete evaluation of the deck and to make necessary repairs.

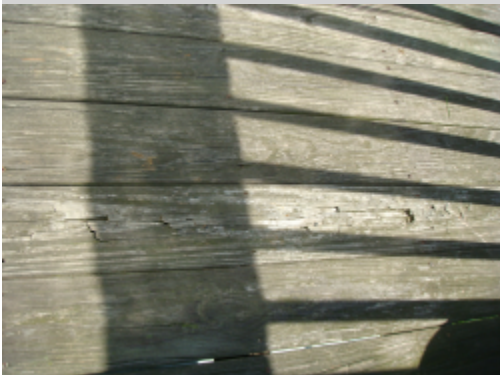
(B3 - 2.4) Deck ; Location: Main House Rear

The deck surface boards are cupped and splintered. Splintering boards can result in injury such as puncture wounds and should be considered hazardous for children. A licensed general contractor should be consulted for evaluation and to make necessary repairs.

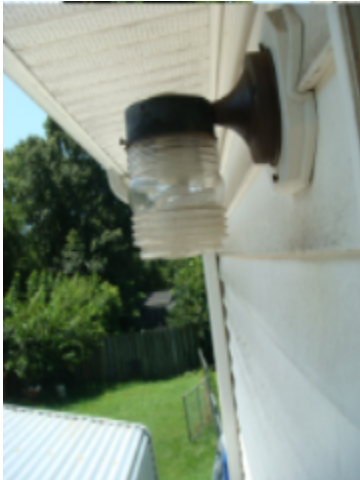
(B3 - 2.5) Deck ; Location: Main House Rear

The light fixture located on the rear deck was not functional when tested. This could indicate a defective bulb or other more serious problem such as faulty wiring or a defective fixture, further evaluation and repair is needed. A licensed electrical contractor should be consulted for further evaluation and repair.

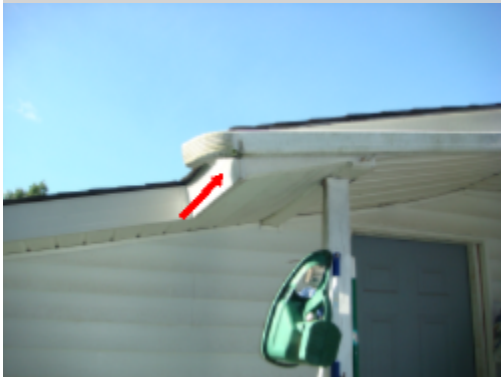
(C2 - 1.1) Main House; System Type: Gutter

The gutter trays and downspouts in various locations around the house are loose and not properly secured. Loose gutter trays can be the result of physical damage or improper support spacing. It is very important to keep gutter functioning properly to reduce direct drainage to the foundation and wall cladding systems. A licensed general contractor should be consulted for a complete evaluation and to make necessary repairs.

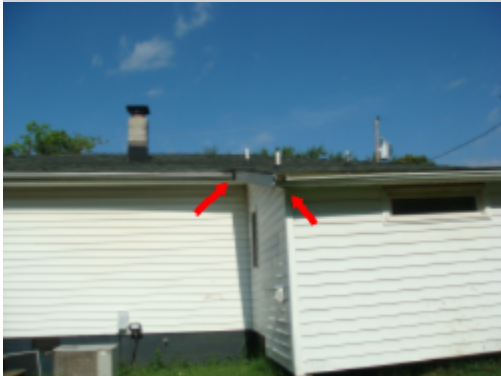
(C2 - 1.2) Main House; System Type: Gutter

Additional Photograph: This is a photograph of gutters

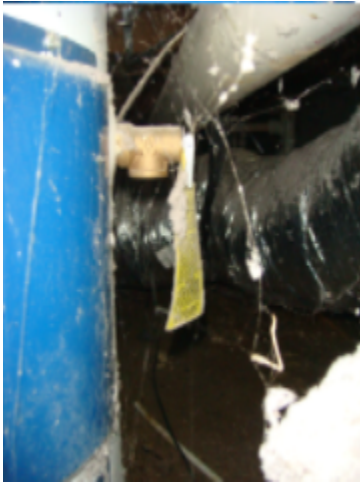
(D3 - 1.1) Unit #1 ; Location: Crawl Space

The hot water temperature for the home was noted to be too high.

The recommended temperature to prevent personal injury and burns is 120 degrees F. The elevated temperature could indicate a malfunction or problems with the water heating unit. A licensed plumbing contractor should be consulted to evaluate the system to ensure that the water heating unit is operating correctly and within a safe temperature range.

The Temperature Pressure Relief Valve (TPRV) for the water heater is a safety device to prevent the unit from exploding in case of a malfunction. The TPRV is located at the top of the hot water unit and to prevent burn injury in the event of a discharge, the TRPV requires a piped extension down to the floor area. The TPRV for this unit is not properly extended to ensure proper valve operation or prevent personal injury, this is a safety issue that needs to be corrected to prevent personal injury or property damage. A plumbing contractor should be consulted for further evaluation and repair.

The hot water temperature for the home was noted to be too high. The recommended temperature to prevent personal injury and burns is 120 degrees F. The elevated temperature could indicate a malfunction or problems with the water heating unit. A licensed plumbing contractor should be consulted to evaluate the system to ensure that the water heating unit is operating correctly and within a safe temperature range.

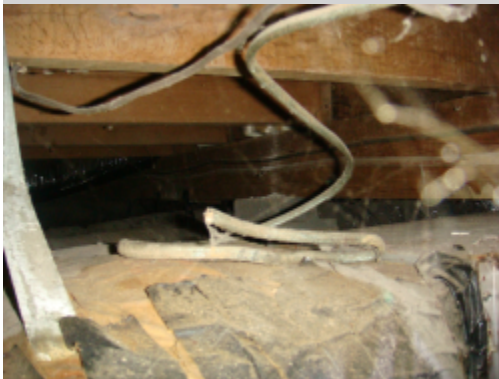
(E4 - 1.1) Crawl Space

Disconnected wires were noted in the crawl space. Disconnected wires should be removed or properly terminated. The disconnected wires leave electrical conductors exposed and in a hazardous condition. Electrical concerns should be considered fire and safety issues and repaired as soon as possible. The electrical systems and components are in need of a complete evaluation and repair by a licensed electrical contractor.

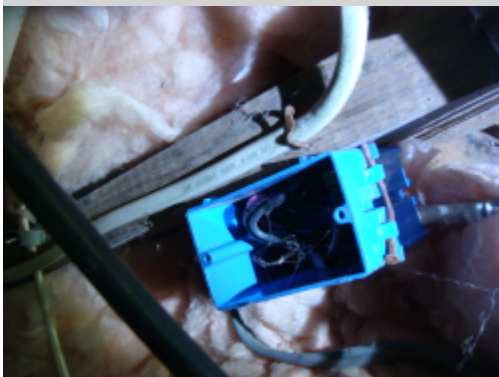
(E4 - 1.2) Crawl Space

Electrical connections have been made in the crawl space without being properly protected in a covered junction box. The damage leaves electrical conductors exposed and in a hazardous condition. Electrical concerns should be considered fire and safety issues and repaired as soon as possible. The electrical systems and components are in need of a complete evaluation and repair by a licensed electrical contractor.

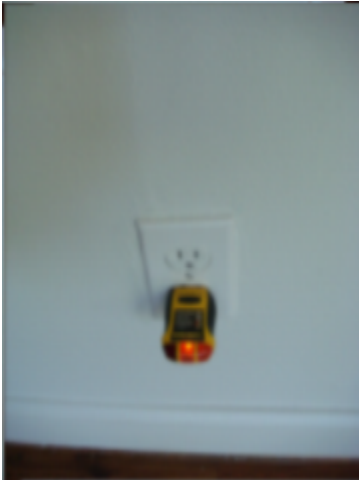
(E4 - 2.1) Interior Spaces

The receptacles located in various rooms throughout the house tested as open ground, even though receptacles are three prongs. An equipment ground provides an extra safety feature to prevent electrical shock hazards and property damage. A licensed electrical contractor should be consulted for a complete evaluation to determine the significance of this concern and make necessary repairs to correct defects and prevent safety hazards.

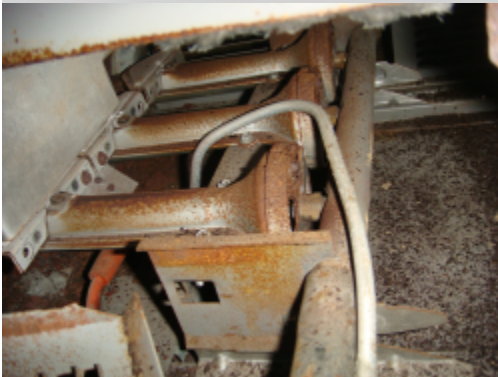
(F1 - 1.1) Heating Unit #1; Location: Crawl Space

The gas furnace unit has visible rust in the burner chamber area. The rust indicates deterioration of the exchanger. Deterioration of the heat exchanger is a serious concern that can result in improper combustion and carbon monoxide poisoning. The furnace needs a complete evaluation which should include a heat exchanger inspection to ensure safe, reliable, and proper operation of the HVAC system. A licensed HVAC contractor should be consulted for repair.

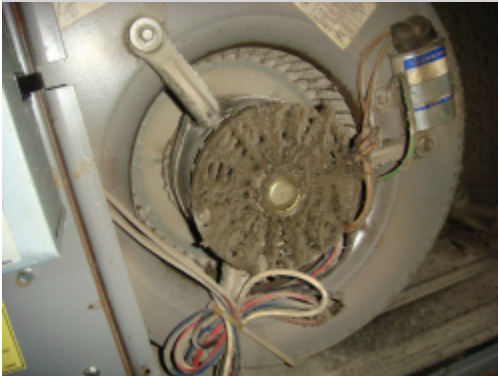
(F1 - 1.2) Heating Unit #1; Location: Crawl Space

The air handler cabinet is dirty and in poor condition. The condition of the cabinet ensures protection of the coil/fan and clean air supply. A HVAC contractor should be consulted for a complete evaluation and to make necessary repairs to ensure safe, reliable, and proper operation of the HVAC system.

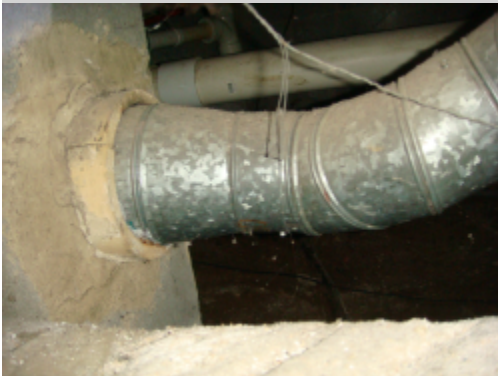
(F1 - 1.3) Heating Unit #1; Location: Crawl Space

The gas furnace has a natural draft exhaust system. The flue exits directly to the side wall without the require height of vertical rise. This configuration creates a hazard that could result in exhaust entering the living spaces of the home and possible carbon monoxide poisoning. A HVAC contractor should be consulted for a complete evaluation and repair of the system to ensure safe and proper operation of the HVAC system.

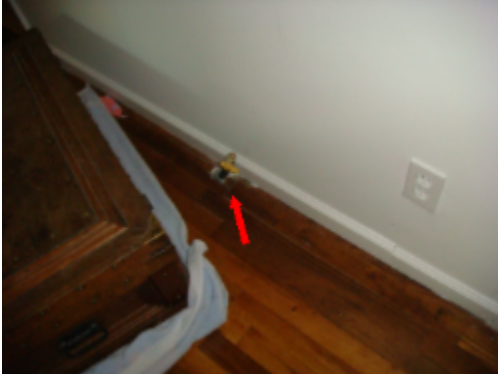
This home has corrugated stainless steel gas lines. This gas line has specific installation requirements related to required bending allowances, support, protection, and electrical bonding to ensure safe conditions. A section of the CSST gas line located in main hallway is not in use and should have a permanent sealing cap installed.

Improper termination could result in leaking and hazardous conditions. A plumbing or HVAC contractor should be consulted for a complete evaluation of the CSST installation and to verify the presence of electrical bonding.

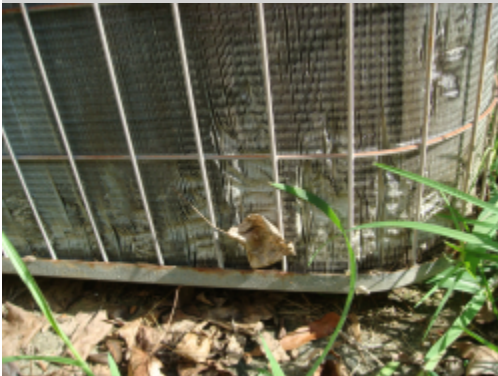
The outside compressor/coil unit for the AC system has visible damage to the coil fins. A damaged coil can result in leaking refrigerant and poor system performance. A HVAC contractor should be consulted for a complete evaluation and repair of the system to ensure reliable and proper operation of the HVAC system.

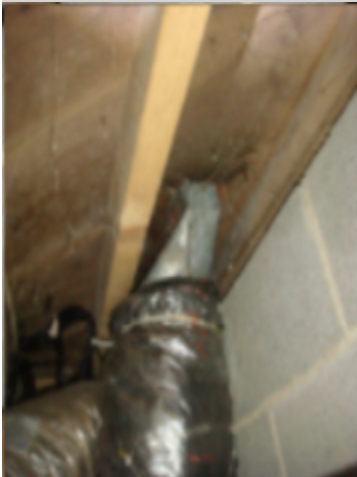
The insulation for the duct branches is not fully insulated to the registers. The insulation prevents condensation from building and causing the floor to deteriorate at the register. A HVAC contractor should be consulted for a complete evaluation and replacement of all damaged duct components to ensure reliable and proper operation of the HVAC system.

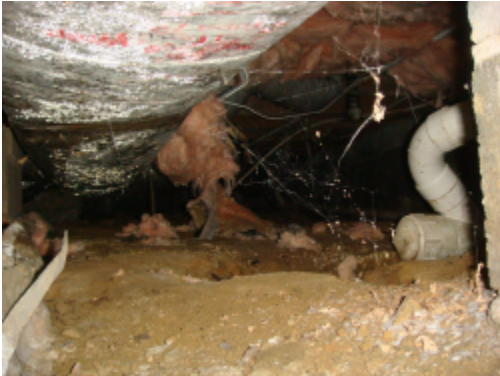
(G2 - 1.2) Cooling Unit #1; Access: Crawl Space

The insulation on the duct trunk line was noted to be wet. The source of the moisture and any related concerns need to be addressed to ensure proper air flow and prevent contamination of the air supply. A HVAC contractor should be consulted for a complete evaluation and replacement of all damaged duct components to ensure reliable and proper operation of the HVAC system.

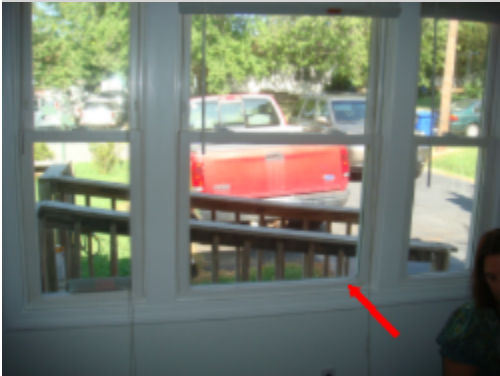
(H1 - 1.1) Living Room

The sash spring were noted to be disconnected on several windows during the inspection. The sash springs assist in lifting and holding the window in place when it is opened. When the springs are disconnected or broken the window will not remain in the open position and can drop suddenly resulting in personal injury. Repair is needed to ensure proper function of the window. A general repair specialist or licensed general contractor should be consulted for evaluation and repair.

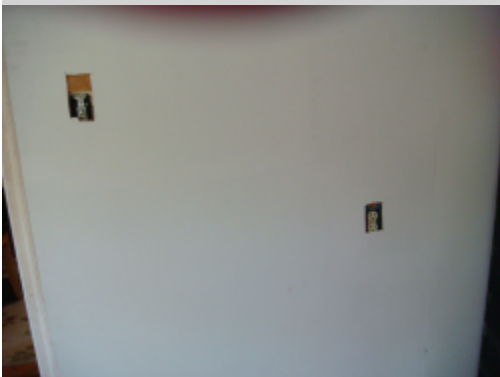
(H1 - 2.1) Addition

The receptacle is missing the cover plate. Exposed uncovered receptacles and junction boxes are fire hazards. A licensed electrical contractor should be consulted for a complete evaluation to determine the significance of this concern and make necessary repairs to correct and prevent safety hazards.

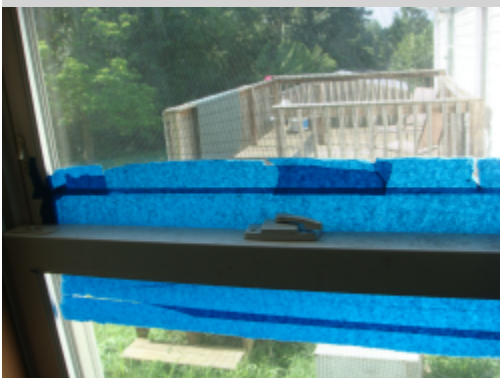
(H1 - 2.2) Addition

The window in the addition needs repair to ensure proper operation. The window did not properly lock. All windows should be evaluated as repairs are made. A licensed general contractor should be consulted.

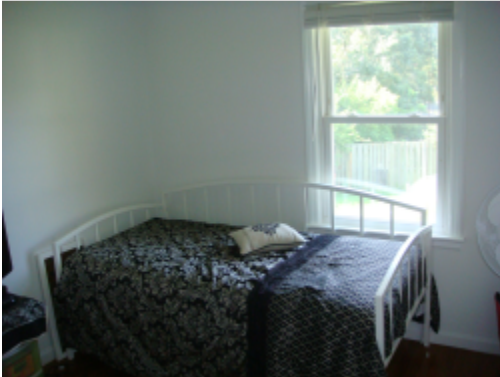
The sash spring were noted to be disconnected on several windows during the inspection. The sash springs assist in lifting and holding the window in place when it is opened. When the springs are disconnected or broken the window will not remain in the open position and can drop suddenly resulting in personal injury. Repair is needed to ensure proper function of the window. A general repair specialist or licensed general contractor should be consulted for evaluation and repair.

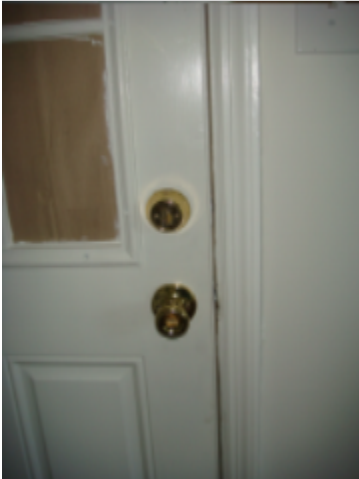
(H1 - 3.3) Bedroom #2 right side rear

The entrance door to the home has a double key deadbolt lock. This type of lock cannot be unlocked from the interior of the home without the key and is not recommended for main egress doors. In the event of an emergency, the key may not be available resulting in a person not being able to exit the home. Replacement is recommended.

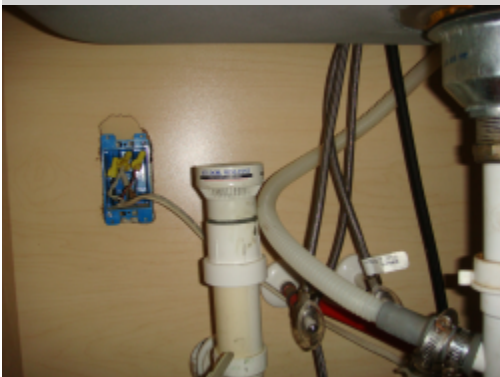
An electrical receptacle was noted in the cabinet behind the storage. The receptacle is missing the cover plate. Exposed uncovered receptacles and junction boxes are fire hazards. A licensed electrical contractor should be consulted for a complete evaluation to determine the significance of this concern and make necessary repairs to correct and prevent safety hazards.

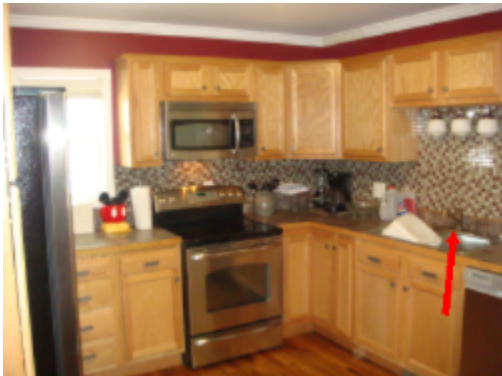
(H2 - 1.2) Kitchen

The kitchen sink hot water supply water flow is low and fills less than half of the faucet opening. Low water flow in the kitchen can indicate an underlying problem with the plumbing systems/components and reduce the effectiveness and function of the fixtures. A licensed plumbing contractor should be consulted for evaluation and repair to ensure proper service.

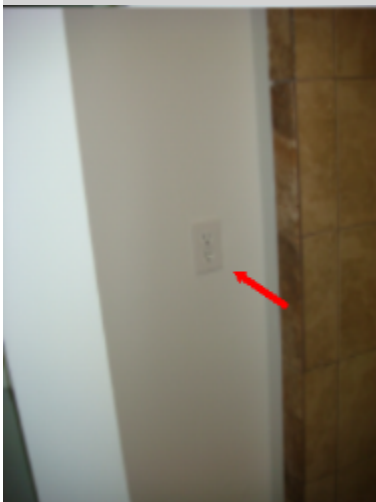
(H3 - 1.1) Bathrooms

The receptacles located in both bathrooms are not GFCI protected. Receptacles located in hazardous or wet locations should be GFCI protected to reduce shock in hazardous locations. A licensed electrical contractor should be consulted for further evaluation and repair.

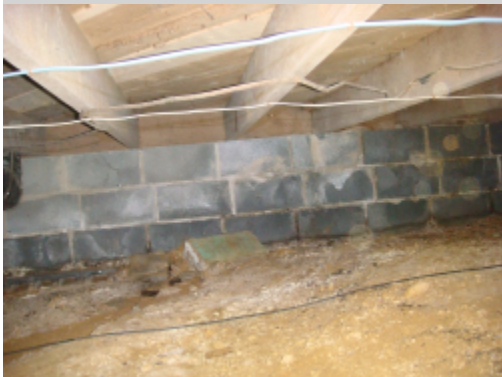
(I1 - 2.1) Crawl Space: All Accessible Areas

Insulation and vapor barrier in the crawl space is missing. Improper insulation installation could result in condensation, over heating of the building components, and inadequate conditioning of the living areas. A licensed general contractor should be consulted for repair/ replacement.

Stains and water lines indicate a history of standing water in the crawl space around the perimeter of the foundation and under the porches. Direct water penetration damages the foundation, the wood structure, and creates an undesirable environment in the crawl space areas that encourages insect, fungal growth such as mold/mildew. Repairs are needed to prevent water penetration. Water in the crawl space indicates an absent or damaged waterproofing and foundation drain system. Repairs are needed to prevent water penetration. A general contractor should be consulted for further evaluation to determine the source of the moisture and to make necessary repairs.

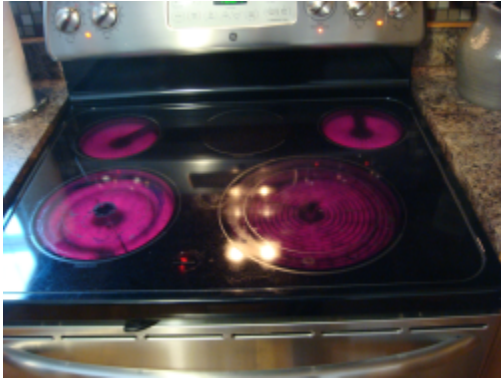
(J1 - 3.1) Range: Electric; Location: Kitchen

The oven/range moves forward when the door is opened. The oven needs to be secured anchored with an anti-tip bracket to prevent the unit was turning over when weight is applied to the door. An appliance repair person or general contractor should be consulted for repair.

The knob for the warming is broken
