Home Inspection Report

Report Number: 91015-1
For The Property Located On:

Louisburg, North Carolina 27549

Date of Inspection: Thursday, September 10, 2015

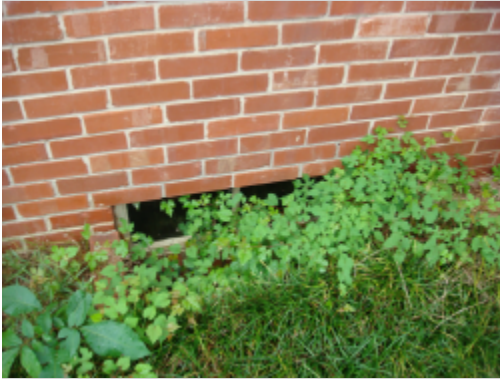
(A1 - 1.1) Main House

The foundation vents are below grade and protected from drainage by the installation of the window well. The window well area was filled with debris and the ventilation is blocked or restricted. The blocked ventilation could result in undesirable conditions in the foundation area and should be corrected. A licensed general contractor should be consulted for a complete evaluation of the window well system and to make necessary repairs.

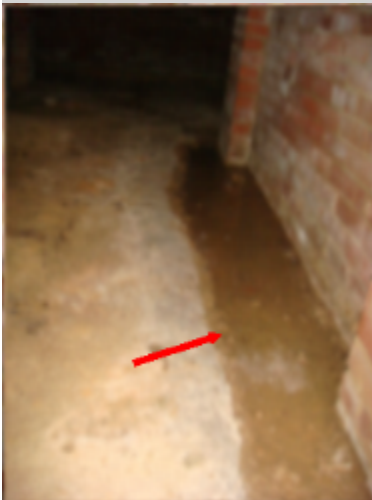
(A1 - 1.2) Main House

Areas of standing water were present in the crawl space around the perimeter of the foundation and under the porches. Direct water penetration damages the foundation, the wood structure, and creates an undesirable environment in the crawl space areas that encourages insect, fungal growth such as mold/mildew. Water in the crawl space indicates an absent or damaged waterproofing and foundation drain system. Repairs are needed to prevent water penetration. A general contractor should be consulted for further evaluation to determine the source of the moisture and to make necessary repairs.

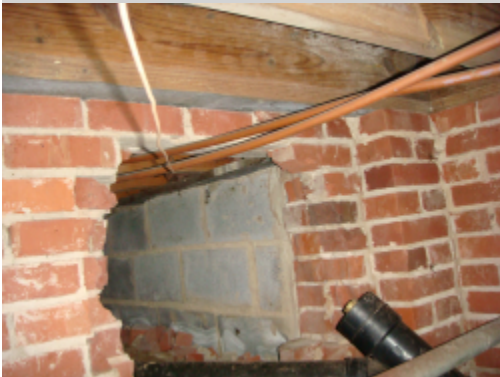
(A1 - 1.3) Main House

An opening was installed in the foundation area to install a (item). The adjacent framing that was originally supported by direct bearing on the foundation was not modified or supplemented by a beam or lintel to span across the opening. A general contractor should be consulted for further evaluation and to make necessary repairs to ensure the stability of the framing.

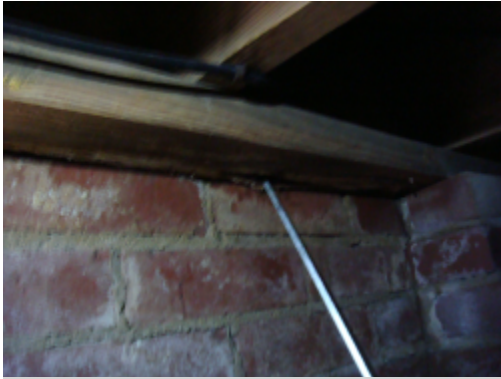
The subflooring around the perimeter of the foundation was noted to be soft and decayed. Evidence suggests direct water penetration and or condensation. A licensed general contractor should be consulted for an invasive investigation to determine the source of the water penetration and the extent of the decay to prevent further damage and undesirable conditions.

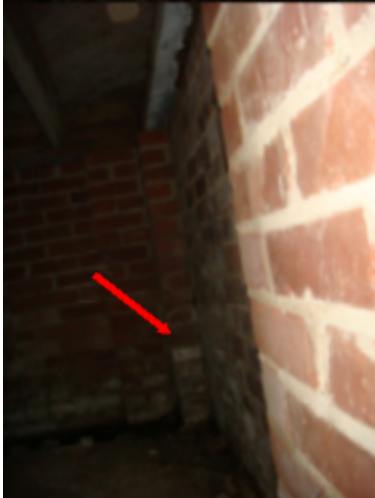
Efflorescence (salt stains) was noted on the foundation walls. The stains indicate that the foundation was been cyclically wet and dry. Water penetration into the foundation area can result in structural damage and undesirable environmental conditions. Water in the foundation area indicates an absent or damaged waterproofing and foundation drain systems. Repairs are needed to prevent water penetration. A general contractor should be consulted for further evaluation to determine the source of the moisture and to make necessary repairs.

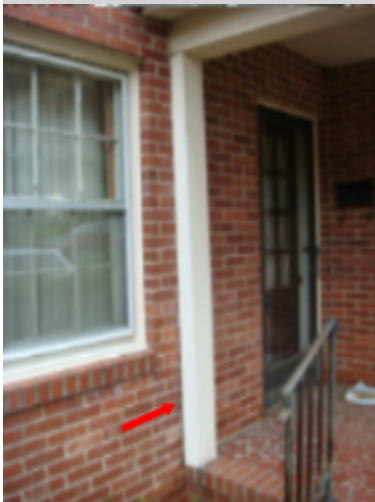
The column located right side porch is not fully bearing on the support base. The improper alignment could indicate improper installation or movement of the column. A licensed general contractor should be consulted for further evaluation and to make necessary repairs.

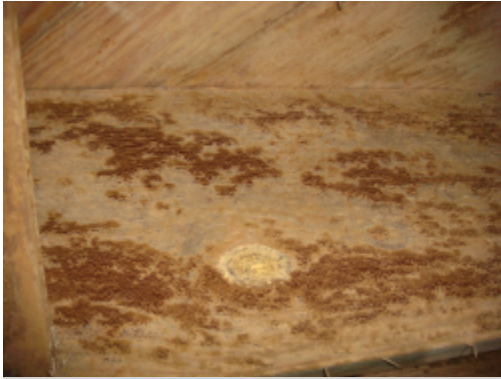
Mold noted in basement/ crawl space area The area was inspected for moisture concerns and evidence of wood damage; however, health related issues concerning mold are beyond the scope of the home inspection. If the buyer has additional concerns related to the presence of the fungal growths such as mold an industrial hygienist should be consulted.

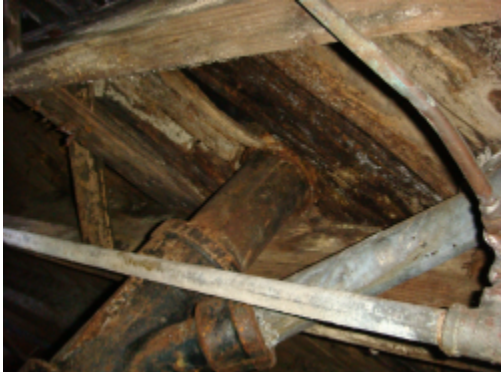
The subflooring under the toilet/bathtub/Shower was noted to be soft and decayed. Evidence suggests direct water penetration. A licensed general contractor should be consulted for an invasive investigation to determine the source of the water penetration and the extent of the decay to prevent further damage and undesirable conditions.

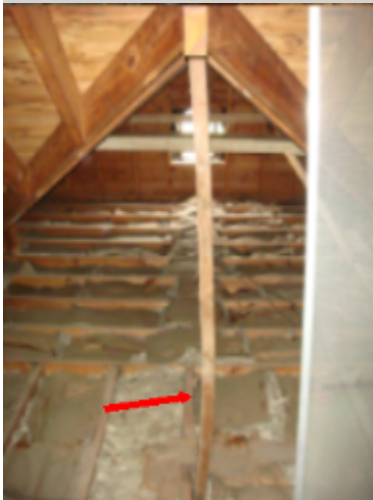
From the attic, the ridge board support for front right gable were noted to be bowed or warped beyond what would be typically expected.

The bowing could indicate an underlying problem with the design, installation, or attic conditions. An engineer should be consulted for further evaluation to determine the significance of the concern and outline necessary repairs to ensure the stability of the structure.

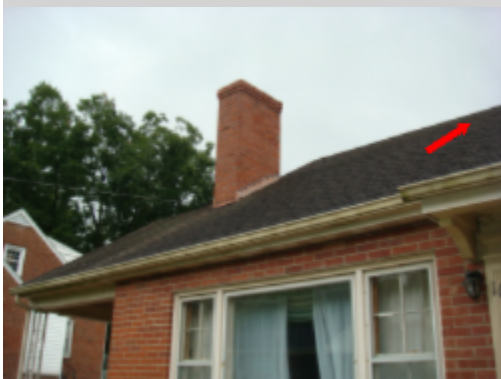
From the exterior of the home, the roof surface has visible sag along the ridge. A licensed general contractor should be consulted for further evaluation and repair to ensure the stability of the structure.

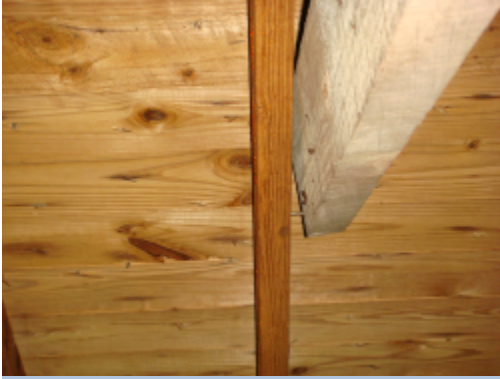
A rafter collar tie is not secure and are separating. A general contractor should be consulted for further evaluation to determine the significance of the concern and outline necessary repairs to ensure the stability of the structure.

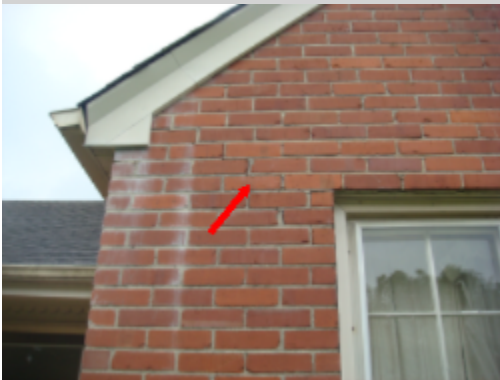
Cracks were noted above /below the windows/doors in the brick veneer. Cracks in brick veneer indicate a deficiency that can change or progress over the life of the home. The cracks on this home were closed at the time of the inspection and presented no visible evidence of progression to the foundation areas. The buyer should observe the cracks and assess their concerns related to the presence of the cracks, the number of cracks, and possibility of the condition worsening over the life of the home. If the buyer has additional concerns an engineer should be consulted to determine the significance of the cracking.

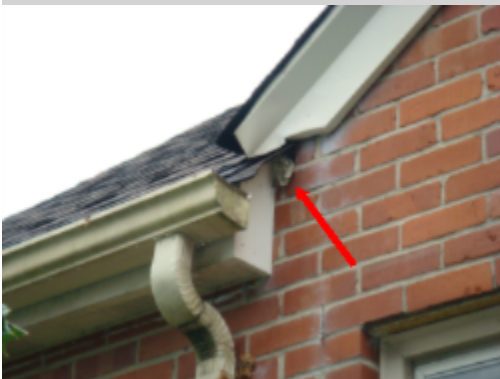
The right side exterior trim at the roof eave of the home need repairs to prevent further damage and water penetration. A licensed general contractor should be consulted for a complete evaluation of the exterior siding, trim and boxing to determine the scope of the damage and make necessary repairs.

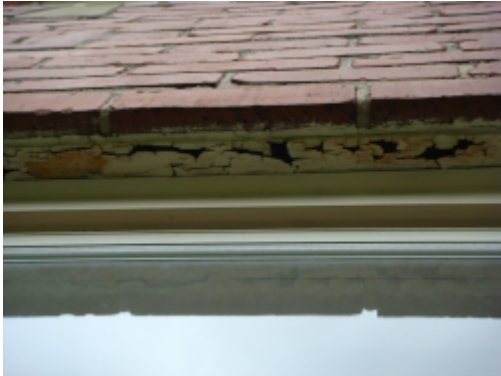
The paint is loose, peeling, on the wood trim 3rd bedroom (front) The exposed wood is subject to deterioration and decay. The windows and trim need paint and repair to prevent leaking, deterioration, and decay. A licensed general contractor should be consulted to evaluate the extent of the damage and make necessary repairs.

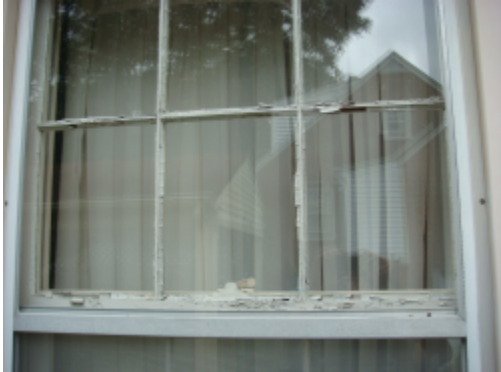
Many windows throughout the house have window glazing is installed in the window frame to secure the glass panes. The glazing on the windows for this home is loose, cracking and missing. The windows need repairs and painting to secure window panes, prevent decay and leaking. A licensed general contractor should be consulted to make necessary repairs.

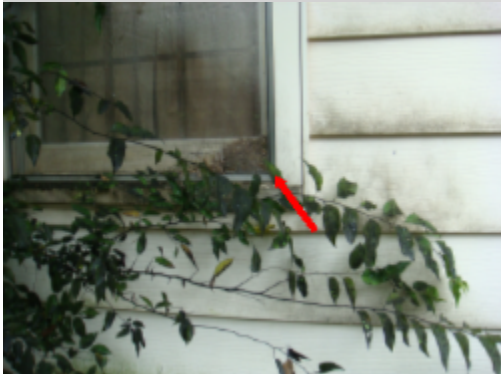
Nests were noted in a couple of windows. This could be evidence of rodents. While not uncommon, rodent can cause damage to building components and unsanitary conditions. A general contractor or pest management company should be consulted to locate and correct the points of entry and determine the extent of the contamination.

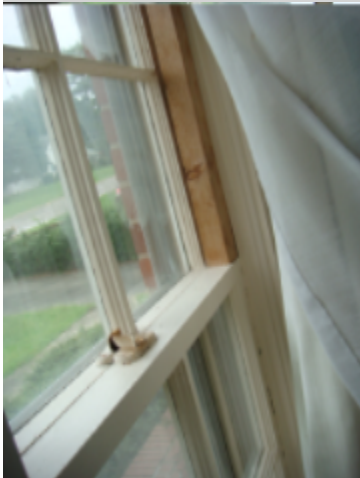
Many windows throughout the house are hard to open or will not open and are in need of repair to ensure proper operation. If in a bedroom the window is the means of emergency egress. It is very important to have a proper method of egress from every sleeping area in case of an emergency such as a fire. A licensed general contractor should be consulted for evaluation and repair.

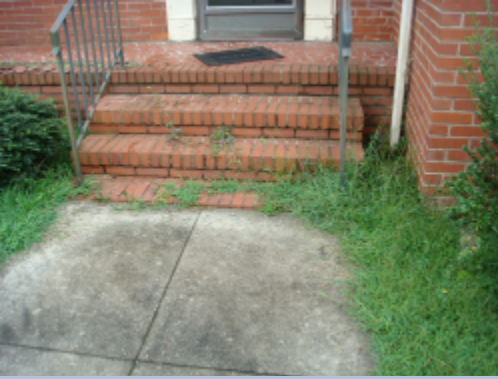
The masonry steps are in need of repair. Deterioration of the bricks and mortar has created conditions that could result in a trip hazard. The steps should be repaired to ensure safe entry and egress for the home. A licensed general contractor should be consulted for a complete evaluation and to make necessary repairs.

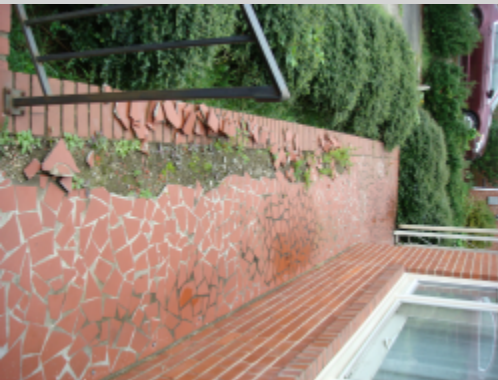
The brick pavers/tile on the porch pad are cracked/loose. The loose brick/tile has resulted in an uneven walking surface and created an opening where water could enter the foundation area. A licensed general contractor should be consulted for further evaluation, to determine the extent of the concern, and to make necessary repairs.

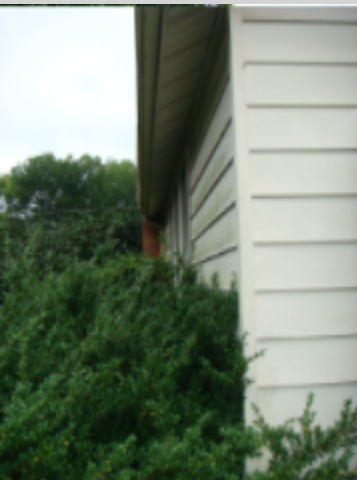
The vegetation around the perimeter of the home is over grown and blocks the air circulation around the home. The growth also limited the inspection access. A landscaping company should be consulted to correct the over growth and the inspection should be completed prior to purchase.

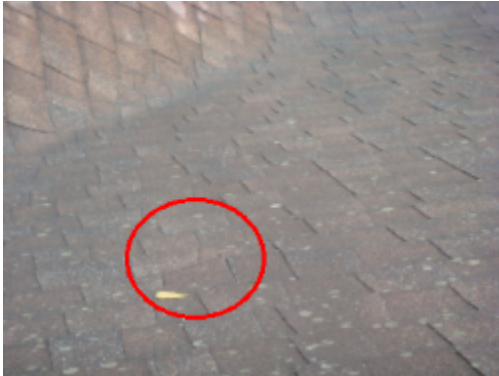
A raised shingle on the front area of the roof surface is in need of repair / replacement. Displaced shingles could indicate an underlying problem with the shingles installation or attic conditions. A licensed roofing contractor should be consulted for a complete evaluation and repair to ensure the weathertightness of the roof covering system.

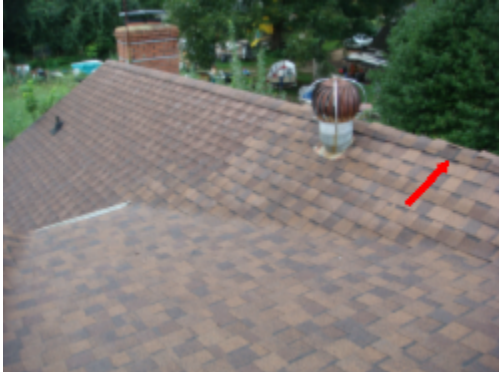
The cap shingles for the ridge section of the roof are not the correct shingle type. Shingle caps for hip areas are most susceptible to wind and storm damage and need to be installed correctly. A licensed roofing contractor should be consulted for a complete evaluation and to make necessary repairs to ensure the weathertightness of the roof covering system.

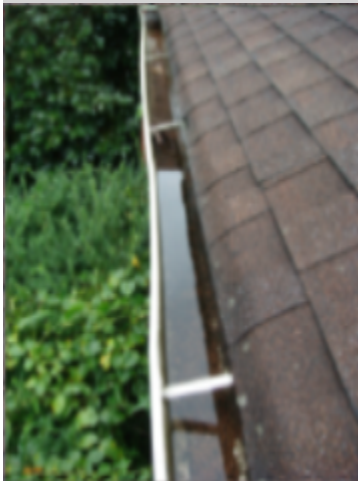
The gutter tray located left side has been overflowing. The gutter installation and slope needs to be verified. . It is very important to keep gutter functioning properly to reduce direct drainage to the foundation and wall cladding systems. A licensed general contractor should be consulted for a complete evaluation and cleaning of all gutters and to make necessary repairs.

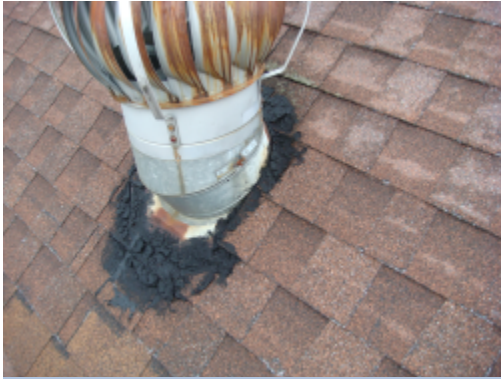
The seam between the roof vent and the roof is heavily caulked and no flashing was visible. Heavy caulking is a temporary repair and an indication of a history of leaking. A licensed roofing contractor should be consulted for evaluation and repair to ensure the weather-tightness of the roof covering system.

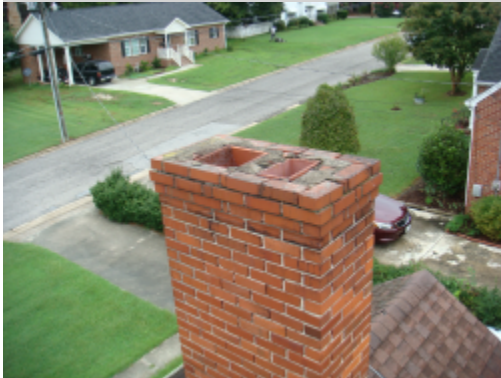
The top brick of the chimney are loose and deteriorated. When the top brick and mortar cap is damaged water can enter between the chimney body and the flue liner resulting in leaks and deterioration. A masonry contractor should be consulted for a complete evaluation of the chimney, the flue liner and the masonry crown and to make necessary repairs.

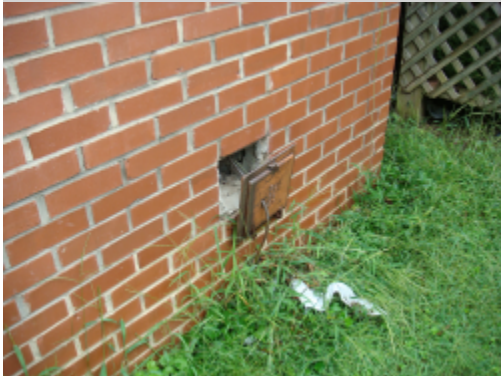
The clean out door is no longer attached on exterior of chimney for family room. A chimney specialist should be consulted for repair

The gas line is routed through the clean out door without a pipe or other device to encase the line to protect it from damage. A plumbing or HVAC contractor should be consulted for a complete evaluation and repair of the gas line installation.

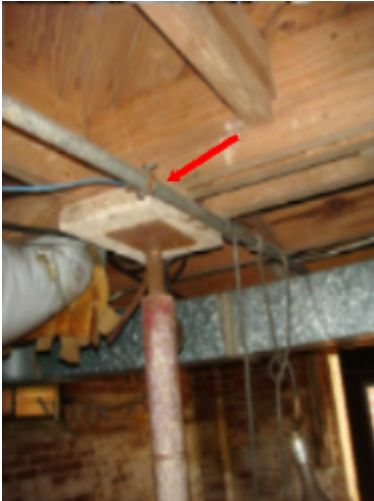
The plumbing supply lines for the home are the original steel galvanized pipes. As galvanized pipes age they tend to corrode along the inside diameter and become clogged. Evidence such as, reduced water pressure, discolored water, and visible area of corrosion indicate that the pipes for this home are nearing the end of their service line. Several areas of corrosion and small dripping leaks were noted in the crawl space / basement. A plumbing contractor should be consulted for a full evaluation of the system and to make necessary repairs.

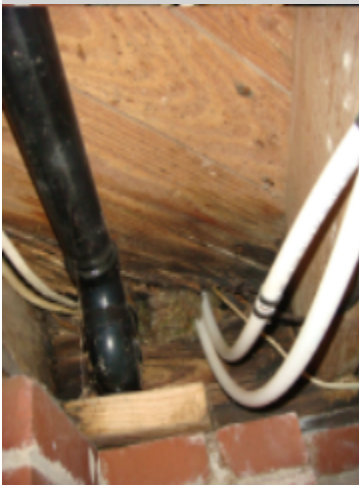
The subflooring under the washing machine drain was noted to be soft and decayed. Evidence suggests direct water penetration. A licensed general contractor should be consulted for an invasive investigation to determine the source of the water penetration and the extent of the decay to prevent further damage and undesirable conditions.

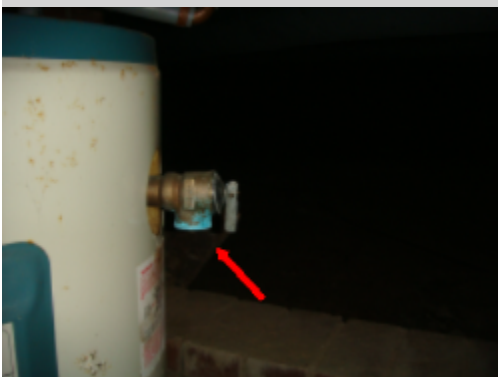
The Temperature Pressure Relief Valve (TPRV) for the water heater is a safety device to prevent the unit from exploding in case of a malfunction. The TPRV is located at the top of the hot water unit and to prevent burn injury in the event of a discharge, the TPRV requires a piped extension down to the floor area. The TPRV for this unit does not have an extension, this is a safety issue that needs to be repaired to prevent personal injury or property damage. A plumbing contractor should be consulted for further evaluation and repair.

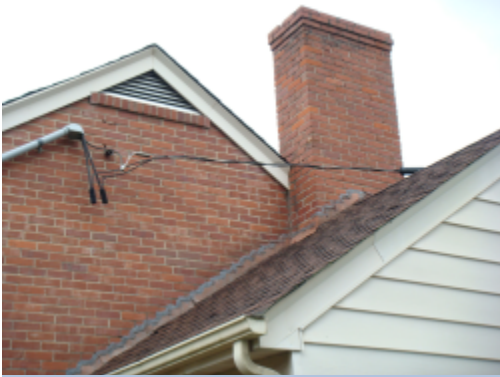
The main electrical service cable which brings the electrical power to the home is routed over the roofline of the home. The cable is lower than typical and could present a safety hazard that could result in serious personal injury and or property damage. The Power Company should be consulted to determine the significance of this concern and if repairs are needed.

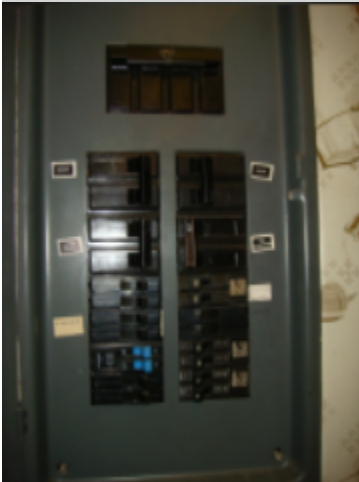
The 40 amp breaker labeled for the HVAC compressor unit is not compatible with the unit label. The breaker and unit label must be matched to safely provide the required service and ensure that the appliance or components of the branch circuit are protected. This condition presents a safety hazard that could result in interrupted service, property damage, and serious personal injury. A licensed electrical contractor should be consulted for further evaluation and repair.

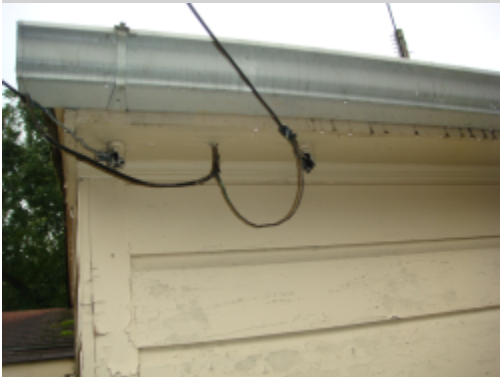
The electrical wire feed to the garage protective insulation cover is deteriorated leaving the electrical conductors exposed to weather and possible human contact. This condition presents a safety hazard that could result in serious personal injury and or property damage. A licensed electrical contractor should be consulted for repair/replacement.

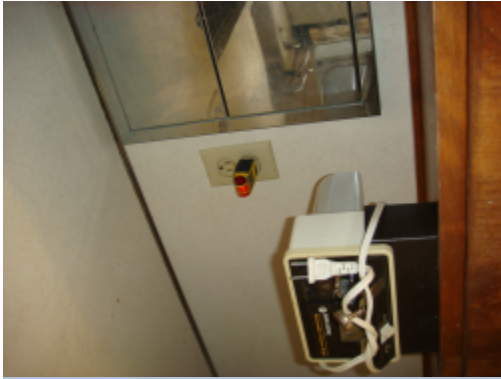
Various receptacles in the house are using 3 prong type receptacles. Many of these tested as open equipment ground. This home was built in an era where receptacles were 2 prong type without an equipment ground. An equipment ground provides an extra safety feature to prevent electrical shock hazards and property damage. Receptacles typically should not be updated to the 3 prong type without the installation of an equipment ground or GFCI protection. A licensed electrical contractor should be consulted for a complete evaluation to determine the significance of this concern and make necessary repairs to correct defects and prevent safety hazards.

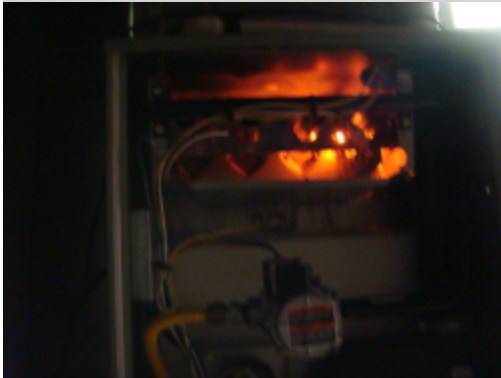
The gas furnace burners did not fire when system called for heat and has visible rust in the burner chamber area. The rust indicates deterioration of the exchanger. Deterioration of the heat exchanger is a serious concern that can result in improper combustion and carbon monoxide poisoning. The furnace needs a complete evaluation which should include a heat exchanger inspection to ensure safe, reliable, and proper operation of the HVAC system. A licensed HVAC contractor should be consulted for repair.

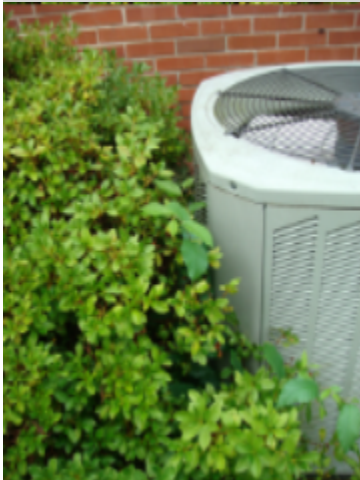
The outside compressor/coil unit for the AC system has limited clearance due to over grown vegetation. Manufacturers require clearance around the compressor /coil unit to allow proper air flow to the refrigerant to ensure proper system performance. A HVAC contractor should be consulted for a complete evaluation and repair of the system to ensure reliable and proper operation of the HVAC system.

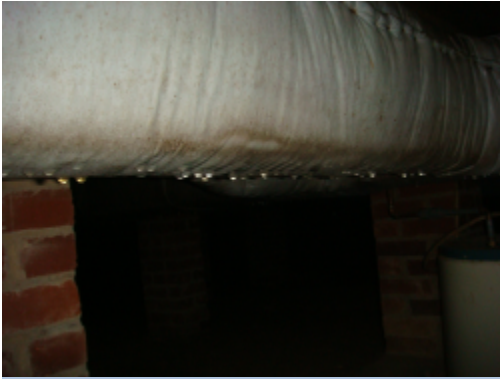
Discolorations typical of mold were noted under the insulation at the duct registers. The discoloration is the result of condensation from the AC system. This condition needs further evaluation. The home was inspected for moisture concerns and evidence of wood damage; however, health related issues concerning mold are beyond the scope of the home inspection. If the buyer has additional concerns related to the presence of the fungal growth in the duct system such as mold an industrial hygienist should be consulted.

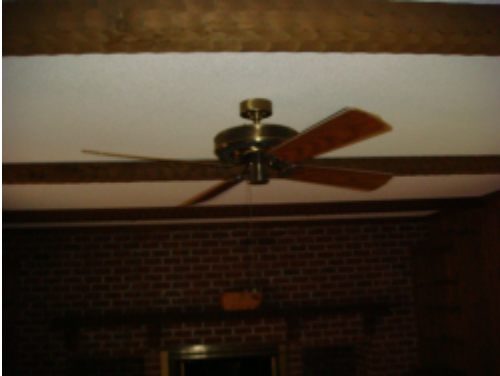
The light fixture located in family room was not tested because no bulbs were present. The bulbs should be installed and the fixture verified to operate properly. A general repair specialist should be consulted.

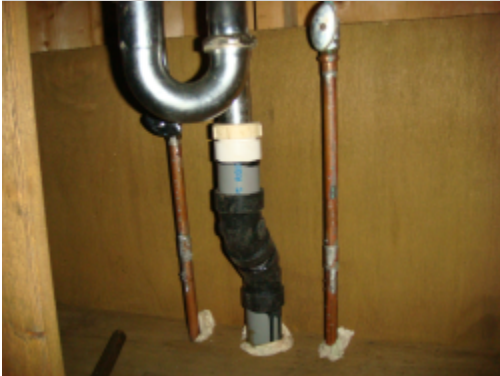
The plumbing trap for the sink in family room is an "S" type trap. This trap has a tendency to siphon and become dry allowing sewer gases to enter the home. The trap plumbing needs to be corrected or replaced to prevent sewer gases from entering the home and to ensure sanitary conditions. A licensed plumbing contractor should be consulted for evaluation and repair.

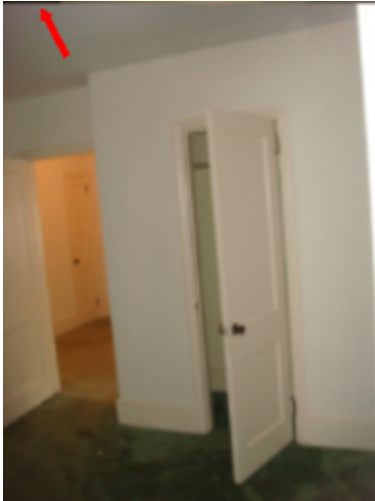
The light fixture located in the 1st bedroom was not functional when tested. This could indicate a defective bulb or other more serious problem such as faulty wiring or a defective fixture, further evaluation and repair is needed. A licensed electrical contractor should be consulted for further evaluation and repair.

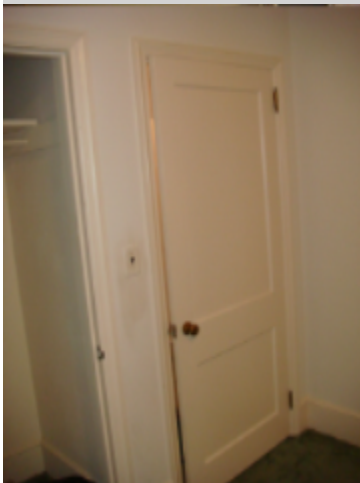
The door needs repair to ensure proper operation and privacy. The door did not properly latch, lock, close.

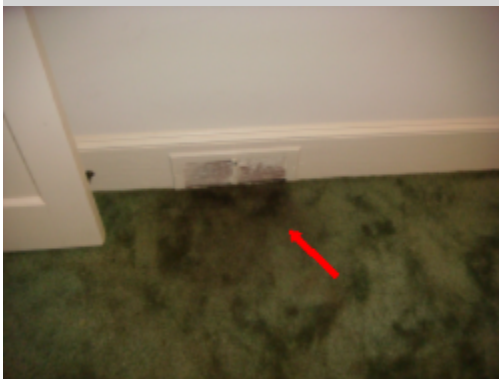
The register is in need of further evaluation and repair. The following concerns were noted at the time of the inspection:
1. unknown dark stain on carpet
A HVAC contractor should be consulted for a complete evaluation and to make necessary repairs to ensure safe, reliable, and proper operation of the HVAC system.

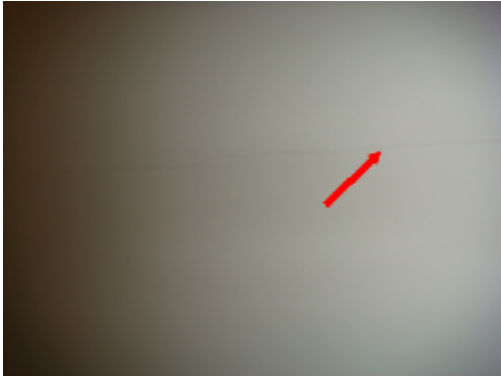
The ceiling is cracked. No related concerns were noted throughout the adjacent inspection areas. The buyer should review the area of concern. If additional concerns or questions are present, invasive inspection and repair will be needed. A general repair specialist should be consulted for evaluation and repair.

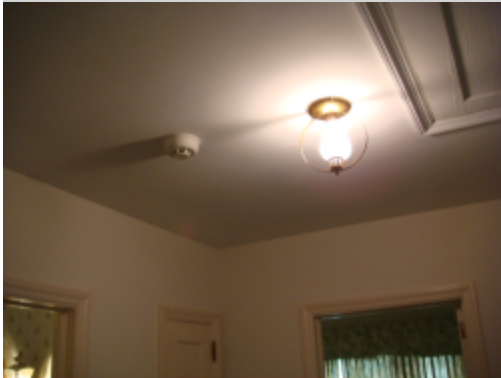
The smoke detectors for the home were not tested because they were thought to be part of a central alarm system. Testing and maintenance of the smoke alarm system is very important. The smoke detectors should be tested and verified to be operating properly prior to purchasing the home.

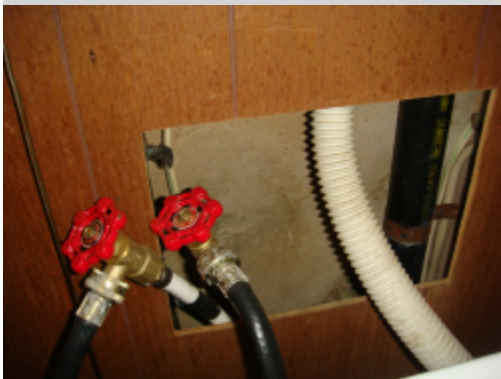
The faucet for the washing machine was noted to be loose and in poor condition. Repair is needed to ensure proper service. A licensed plumbing contractor should be consulted for evaluation repair/replacement.

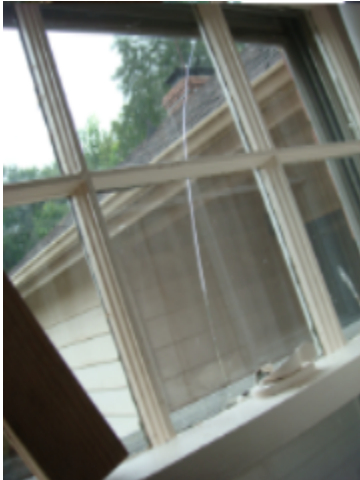
The kitchen window needs further evaluation and repair. The window was cracked. A window installation repair specialist or a general contractor should be consulted for further evaluation or repair/replacement.

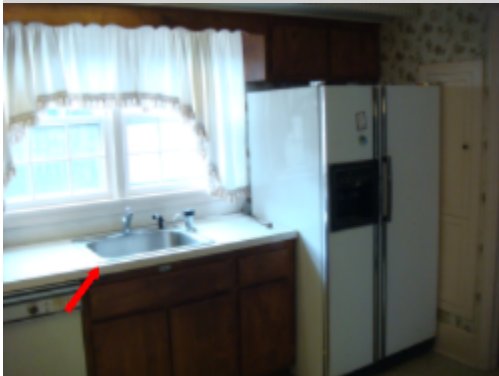
The sink faucet had no water flow. A licensed plumbing contractor should be consulted for evaluation and repair to ensure proper service.

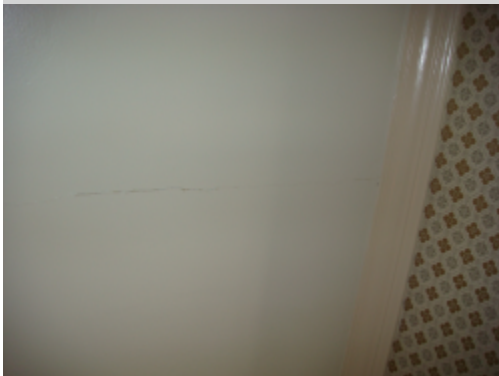
The ceiling is cracked. No related concerns were noted throughout the adjacent inspection areas. The buyer should review the area of concern. If additional concerns or questions are present, invasive inspection and repair will be needed. A general repair specialist should be consulted for evaluation and repair.

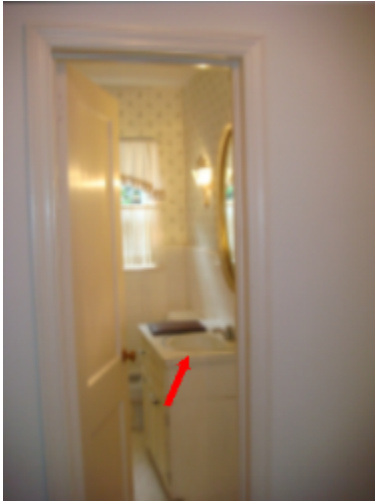
The sink drain has no stopper. A licensed plumbing contractor should be consulted for evaluation and repair to ensure proper service.

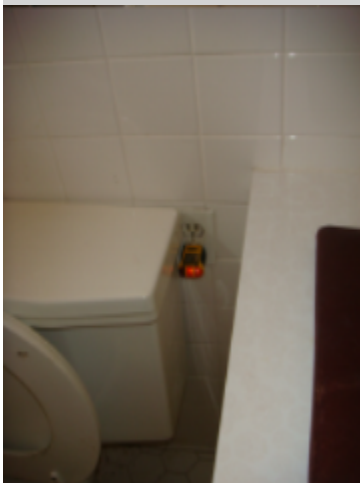
The receptacle located in full bathroom is not GFCI protected, and is in a unsafe location Receptacles located in hazardous or wet locations should be GFCI protected to reduce shock in hazardous locations. A licensed electrical contractor should be consulted for further evaluation and repair.

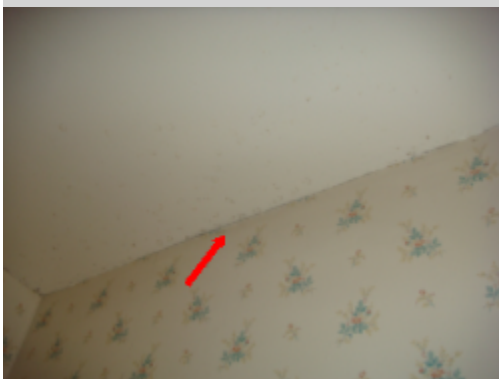
Mold was noted in bathroom ceiling area. The bathroom was inspected for moisture concerns and evidence of wood damage; however, health related issues concerning mold are beyond the scope of the home inspection. If the buyer has additional concerns related to the presence of the fungal growths such as mold an industrial hygienist should be consulted.

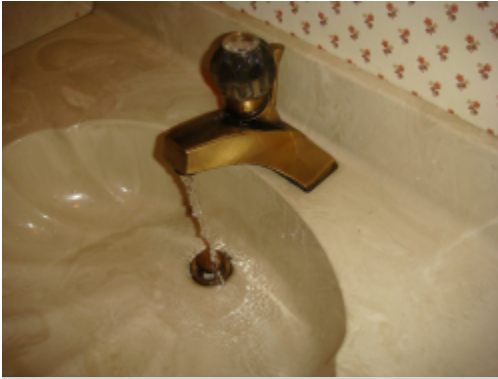
No hot water was available and the sink faucet leaks at the handle base area when turned on. The leaks could result in damage to the sink and cabinet and should be repaired as soon as possible. A licensed plumbing contractor should be consulted for a complete evaluation to determine the significance of this concern and make necessary repairs to prevent leaks and ensure sanitary conditions.

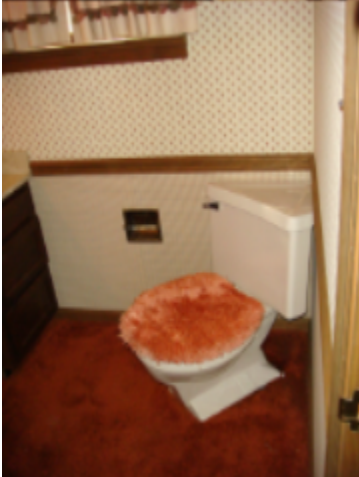
The turn off valve for the toilet is leaking/ corroded. The leak could result in damage to the floor framing and should be repaired as soon as possible. A licensed plumbing contractor should be consulted for evaluation and repair.

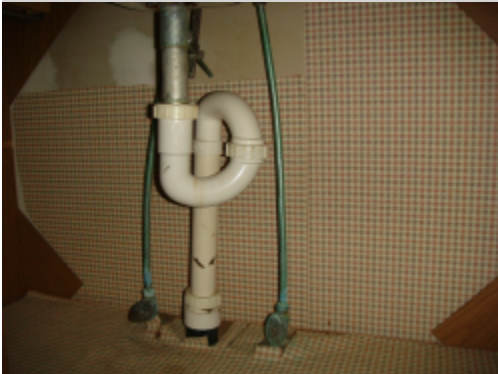
The plumbing trap for the sink is an "S" type trap. This trap has a tendency to siphon and become dry allowing sewer gases to enter the home. The trap plumbing needs to be corrected or replaced to prevent sewer gases from entering the home and to ensure sanitary conditions. A licensed plumbing contractor should be consulted for evaluation and repair.

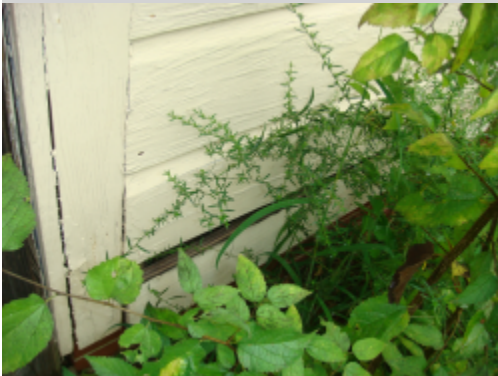
The exterior trim and boxing of the garage need repairs and painting to prevent further damage and water penetration. The following items were noted during the inspection all areas should be evaluated as a repair plan is prepared. Boxing and trim areas were found to have damage in a few areas related to age, boring bees, gutter overflow, decay, leaking at gutter corners, leaking at gutter seams, and roof drainage flowing behind the gutters. A licensed general contractor should be consulted for a complete evaluation of the exterior siding, trim and boxing to determine the scope of the damage and make necessary repairs.

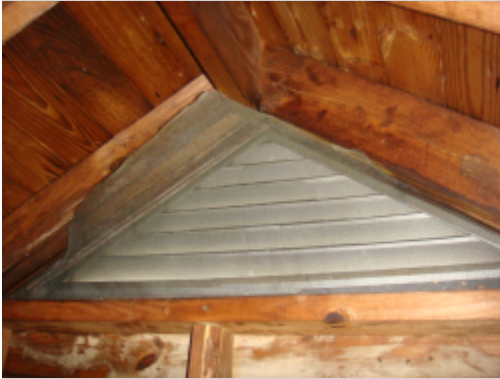
The attic gable vents screens are loose. This could allow rodents access to the attic space. A licensed general contractor should be consulted for repair/ replacement.

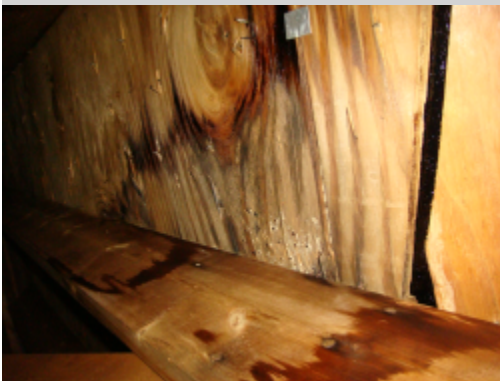
From the attic, the wood framing components located in valley near addition are discolored and decayed. The level of decay indicates a long term leak that could involve hidden areas of damage, the flashing, and the roof covering systems. The area was also wet at the time of the inspection indicating an active leak. A licensed general contractor should be consulted for further evaluation and repair to determine the source of the leak and extent of the damage to ensure the stability of the home and prevent additional damage.

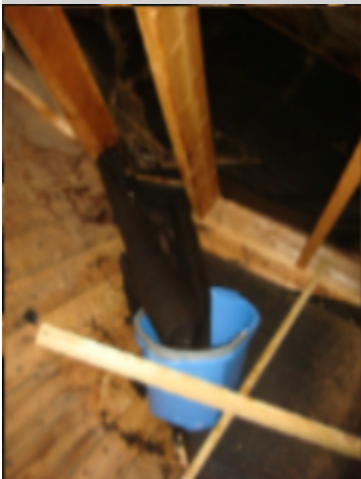
Additional Photograph: This is a photograph of history of leak in addition area

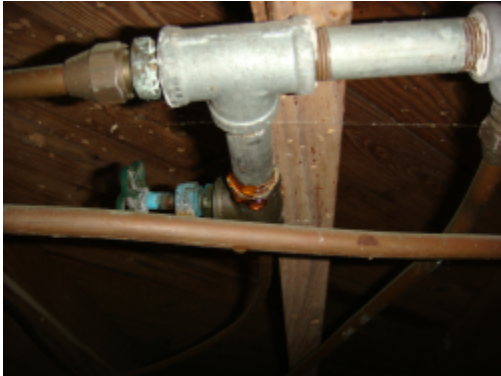
A valve located near the basement entrance is leaking. Leaks in the water supply lines should be addressed as soon as possible to prevent property damage and flooding. A licensed plumbing contractor should be consulted to make necessary repairs.

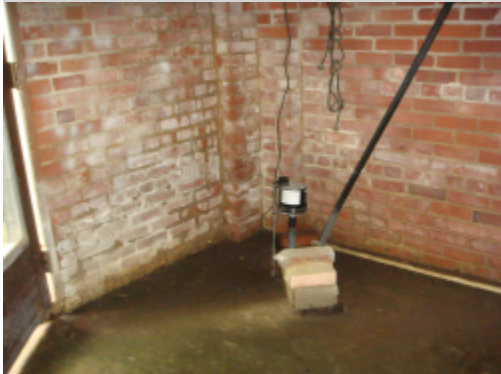
There is evidence in the form of water lines on the wall surfaces, stains /damage on storage, mud lines in the basement area. Water penetration into foundation areas can result in damage to the foundation and undesirable environmental conditions. The homeowner should be asked for more information regarding the frequency and intensity of water penetration into the basement area. A drainage and waterproofing specialist should be consulted to determine adequacy of the basement waterproofing and drainage systems.

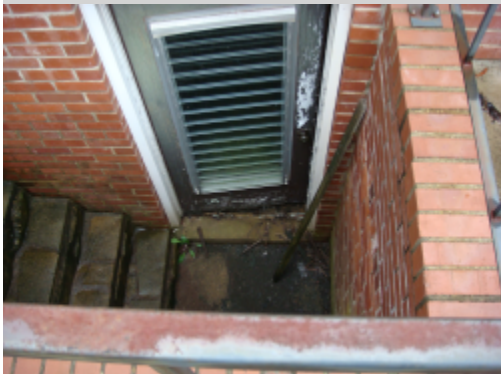
Evidence suggests that water has entered the basement at the door area. Direct water penetration damages the foundation, the wood structure, and creates an undesirable environment in the crawl space areas that encourages insect, fungal growth such as mold/mildew. A general contractor should be consulted for further evaluation to determine the source of the moisture and necessary repair.

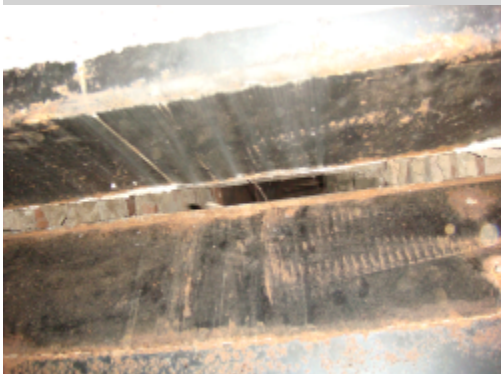
The fireplace is damper has debris preventing it from opening fully. This is a hazardous condition that needs correction. A licensed general contractor should be consulted for a complete evaluation and repair.

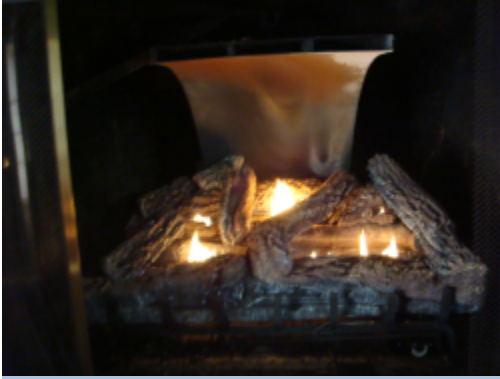
The gas log unit located the family room has visible soot on the components and damper area. The soot indicates improper operation of the unit and possible obstruction of the exhaust. The gas log unit needs a complete inspection and service that includes the exhaust system; flue and chimney system.

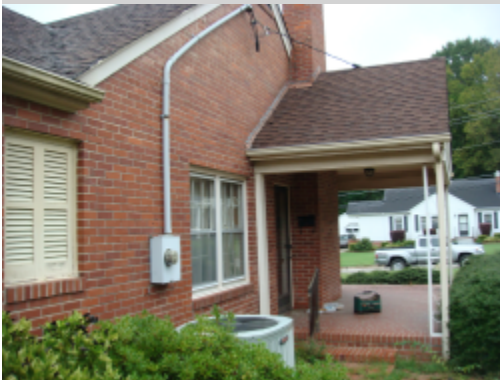
The attic space over the left side porch is not accessible and there are no apparent intake or exhaust sources for ventilation. Improper ventilation could result in condensation, over heating of the building components, and inadequate conditioning of the living areas. A licensed general contractor should be consulted for a complete evaluation to determine the significance of the concern and make necessary repairs. (small porches do not require ventilation)

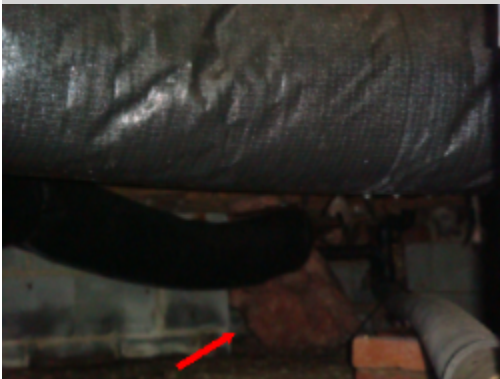
A section of insulation in the crawl space under addition has fallen. Improper insulation installation could result in condensation, over heating of the building components, and inadequate conditioning of the living areas. A licensed general contractor should be consulted for repair/ replacement.

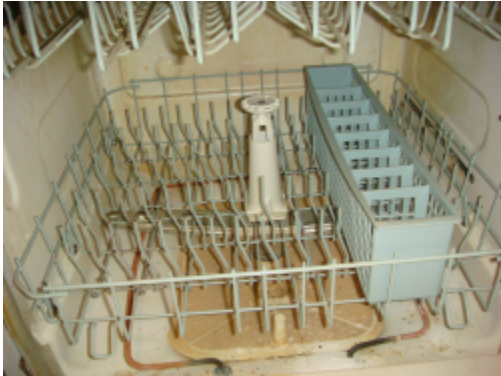
The water supply for the dishwasher was turned off at the time of the inspection. The inspector did not have permission or knowledge of the circumstances that required the water to be turned off and therefore did not turn the unit on. The inspection of the dishwasher was not completed because the unit was not operated through one normal cycle. It is recommended that the power be restored and the inspection completed prior to the purchase of the home.

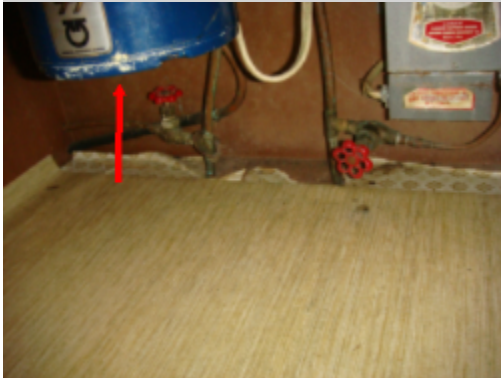
The disposal did not operate when turned to the on position. Appliances should be repaired and inspected prior to purchase to ensure safe and proper operation. An appliance repair person should be consulted for full evaluation and repair.
