# Home Inspection Report

**Report Number: 7715-1**  
**For The Property Located On:**

Prospect Hill, North Carolina 27314

Date of Inspection: Tuesday, July 7, 2015

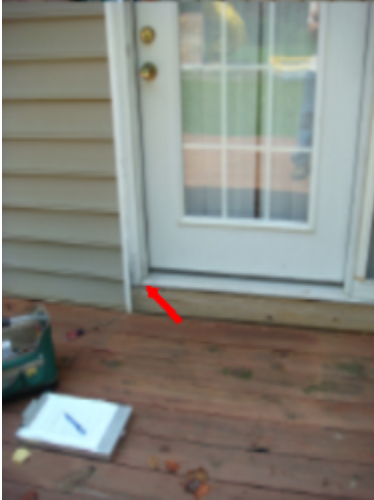
#### (B2 - 2.1 ) All Doors; Location: All Accessible

The door has the beginnings of decayed wood in the frame area.

Decay in the door frames can result in leaking and water penetration and should be repaired as soon as possible. All doors should be inspected for similar damage as repairs are made. A general repair specialist or licensed general contractor should be consulted for evaluation and repair.

The door has the beginnings of decayed wood in the frame area. Decay in the door frames can result in leaking and water penetration and should be repaired as soon as possible. All doors should be inspected for similar damage as repairs are made. A general repair specialist or licensed general contractor should be consulted for evaluation and repair.

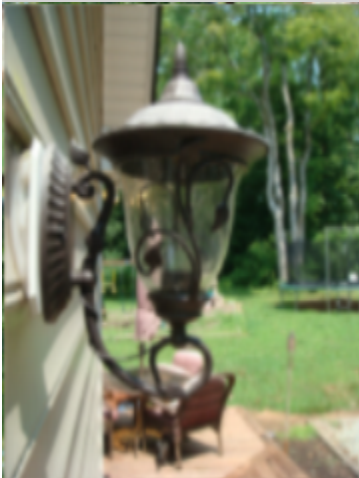
#### (B3 - 2.1 ) Deck ; Location: Main House Rear/ right

The light fixture located by right side door was not functional when tested. This could indicate a defective bulb or other more serious problem such as faulty wiring or a defective fixture, further evaluation and repair is needed. A licensed electrical contractor should be consulted for further evaluation and repair.

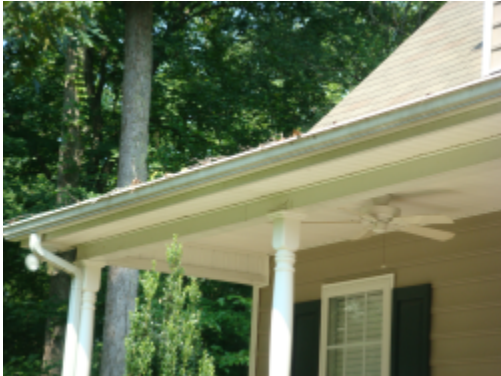
#### (C2 - 1.1 ) Main House; System Type: Gutter

The gutter on both front and rear of house are filled with debris. Direct drainage from the gutter system can result in water penetration into the foundation area and foundation deterioration. A licensed general contractor should be consulted for a complete evaluation and to make necessary repairs.

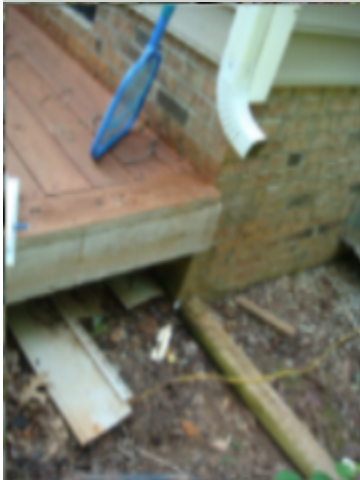
**(C2 - 2.1 ) Main House rear left and right side; System Type: Gutter**

The gutter downspouts are not extended or piped to direct roof drainage away from the foundation. Direct drainage from the gutter system can result in direct water penetration into the foundation area and foundation deterioration. A licensed general contractor should be consulted for a complete evaluation and to make necessary repairs.

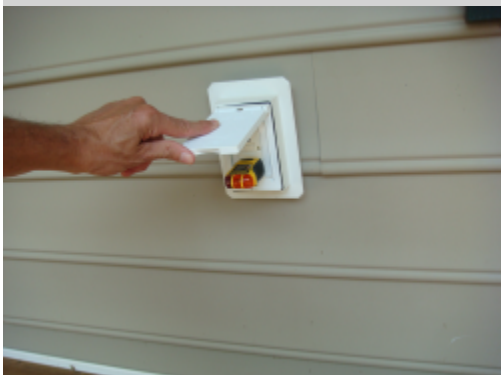
**(E5 - 1.1 ) Exterior**

The receptacle located porch right side had no power. This could indicate a damaged receptacle or branch wiring circuit. A licensed electrical contractor should be consulted for a complete evaluation to determine the significance of this concern and make necessary repairs to correct defects and prevent safety hazards.

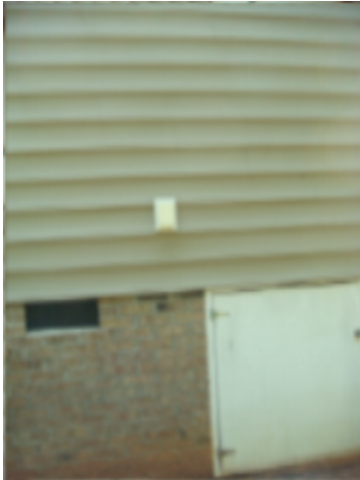
**(E5 - 1.2 ) Exterior**

The receptacle located left side of house has wasps and was not tested. The nest should be removed to ensure proper and safe operation. A pest exterminator should be consulted.

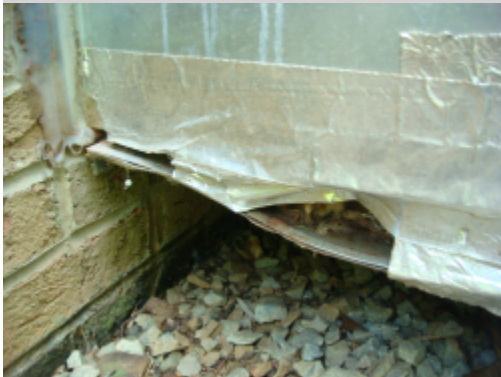
**(G2 - 1.1 ) Cooling Unit #1; Access: Crawl Space**

The insulation cover for the duct branch that supplies first floor is deteriorated. The cover protects the duct structure and holds the insulation in place. A HVAC contractor should be consulted for a complete evaluation and replacement of all damaged duct components to ensure reliable and proper operation of the HVAC system.

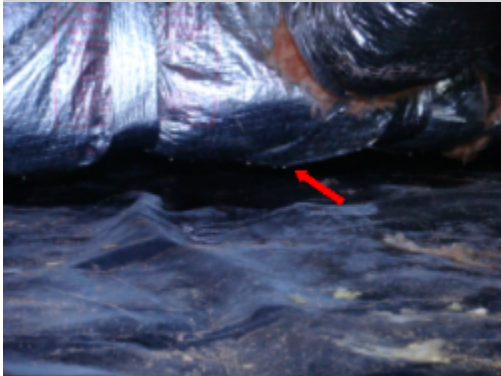
**(G2 - 1.2 ) Cooling Unit #1; Access: Crawl Space**

The duct system has visible condensation. Condensation occurs when the duct surfaces reach the dew point of the surrounding air; this can be related to a wet duct environment, duct air leaks, excessive demand on the HVAC system, and or improper HVAC system operation. A licensed general contractor should be consulted to evaluate the crawl space for moisture related concerns. The HVAC contractor should be consulted for a complete evaluation of the HVAC system to ensure reliable and proper operation of the HVAC system.

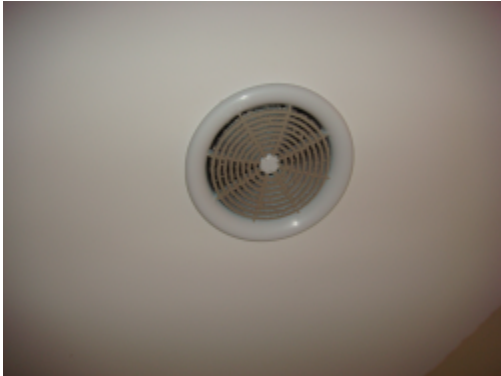
**(H1 - 1.1 ) Laundry**

The ventilation fan has lint in the grill area and on the exterior exit at the roof surface. The fans needs to be cleaned and inspected to ensure proper operation. A general repair person should be consulted.

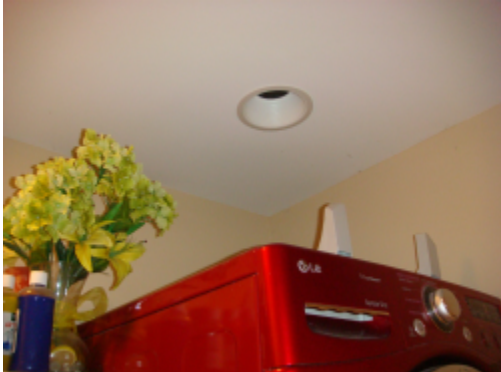
**(H1 - 1.2 ) Laundry**

The light fixture located in the laundry room was not functional when tested. This could indicate a defective bulb or other more serious problem such as faulty wiring or a defective fixture, further evaluation and repair is needed. A licensed electrical contractor should be consulted for further evaluation and repair.

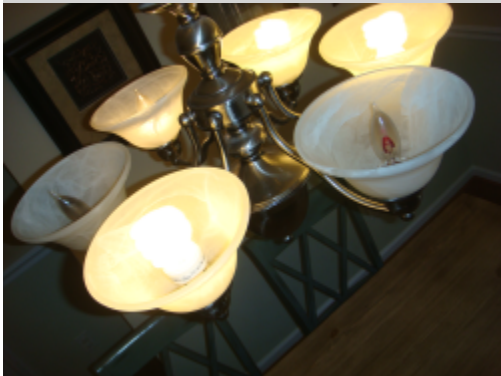
**(H1 - 2.1 ) Dining Room**

The light fixture located in the dinning room was not fully functional when tested. This could indicate a defective bulb or other more serious problem such as faulty wiring or a defective fixture, further evaluation and repair is needed. A licensed electrical contractor should be consulted for further evaluation and repair.

The light fixture located in the dining room was not fully functional when tested. This could indicate a defective bulb or other more serious problem such as faulty wiring or a defective fixture, further evaluation and repair is needed. A licensed electrical contractor should be consulted for further evaluation and repair.

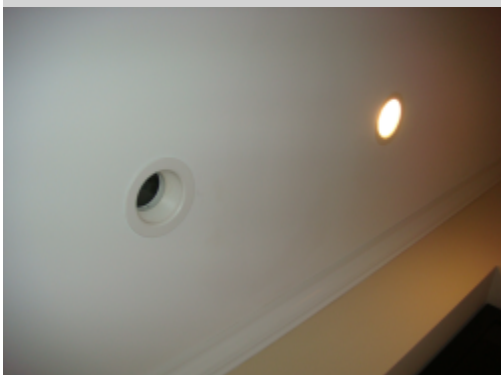
**(H1 - 3.1 ) Living Room**

The light fixture located in the living room was not functional when tested. This could indicate a defective bulb or other more serious problem such as faulty wiring or a defective fixture, further evaluation and repair is needed. A licensed electrical contractor should be consulted for further evaluation and repair.

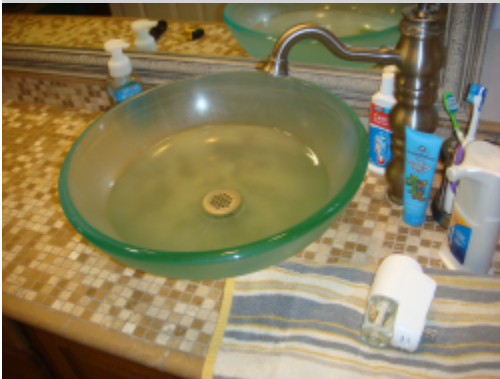
**(H3 - 1.1 ) Bathroom: Master**

The sink drain was noted to be slow. A slow drain could indicate a clogged line or an underlying problem with the drain/waste/vent system. A licensed plumbing contractor should be consulted for evaluation and repair to ensure proper service.

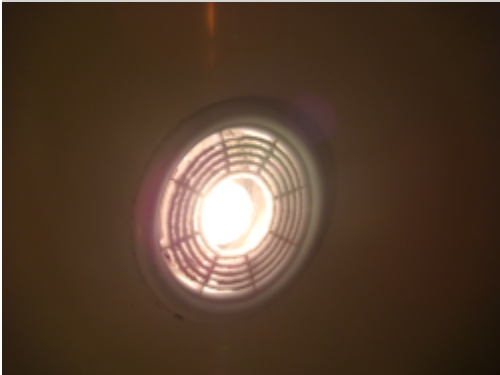
**(H3 - 2.1 ) Bathroom #1 first floor half bath**

The ventilation fan is clogged and did not operate properly. The fan needs repair/ replacement to ensure proper ventilation and moisture control. A general repair specialist should be consulted.

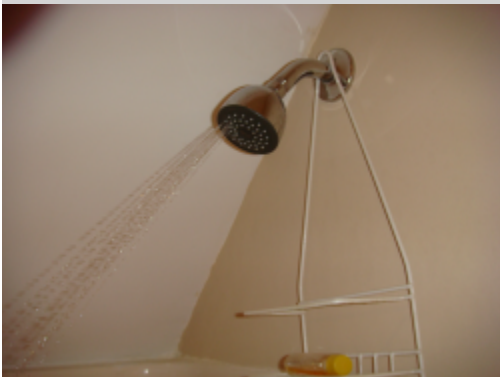
**(H3 - 3.1 ) Bathroom #2**

The shower is in need of further evaluation and repair. The following concerns were noted at the time of the inspection:

1. water flow from shower head.

A licensed plumbing contractor should be consulted for a complete evaluation to determine the significance of this concern and make necessary repairs to prevent leaks and ensure sanitary conditions.

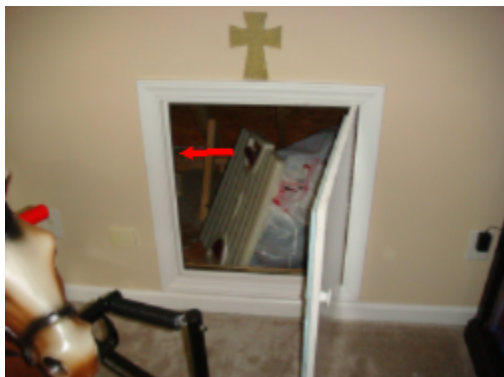
**(H5 - 1.1 ) Attic: Unfinished**

The light fixture located in the attic access at top landing of stairs was not functional. This could indicate a defective bulb or unable to find correct switch or other more serious problem such as faulty wiring or a defective fixture, further evaluation and repair is needed. A licensed electrical contractor should be consulted for further evaluation and repair.

The light fixture located in the attic access at top landing of stairs was not functional. This could indicate a defective bulb or unable to find correct switch or other more serious problem such as faulty wiring or a defective fixture, further evaluation and repair is needed.

A licensed electrical contractor should be consulted for further evaluation and repair.

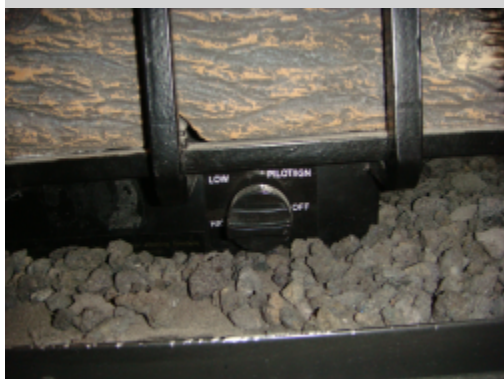
**(H6 - 1.1 ) Fireplace: Pre-Manufactured: Metal: Box: Sided Exterior; Location: Living Room**

The gas log fireplace located in the living room was visually inspected but not operated because the pilot was off. The unit should be serviced and operated prior to closing to ensure safe and proper operation of the HVAC system.

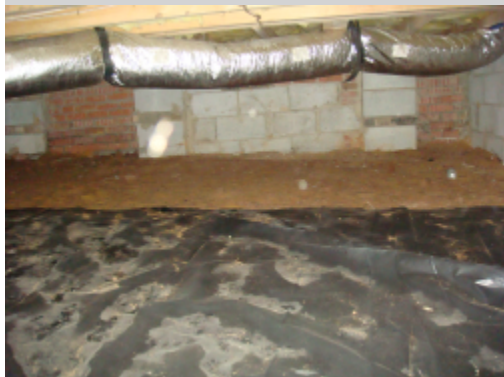
**(I1 - 2.1 ) Crawl Space: All Accessible Areas**

The vapor barrier for the crawl space insulation was not covering all areas. Improper installation could result in condensation, A licensed general contractor should be consulted for repair/ replacement.

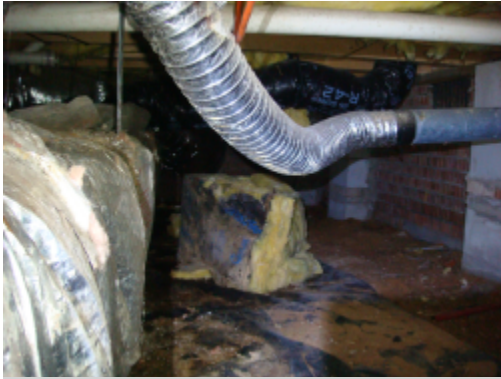
**(I1 - 2.2 ) Crawl Space: All Accessible Areas**

A section of insulation in the crawl space is missing. Improper insulation installation could result in condensation, over heating of the building components, and inadequate conditioning of the living areas. A licensed general contractor should be consulted for repair/ replacement.

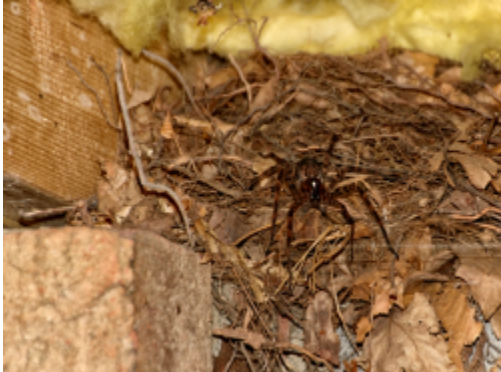
**(I1 - 2.3 ) Crawl Space: All Accessible Areas**

spiders and nest were noted in the crawl space. While not uncommon, pests can cause damage to building components and unsanitary/ unsafe conditions. A general contractor or pest management company should be consulted to locate and correct the points of entry and determine the extent of the contamination.

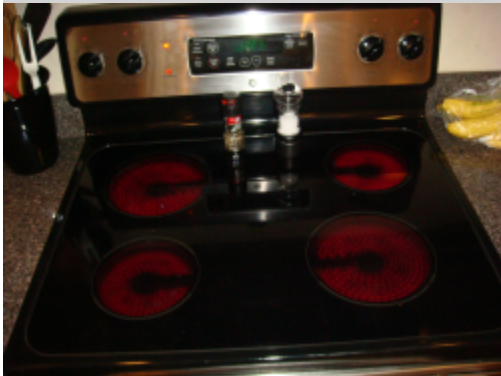
**(J1 - 3.1 ) Range: Electric; Location: Kitchen**

The oven/range moves forward when the door is opened. The oven needs to be secured anchored with an anti-tip bracket to prevent the unit was turning over when weight is applied to the door. An appliance repair person or general contractor should be consulted for repair.
