Home Inspection Report

Report Number: 20116-1
For The Property Located On:

Raleigh, North Carolina 27613

Date of Inspection: Monday, February 1, 2016

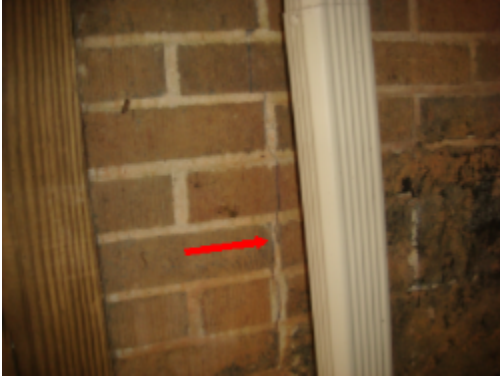
(B1 - 1.1) Main House

Cracks were noted in the brick veneer left front corner, left rear corner, rear right above basement door and between package unit and window right side. Cracks in brick veneer indicate a deficiency that can change or progress over the life of the home. The cracks on this home were closed at the time of the inspection and presented no visible evidence of progression to the foundation areas, however, the cracks could open or change seasonally. The owners should be asked for disclosure related to progression, history of repairs, or seasonal changes of the cracks. Even closed or minor cracks can cause consumers or buyers concerns at the time of resell. The buyer should observe the cracks and assess their concerns related to the presence of the cracks, the number of cracks, and possibility of the condition worsening over the life of the home. The cracks should be noted, repaired, and monitored to establish a history of stability. If additional information is needed an engineer should be consulted.

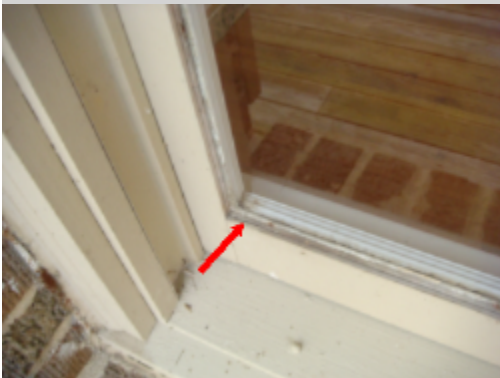
(B2 - 3.1) Windows ; Location: All Accessible

Window glazing is installed in the window frame to secure the glass panes. The glazing on many of the windows for this home is loose, cracking and missing. The windows need repairs and painting to secure window panes, prevent decay and leaking. A licensed general contractor should be consulted to make necessary repairs.

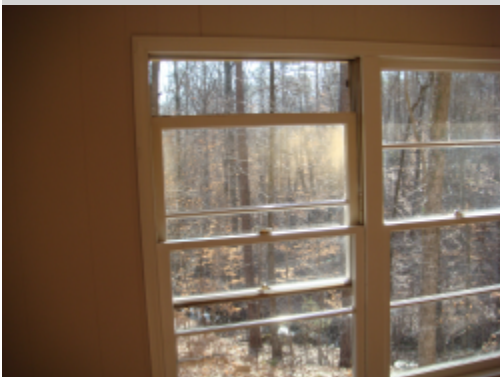
(B2 - 3.2) Windows ; Location: All Accessible

Many window throughout the house are either hard to open or the top will not stay in position. and need repair to ensure proper operation. In the case of bedroom windows It is very important to have a proper method of egress from every sleeping area in case of an emergency such as a fire. A licensed general contractor should be consulted for evaluation and repair.

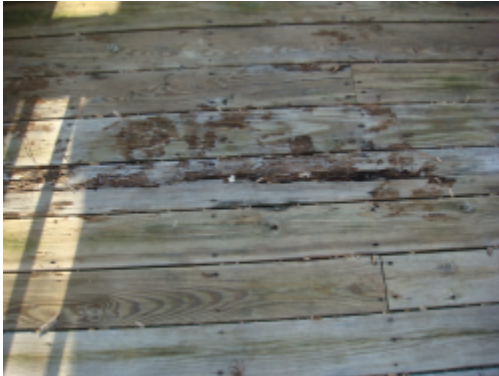
(B3 - 1.1) Deck ; Location: Main House Front

Some of the deck surface boards are cupped, splintered decayed. Splintering boards can result in injury such as puncture wounds and should be considered hazardous for children. A licensed general contractor should be consulted for evaluation and to make necessary repairs.

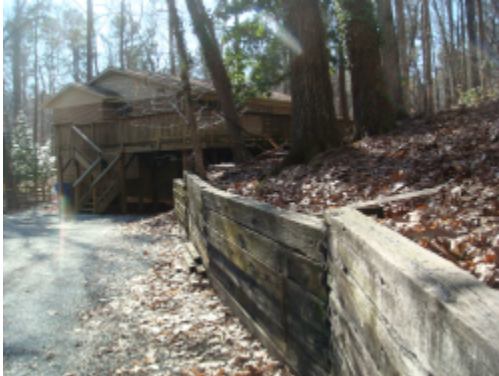
(B4 - 2.1) Retaining Wall ; Location: Main House Rear

The front section of the lot for this home is a steep grade that is currently retained by a wood timber wall. Retaining this section of the lot will be very important over the life of this home. An engineer should be consulted for a complete inspection of the retaining system prior to purchase.

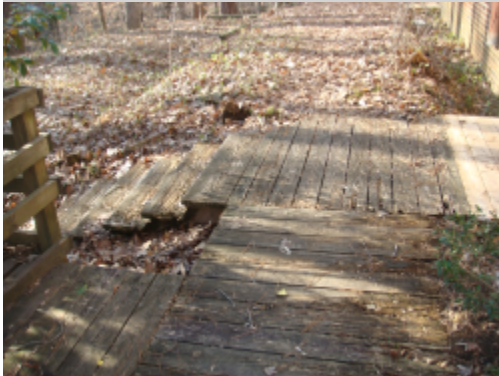
(B4 - 3.1) Walk ; Location: Main House Rear

The wood deck walk/ steps in the left rear was found to be in poor condition. A licensed general contractor should be consulted for complete evaluation of the deck and to make necessary repairs or replacement as needed.

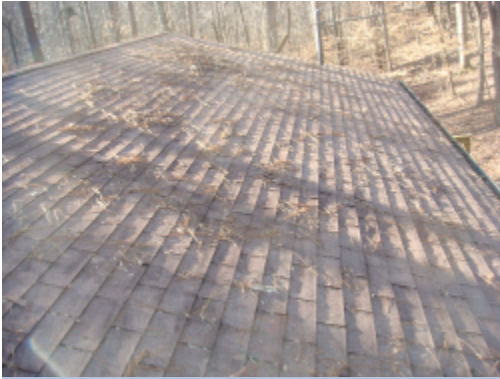
(C1 - 1.1) Main House

The shingles for the home are covered with a heavy build- up of leaves/pine needles/debris. This limited the inspection of the roof surface. Debris on the roof surface can trap moisture allow water and debris to travel under the shingle tabs resulting in material failure and leaks. A roofing contractor should be consulted to remove the debris and inspect the shingles / adjacent component for evidence of damage and make necessary repairs.

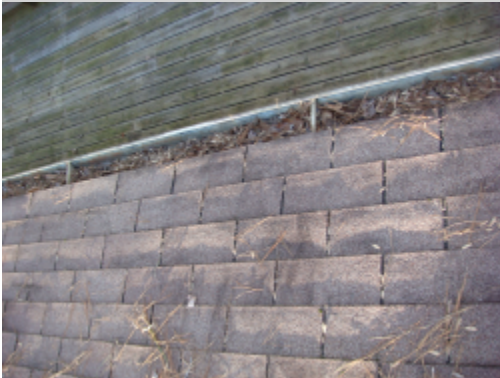
(C2 - 1.1) Main House Front; System Type: Gutter

The gutter in the front of the house is clogged. Clogged gutters can lead to unwanted water penetration . A licensed general contractor should be consulted to make necessary repairs.

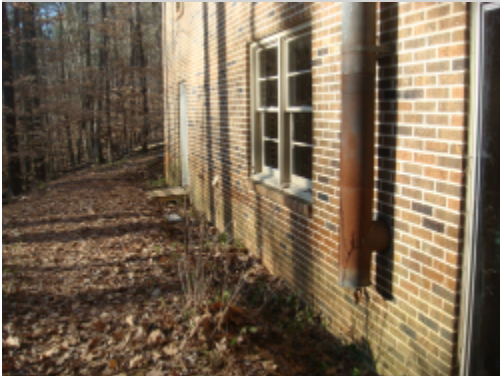
(C4 - 1.1) Main House Rear; Location: Metal

The metal chimney was found to be in poor condition (rusted) and the wrong type for a wood stove application (not UL listed class A). A chimney specialist should be consulted to ensure that if the chimney is also safe to use.

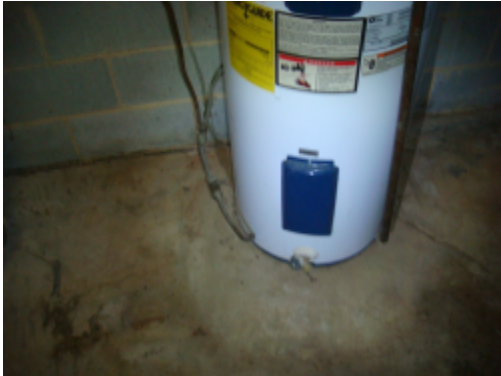
(D3 - 1.1) Unit #1 ; Location: Basement

The hot water temperature for the home was noted to be too high.

The recommended temperature to prevent personal injury and burns is 120 degrees F. The elevated temperature could indicate a malfunction or problems with the water heating unit. A licensed plumbing contractor should be consulted to evaluate the system to ensure that the water heating unit is operating correctly and within a safe temperature range.

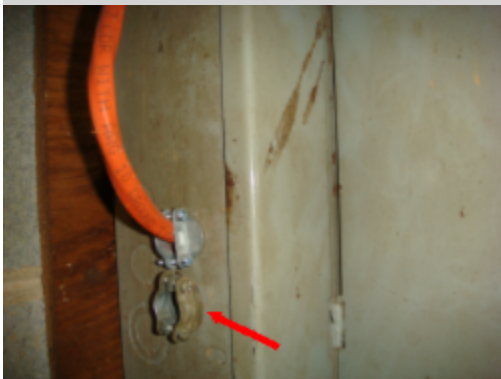
(E2 - 1.2) Main Panel #1; Location: Basement

The electrical service panel cover is missing knock out opening plugs. The covers or plugs prevent direct contact with hot electrical circuits. This condition presents a safety hazard that could result in interrupted service and serious personal injury /death from electrocution. A licensed electrical contractor should be consulted for a complete inspection of the electrical system and for repair/replacement of the panel to ensure that it is safe and functioning properly.

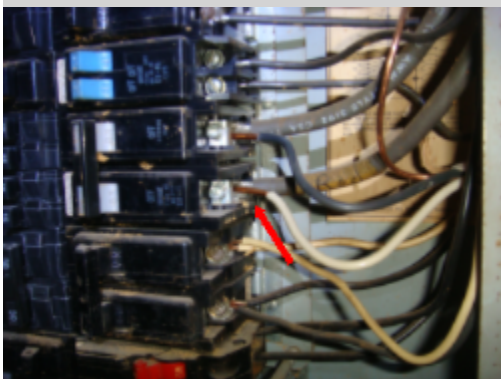
(E2 - 1.3) Main Panel #1; Location: Basement

Two breakers located on the right side of the electrical panel has two conductors attached to the power screw. Typically breakers are not rated for double taps due to possible loose connections and circuit overloads. This condition presents a safety hazard that could result in interrupted service, property damage, and serious personal injury. A licensed electrical contractor should be consulted for further evaluation and repair.

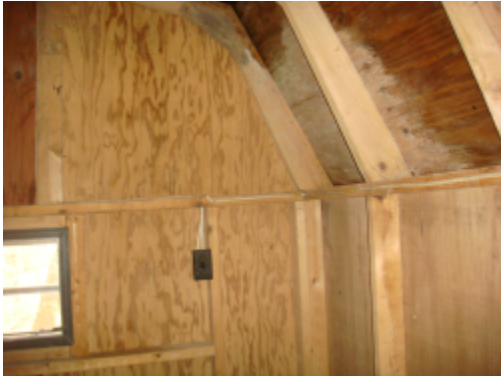
(E4 - 1.1) Exterior Shed

The detached building is not part of the standard home inspection, however, the electrical for building was inspected and found to be not operational. A licensed electrical contractor should be consulted for further evaluation and repair.

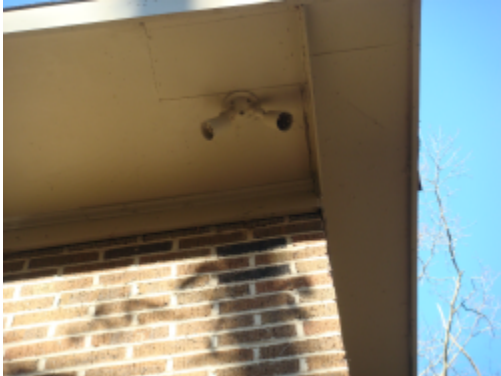
(E5 - 1.1) Exterior

This house has three external spot light fixtures none were tested because no bulbs were present. The bulbs should be installed and the fixture verified to operate properly. A general repair specialist should be consulted.

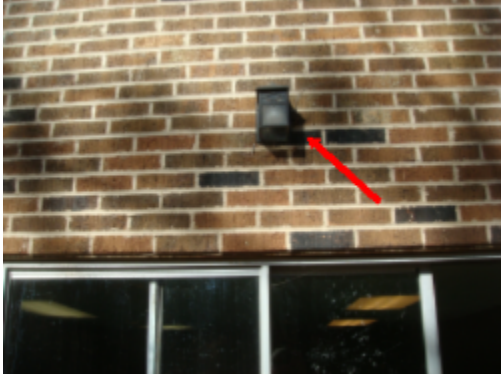
(E5 - 1.2) Exterior

The light fixture located out side sliding basement door was not functional when tested. This could indicate a defective bulb or other more serious problem such as faulty wiring or a defective fixture, further evaluation and repair is needed. A licensed electrical contractor should be consulted for further evaluation and repair.

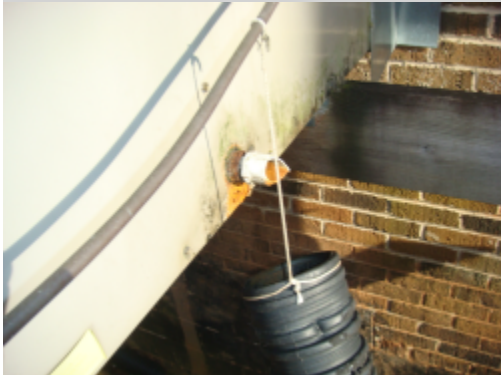
(G1 - 1.1) Cooling Unit #1; Location: Exterior Package Unit (Heating and Cooling)

The condensate drain lines are not properly attached to the inside coil. The drain lines are attached to the line openings provided for horizontal / vertical installation and the unit is installed in the vertical / horizontal location. Improper drainage of the condensate water can result in system and property damage. A HVAC contractor should be consulted for a complete evaluation and repair of the system to ensure reliable and proper operation of the HVAC system.

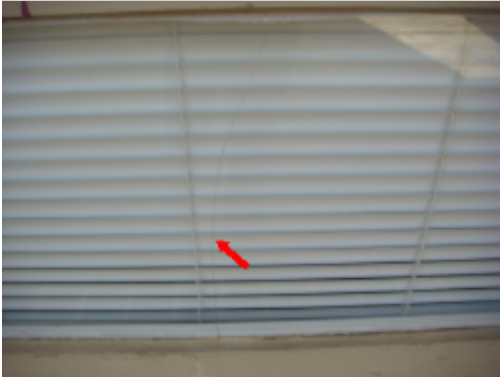
(H1 - 1.1) Bedroom #1 (right front)

The right front bedroom window needs further evaluation and repair. The window was cracked. All windows should be evaluated as repairs are made. A licensed general contractor should be consulted. Refer to the exterior section of the report.

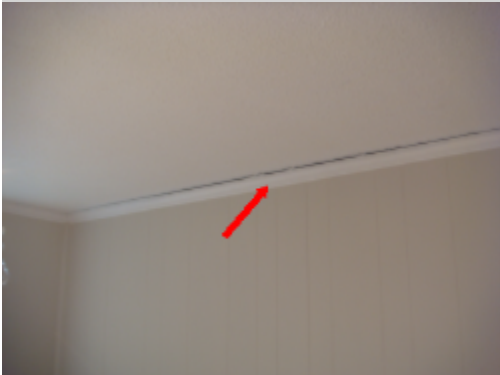
(H1 - 2.1) Dining Room

In the dining room, and hallway The junction of the wall and ceiling has a gap. No related concerns were noted throughout the adjacent inspection areas. The buyer should review the area of concern. If additional concerns or questions are present, invasive inspection and repair will be needed. A general repair specialist should be consulted for evaluation and repair.

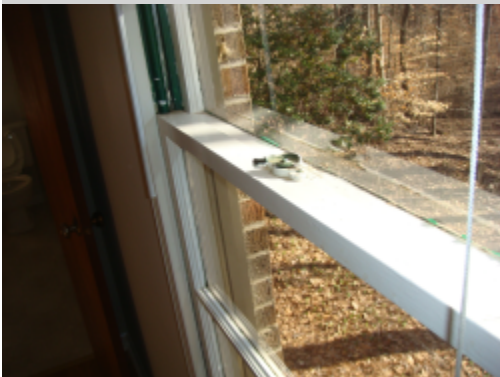
(H1 - 3.1) Bedroom: Master

The window for the master bedroom needs repair to ensure proper operation. The window did not properly lock. All windows should be evaluated as repairs are made. A licensed general contractor should be consulted.

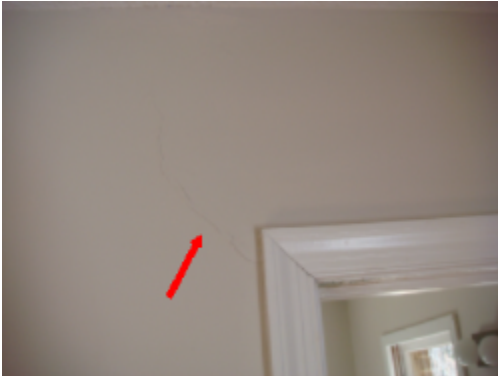
(H1 - 3.2) Bedroom: Master

The wall in the master bedroom above the bathroom door is cracked. No related concerns were noted in the throughout the other inspection areas. The buyer should review the area of concern. If additional concerns or questions are present, invasive inspection and repair will be needed.

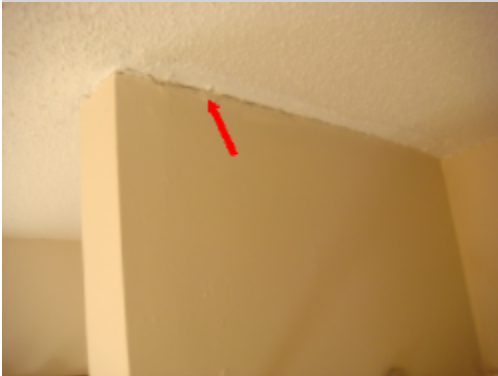
(H3 - 1.1) Bathroom #1

The ceiling is cracked. No related concerns were noted throughout the adjacent inspection areas. The buyer should review the area of concern. If additional concerns or questions are present, invasive inspection and repair will be needed. A general repair specialist should be consulted for evaluation and repair.

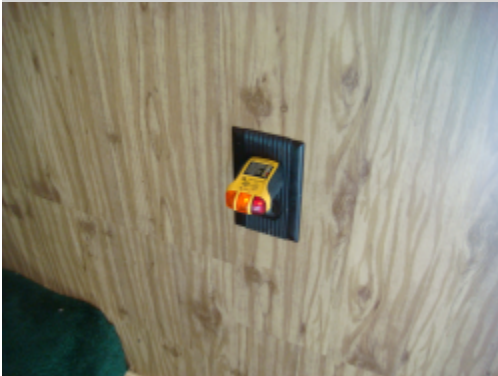
(H5 - 1.1) Basement: Finished Room

Two receptacle(s) located finished part of the basement tested as reversed polarity. Polarization provides an extra safety feature to prevent electrical shock hazards and property damage. A licensed electrical contractor should be consulted for a complete evaluation to determine the significance of this concern and make necessary repairs to correct defects and prevent safety hazards.

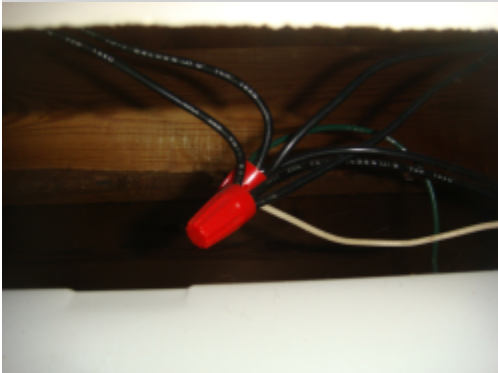
(H5 - 1.2) Basement: Finished Room

Electrical connections have been made in the finished basement area above the dropped ceiling without being properly protected in a covered junction box. The open junction leaves electrical conductors exposed and in a hazardous condition. Electrical concerns should be considered fire and safety issues and repaired as soon as possible. The electrical systems and components in the attic are in need of a complete evaluation and repair by a licensed electrical contractor.

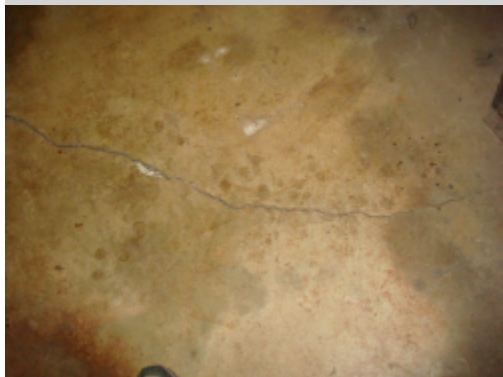
(H5 - 2.1) Basement: Unfinished Area

The basement floor pad is cracked. The pad surface was even and no evidence of differential movement was noted. A general repair person should be consulted to seal the crack to prevent water penetration.

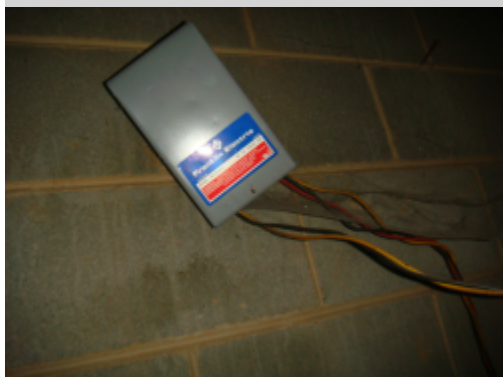
(H5 - 2.2) Basement: Unfinished Area

The electrical panel is not secure where it is attached to the wall of the home. This condition presents a safety hazard that could result in serious personal injury and or property damage. The electrical panel cover was not removed and the inspection was not completed. A licensed electrical contractor should be consulted for a complete inspection of the electrical system and for repair/replacement of the panel to ensure that it is safe and functioning properly.

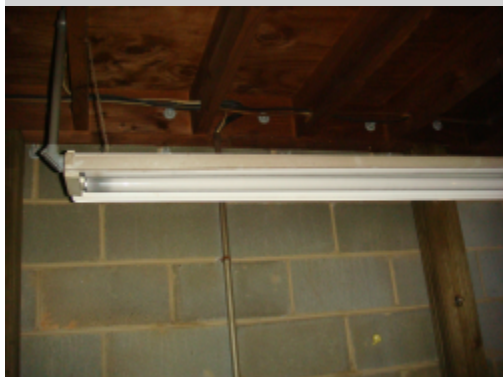
(H5 - 2.3) Basement: Unfinished Area

The light fixture located in the unfinished basement was not functional when tested. This could indicate a defective bulb or other more serious problem such as faulty wiring or a defective fixture, further evaluation and repair is needed. A licensed electrical contractor should be consulted for further evaluation and repair.

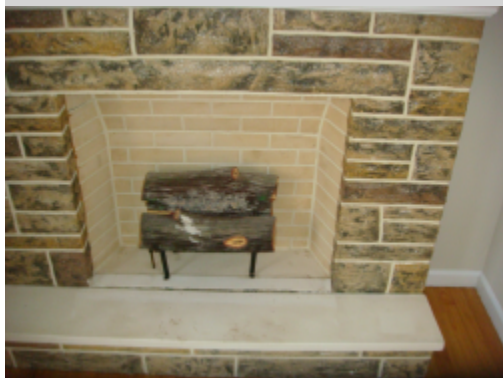
(H6 - 1.1) Fireplace: Pre-Manufactured;; Location: Living Room

The gas log unit located in the living room was visually inspected but not operated because the pilot was off. The unit should be serviced and operated prior to closing to ensure safe and proper operation of the HVAC system.

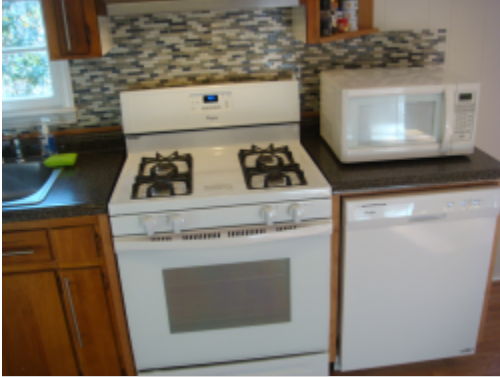
(J1 - 2.1) Range: Gas; Location: Kitchen

The oven/range moves forward when the door is opened. The oven needs to be secured anchored with an anti-tip bracket to prevent the unit was turning over when weight is applied to the door. An appliance repair person or general contractor should be consulted for repair.

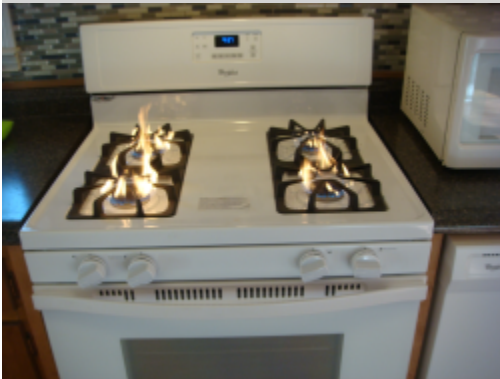
(J1 - 2.2) Range: Gas; Location: Kitchen

The top burners for the range did not function properly. Flames were yellow and uneven, improper burners can result in improper operation and dangerous level of carbon monoxide in the appliance exhaust. An appliance repair person should be consulted for further evaluation and repair to ensure safe and proper operation of the appliance.
