Home Inspection Report

Report Number: 100215-1
For The Property Located On:

Spring Hope, North Carolina 27882

Date of Inspection: Wednesday, October 14, 2015

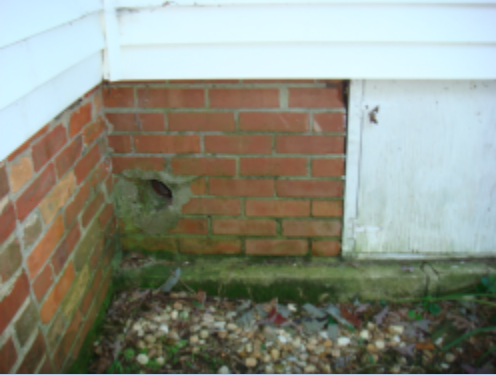
(A1 - 1.1) Main House

In the crawl space, the foundation walls right side has an openings in the foundation walls and provide a path for rodent entry. and creates an undesirable environment in the crawl space areas. Unused hole should be sealed. A general contractor should be consulted to make necessary repairs.

In the crawl space, the foundation walls right side has an openings in the foundation walls and provide a path for rodent entry. and creates an undesirable environment in the crawl space areas Unused hole should be sealed. A general contractor should be consulted to make necessary repairs.

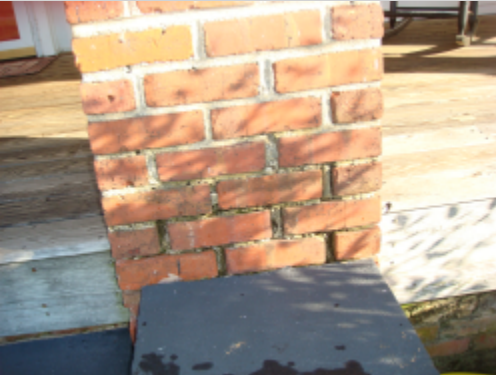
(A2 - 1.1) Porch

The Column located by front steps has visible areas of decay at the base. The damage could jeopardize the strength of the column. The decay indicates a history of direct water penetration in or around the column area. A licensed general contractor should be consulted for further evaluation, to make necessary repairs, and determine the cause of the deterioration.

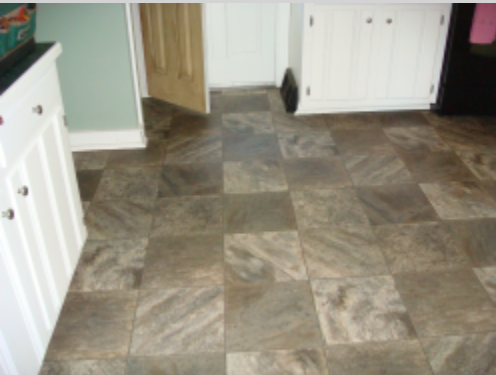
(A3 - 1.1) Main House

The floor in the kitchen next to the left side door Interior floors were noted to slope. No related concerns were noted in the foundation area. The buyer should review the area of concern. If additional concerns or questions are present, an engineer should be consulted to evaluate the structure of the home to determine the significance of this concern and if repairs are necessary.

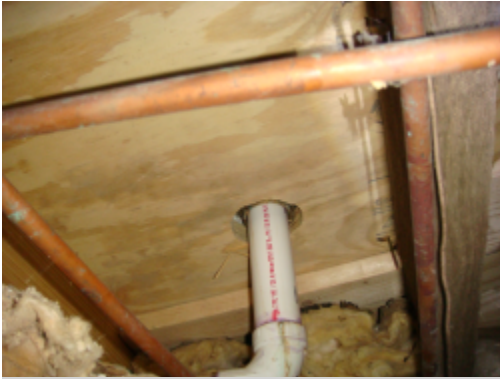
(A3 - 1.2) Main House

The drain under the mater bathroom shower was noted to be leaking into the crawl space. The shower system needs a complete evaluation. A licensed general contractor should be consulted for an invasive investigation to determine the source of the water penetration and the extent of the decay to prevent further damage and undesirable conditions.

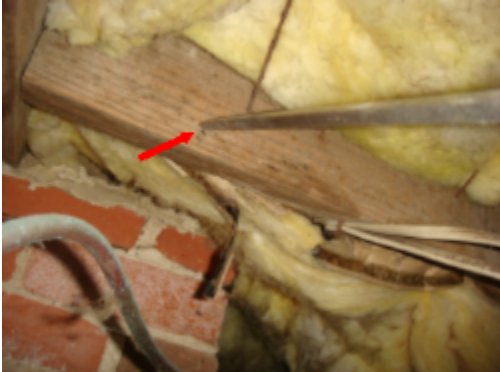
(A3 - 1.3) Main House

The wood framing components near right side chimney foundation in the crawl space of this home has soft wood. A framing component is a main structural component that provides support of the framing structure and transfers loads to the foundation. It is recommended that a licensed general contractor be consulted to perform an invasive inspection to determine the extent of the damage and to make necessary repairs.

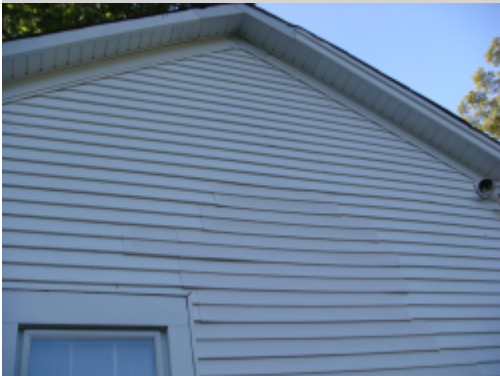
(B1 - 1.1) Main House

The siding for this home is a vinyl material. The rear and left side of the house has visible areas of damage, loose pieces. A licensed general contractor should be consulted for complete evaluation to locate and repair all areas of damage.

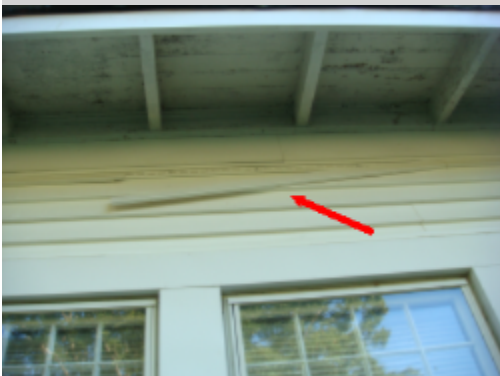
(B1 - 1.2) Main House

Additional Photograph: This a photograph of damaged siding left side of house

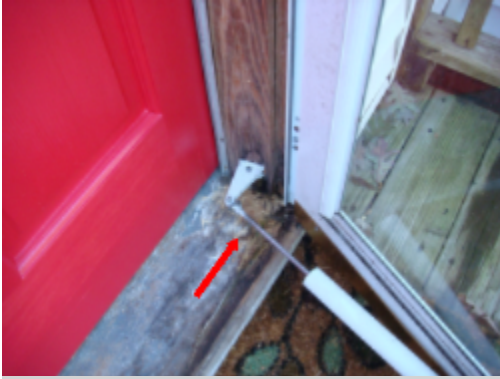
(B2 - 1.1) Doors ; Location: All Accessible

The side door frame is weathered and damaged. The door needs repairs and sealing to prevent further damage. A licensed general contractor should be consulted for evaluation and repair.

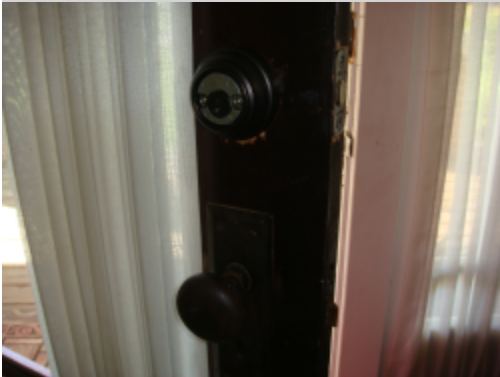
(B2 - 1.2) Doors ; Location: All Accessible

The entrance door front, left and right sides to the home has a double key deadbolt lock. This type of lock cannot be unlocked from the interior of the home without the key and is not recommended for main egress doors. In the event of an emergency, the key may not be available resulting in a person not being able to exit the home. Replacement is recommended.

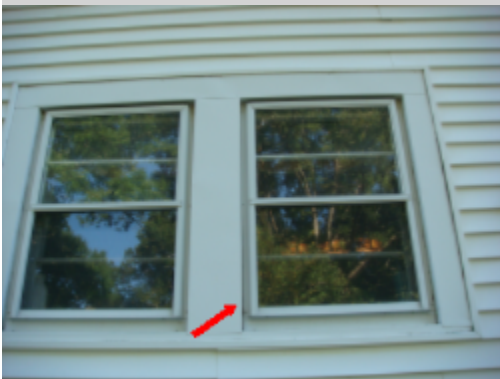
The kitchen widow frame is loose. The window needs repair is weather tight. A general repair specialist or licensed general contractor should be consulted for evaluation and repair.

The kitchen window frame is loose. The window needs repair is weather tight. A general repair specialist or licensed general contractor should be consulted for evaluation and repair.

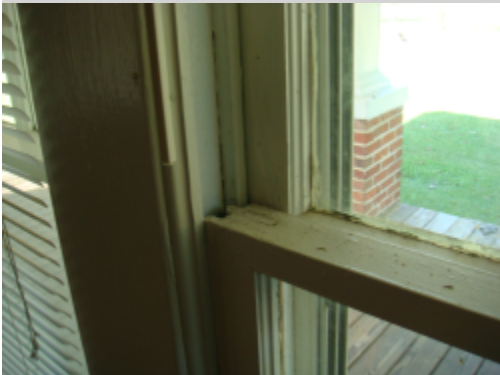
Many windows throughout the house The sash cords/ springs are disconnected. The sash cords /springs assist in lifting and holding the window in place when it is opened. When the cords/springs are disconnected or broken the window will not remain in the open position and can drop suddenly resulting in personal injury. Repair is needed to ensure proper function of the window. A general repair specialist or licensed general contractor should be consulted for evaluation and repair.

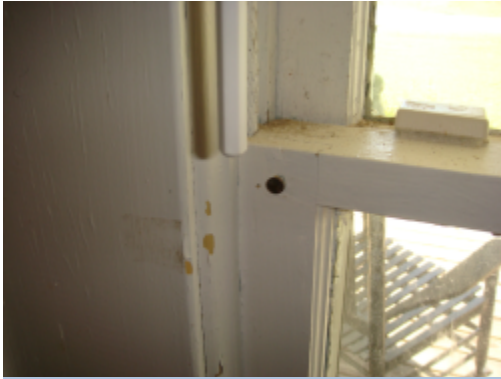
Many windows throughout the house have been permanently shut using nails or screws. Windows in bedroom are especially important to be fully operational as they provide a means of escape in emergency. It is very important to have a proper method of egress from every sleeping area in case of an emergency such as a fire. A licensed general contractor should be consulted for evaluation of all windows and repair.

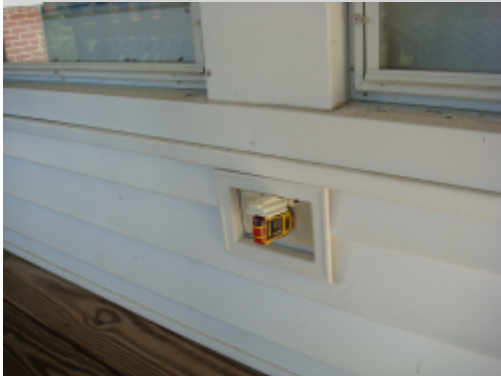
The receptacle located on front porch had no power. This could indicate a damaged receptacle or branch wiring circuit. A licensed electrical contractor should be consulted for a complete evaluation to determine the significance of this concern and make necessary repairs to correct defects and prevent safety hazards.

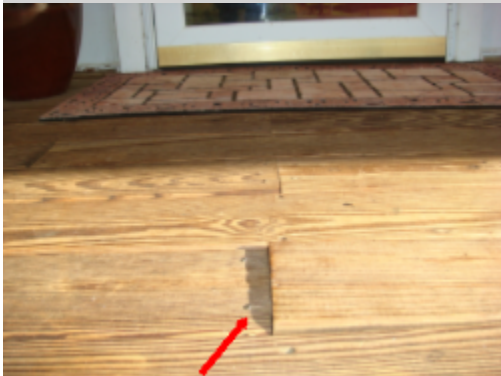
Several front porch surface boards are raised. This uneven surface is a trip hazard. A licensed general contractor should be consulted for evaluation and to make necessary repairs.

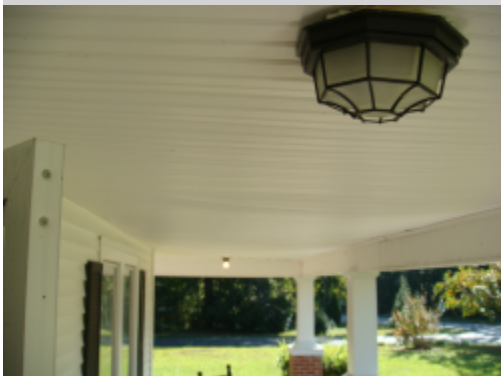
The light fixture located on front porch was not functional when tested. This could indicate a defective bulb or other more serious problem such as faulty wiring or a defective fixture, further evaluation and repair is needed. A licensed electrical contractor should be consulted for further evaluation and repair.

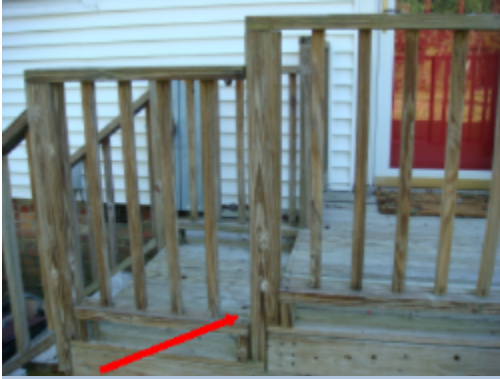
The hand railings for the steps are loose and in need of repair or replacement to ensure safe and functional use of the steps. A licensed general contractor should be consulted for a complete evaluation and to make necessary repairs.

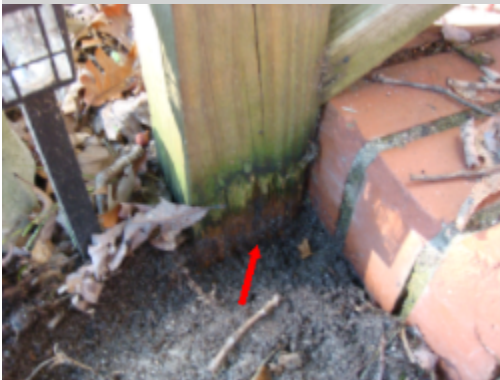
The rear porch step railings post have soft and rotted wood at the ground surface. A licensed general contractor should be consulted for complete evaluation of the deck and to make necessary repairs.

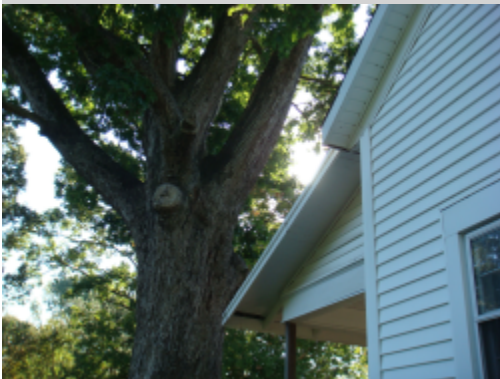
The home has historical trees. Historical trees require annual maintenance and service to reduce risk hazards related to the home. An arborist should be consulted to determine the general health of the tree, required service, and recommend a care plan.

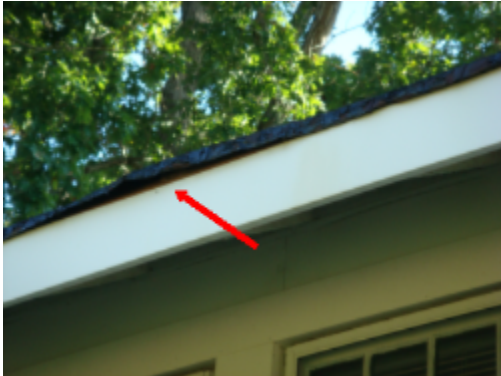
(C1 - 1.1) Main House

This home as has a metal roofing system. The metal system is in need of further evaluation and repair. The edge of the roof is lifted in several areas which could allow rodent access to the attic. A licensed roofing contractor with experience with metal roof systems should be consulted for a complete evaluation to determine significance of the concerns and to make necessary repairs.

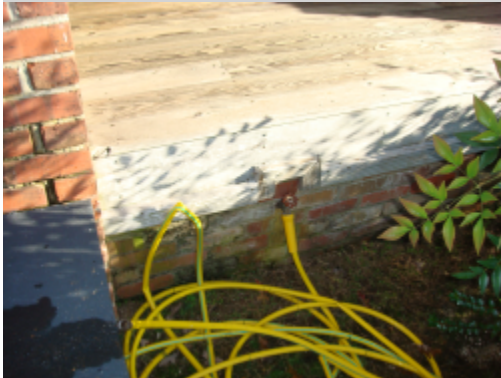
The exterior faucet located by front steps did not operate. A licensed plumbing contractor should be consulted to make necessary repairs.

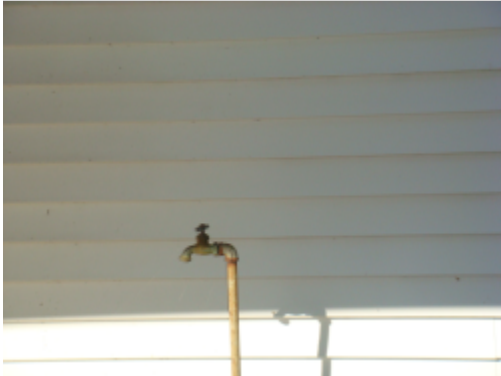
Additional Photograph: This is a photograph of non working faucet right side of hose

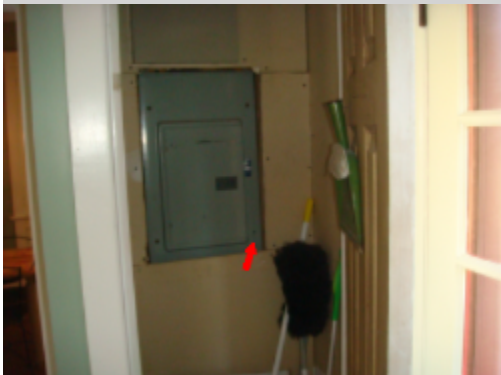
The electrical service panel cover is missing fasteners that secure the cover to the enclosure. The door/cover prevents direct contact with hot electrical circuits and contains the electrical energy of the electrical system in the event of a short or electrical explosion; therefore the cover must be secured with the correct type, size and number of fasteners. This condition presents a safety hazard that could result in serious personal injury or death. A licensed electrical contractor should be consulted for a complete inspection of the electrical system and for repair/replacement of the panel to ensure that it is safe and functioning properly.

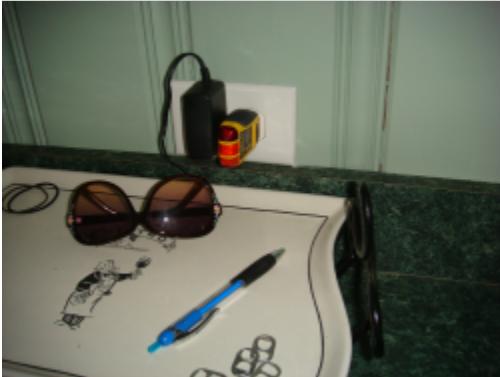
Some of the 3 prong type receptacle(s) in the house tested as open equipment ground. This home was built in an era where receptacles were 2 prong type without an equipment ground. An equipment ground provides an extra safety feature to prevent electrical shock hazards and property damage. Receptacles typically should not be updated to the 3 prong type without the installation of an equipment ground or GFCI protection. A licensed electrical contractor should be consulted for a complete evaluation to determine the significance of this concern and make necessary repairs to correct defects and prevent safety hazards.

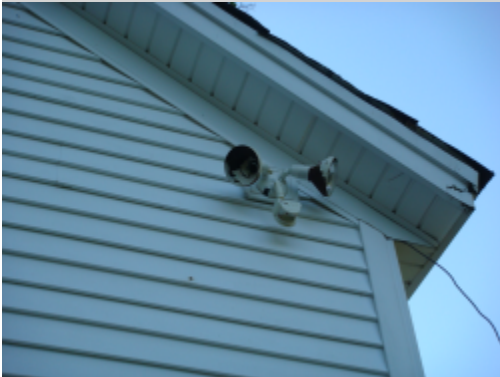
The light fixture located in the rear was not functional when tested. This could indicate a defective bulb or other more serious problem such as faulty wiring or a defective fixture, further evaluation and repair is needed. A licensed electrical contractor should be consulted for further evaluation and repair.

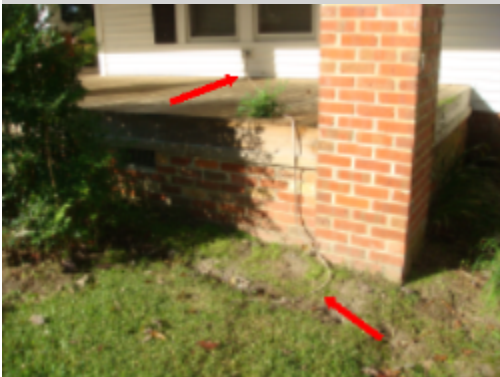
Extension cords have been used in place of hard wire (right side of house). This indicates amateur electrical work and could result in increased shock and fire hazards. A licensed electrical contractor should be consulted to review the installations and make necessary repairs to ensure safe and proper operation and installation.

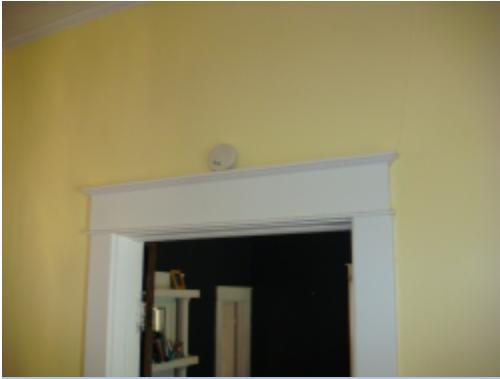
The smoke detector and carbon detectors located in hallway and kitchen areas are not properly mounted. The units should be repaired or replaced to ensure a safe environment.

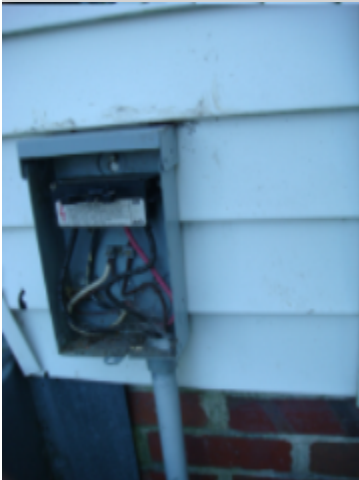
The package unit electrical service panel is missing the inside cover. The cover prevents direct contact with hot electrical circuits and contains the electrical energy of the electrical system in the event of a short or electrical explosion. This condition presents a safety hazard that could result in interrupted service and serious personal injury /death from electrocution. A licensed electrical contractor should be consulted for a complete inspection of the electrical system and for repair/replacement of the panel to ensure that it is safe and functioning properly.

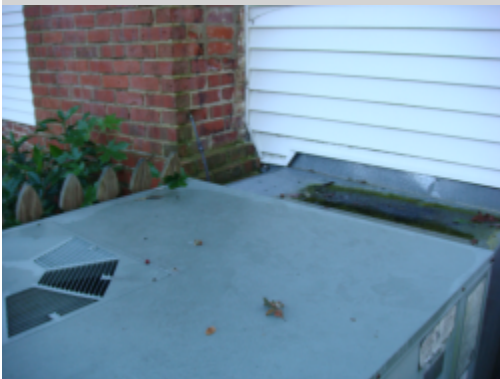
The shroud that covers the opening in the foundation between the package unit and the house is ponding water. The shroud prevents water, debris, and animals from entering the foundation area of the home. A HVAC contractor should be consulted for a complete evaluation and to make necessary repairs to protect the unit, the ducts, and the foundation opening.

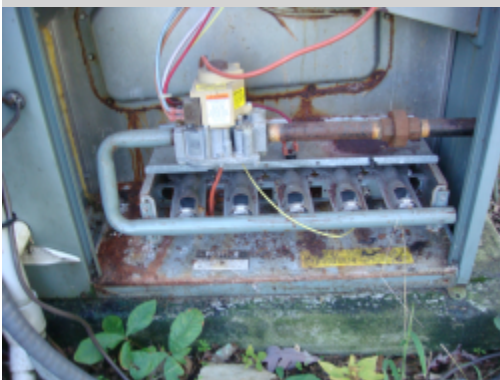
The gas furnace unit has visible rust in the burner chamber area. The rust indicates deterioration of the exchanger. Deterioration of the heat exchanger is a serious concern that can result in improper combustion and carbon monoxide poisoning. The furnace needs a complete evaluation which should include a heat exchanger inspection to ensure safe, reliable, and proper operation of the HVAC system. A licensed HVAC contractor should be consulted for repair.

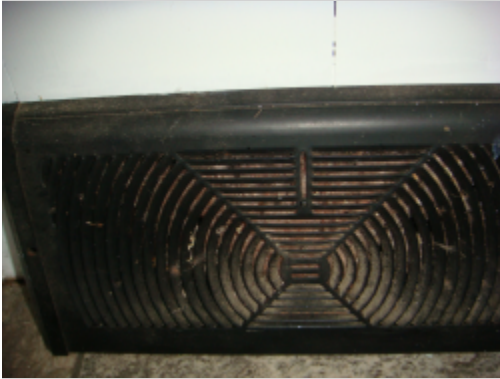
The duct register that supplies kitchen is filled with debris. The debris reduces the air flow and contaminates the air supply. A HVAC contractor should be consulted for a complete evaluation and replacement of all damaged duct components to ensure reliable and proper operation of the HVAC system.

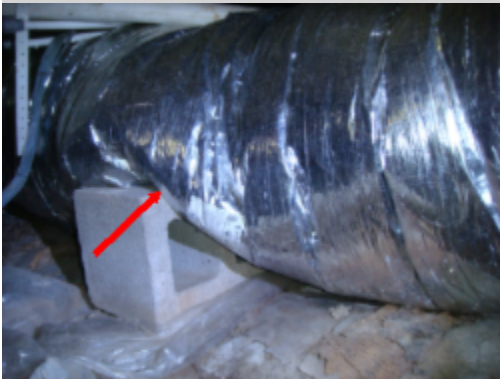
The return duct system located rear left side is not properly supported, and appears to be restricted. Proper support is needed to ensure correct air flow and system function. A HVAC contractor should be consulted for a complete evaluation and repair of the duct system and components to ensure reliable and proper operation of the HVAC system.

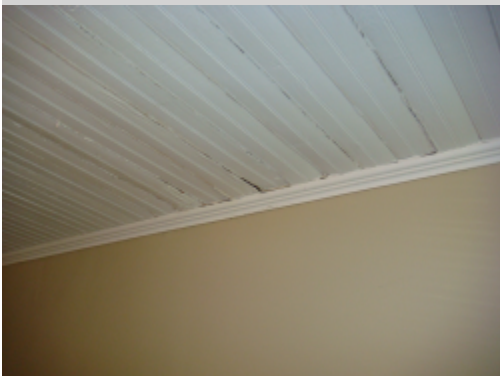
Stains on the ceilings indicate a history of a leak. At the time of the inspection it was not possible to determine if the condition was due to an active or past occurrence. Further investigation by a repair specialist and owner disclosure is recommended.

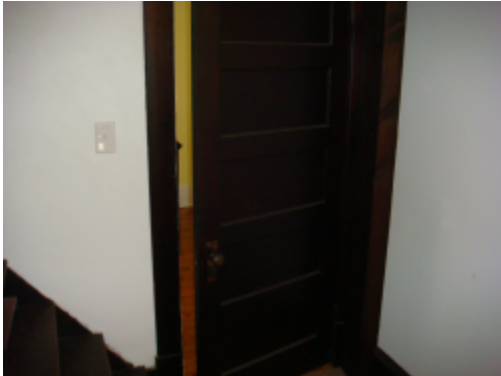
The door needs repair to ensure proper operation and privacy. The door did not properly latch.

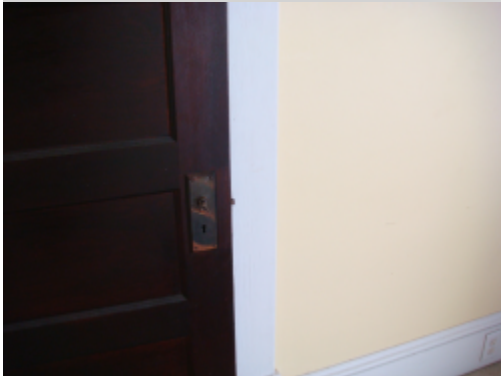
The door needs repair to ensure proper operation and privacy. The door did not properly latch, lock, close.

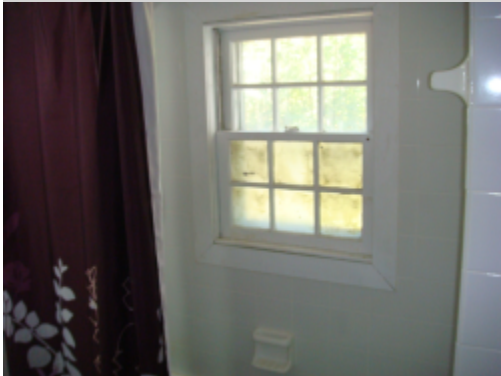
The window for the bathroom is the only means of ventilation and is in need repair to ensure proper operation. The window did not properly latch, lock, open. All windows should be evaluated as repairs are made. A licensed general contractor should be consulted.

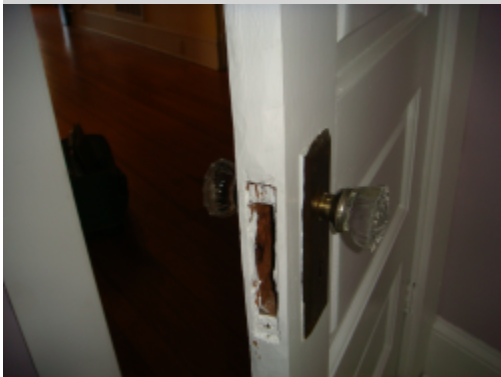
The door for the bathroom needs repair to ensure proper operation and privacy. The door did not properly latch, lock, close.

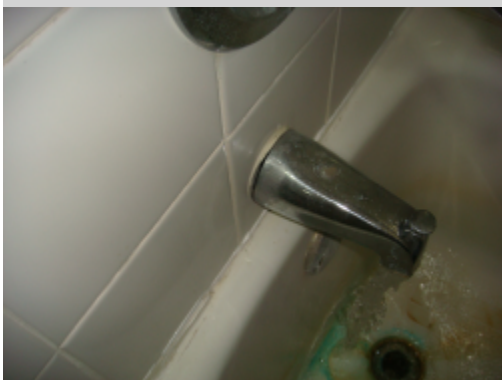
The shower faucet assembly is not sealed to wall, this could allow water penetration into the wall cavity. A licensed plumbing contractor should be consulted for evaluation and repair to ensure proper service.

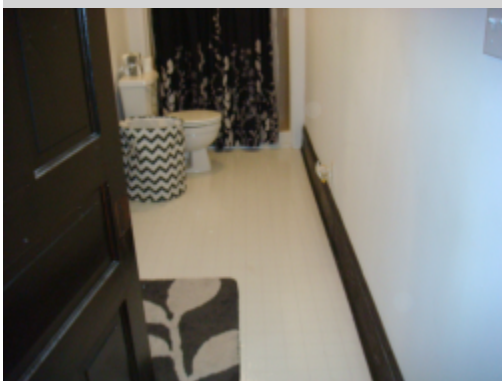
The door for the bathroom needs repair to ensure proper operation and privacy. The door did not properly latch, lock, close.

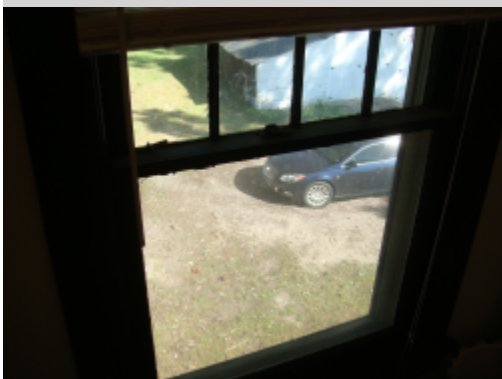
The bathroom window needs further evaluation and repair. The window was cloudy, cracked, decayed, broken. All windows should be evaluated as repairs are made. A licensed general contractor should be consulted.

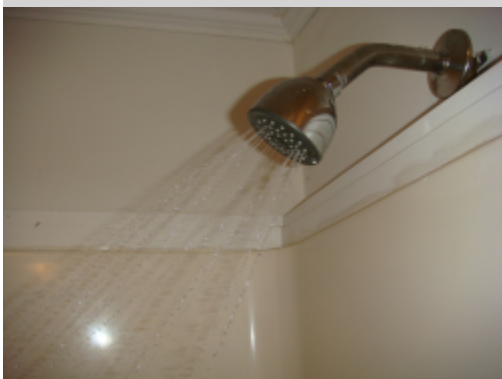
The water flow to the fixtures is low. Low water flow in the bathroom can indicate an underlying problem with the plumbing systems/components and reduce the effectiveness and function of the fixtures. A licensed plumbing contractor should be consulted for evaluation and repair.

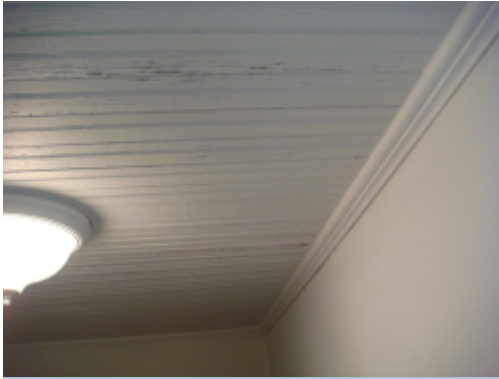
The wood ceiling has areas of decay typical of water moisture. A licensed general contractor should be consulted for an investigation to determine the source of the water moisture and the extent of the decay to prevent further damage and undesirable conditions

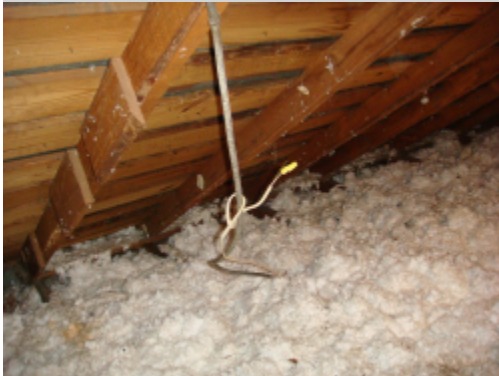
Electrical connections have been made in the attic area without being properly protected in a covered junction box. The open junction leaves electrical conductors exposed and in a hazardous condition. Electrical concerns should be considered fire and safety issues and repaired as soon as possible. The electrical systems and components in the attic are in need of a complete evaluation and repair by a licensed electrical contractor.

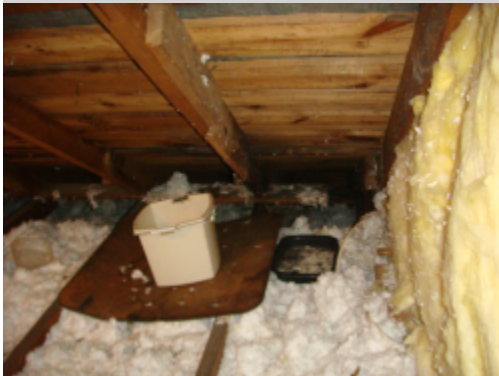
From the attic, the presents of collections buckets indicates a history of a long term leak that could involve hidden areas of damage, the flashing, and the roof covering systems. A licensed general contractor should be consulted for further evaluation and repair to determine the source of the leak and extent of the damage to ensure the stability of the home and prevent additional damage.

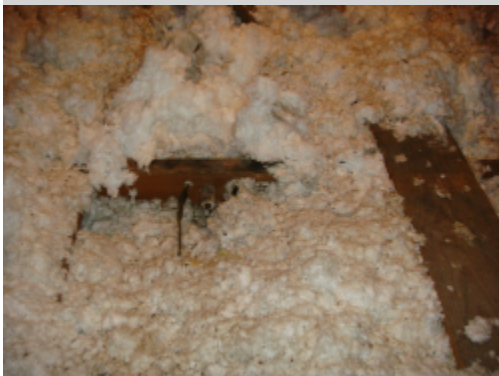
The historical knob & tube wiring has been covered with insulation. Blown-in, foamed-in, or rolled insulation prevents the dissipation of heat into the free air space, resulting in higher conductor temperature, which could cause insulation breakdown and possible ignition of the insulation. A complete evaluation by an electrical contractor is recommended to ensure the safest system configuration and determine the integrity of the system. ****Please note it was not clear if the wiring is still in use****

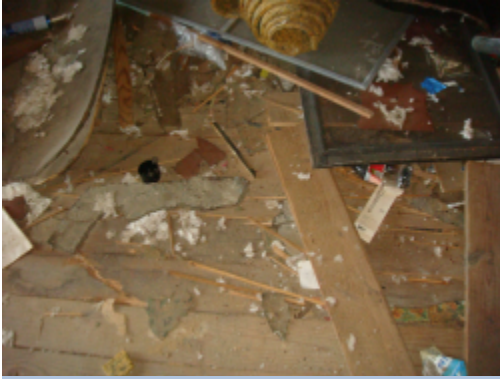
The attic area has damaged walk boards. The inspection was performed from the attic access opening and was very limited. The inspection of the attic is an important part of the home inspection and should be completed after conditions are corrected and prior to purchase.

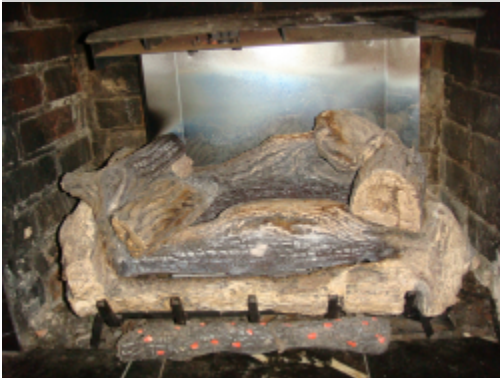
The gas log unit located in the living room was visually inspected but not operated because the pilot was off. The unit should be serviced and operated prior to closing to ensure safe and proper operation of the HVAC system.

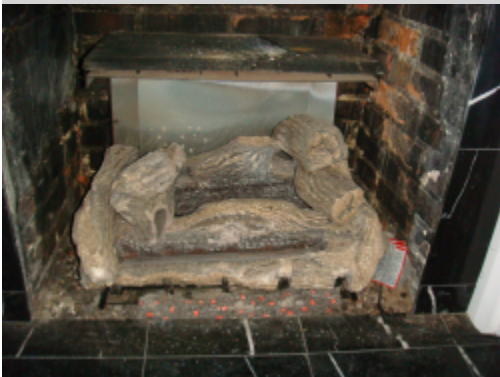
The gas log unit located in the kitchen was visually inspected but not operated because the pilot was off. The unit should be serviced and operated prior to closing to ensure safe and proper operation of the HVAC system.

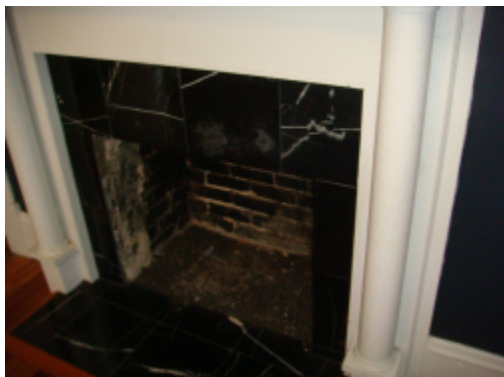
The fireplace in the master bedroom has a gas line installed and is capped. Please note the damper area is sealed and most vent-free appliances are not approved for use in bedrooms or bathrooms. When approved, the BTU rating must be limited to 10,000 BTU's for bedroom use and 6,000 BTU's for bathroom use. This unit needs to be verified to be rated for a sleeping area. A HVAC contractor or the local gas company should be consulted for a complete evaluation.

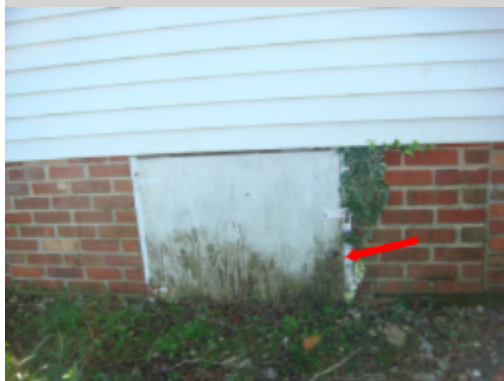
Evidence of condensation and discoloration of the crawl space access door right side of house indicates a problem with excessive moisture. A licensed general contractor should be consulted for a complete evaluation of the crawl space to determine the significance of the concern and make necessary repairs.

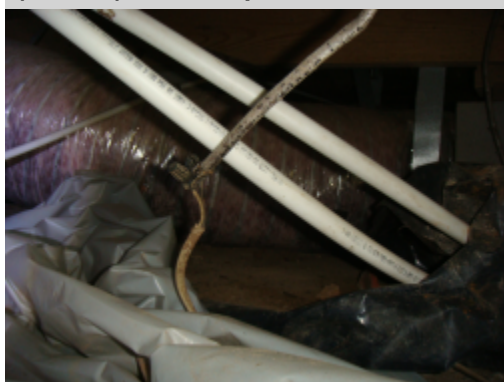
Electrical connections have been made in the crawl space without being properly protected in a covered junction box. The open junction leaves electrical conductors exposed and in a hazardous condition. Electrical concerns should be considered fire and safety issues and repaired as soon as possible. The electrical systems and components in the attic are in need of a complete evaluation and repair by a licensed electrical contractor.

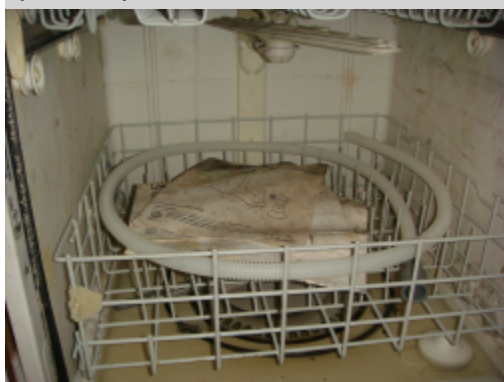
The dishwasher was found to be in poor condition mold on the inside, standing water, and hose and manual inside unit. The dishwasher was not tested. The dishwasher was also not properly attached to underside of counter. An appliance repair person should be consulted for further evaluation and repair to ensure proper operation of the appliance.

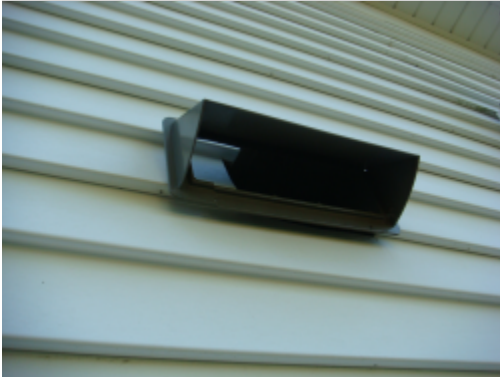
The range hood fan exit hood is not securely mounted. The unit needs to be secured to prevent damaged. A licensed general contractor should be consulted for further evaluation and repair to ensure proper and safe operation of the appliance.

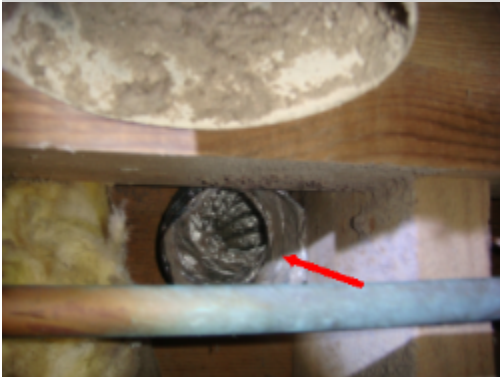
The exhaust duct for the clothes dryer is disconnected in the crawl space and does not have proper termination at the floor level inside the home. The dryer duct should be kept in good working order to prevent fire hazards and properly distribute moisture to the exterior of the home. Note: the dryer duct for this home is a flexible plastic duct, most new dryers require a solid pipe metal duct. A HVAC contractor should be requested to upgrade this duct for safest operation.
