Home Inspection Report

Report Number: 102415-1
For The Property Located On:

Wake Forest, North Carolina 27587

Date of Inspection: Saturday, October 24, 2015

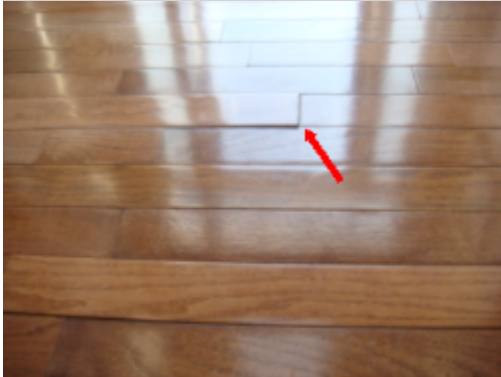
(A3 - 1.1) Main House

In the front hallway a hardwood floor board was raised. Excessive movement of the hardwood floors can indicate improper installation and or unbalanced moisture conditions that indicate underlying problems. . A flooring installation/ repair company should be consulted for further evaluation to determine the significance and source of the concern.

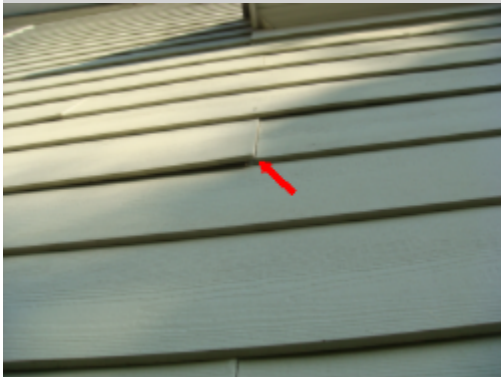
(B1 - 1.1) Main House

The exterior of the home was noted to have several loose siding boards left side and rear. Also noted were several locations where gaps between boards have expanded leaving opportunities for water penetration. The loose siding boards can indicate improper installation, failure of the fasteners, and or problems with the sheathing. A licensed general contractor should be consulted for a complete evaluation of the exterior of the home to evaluate the siding installation, the condition of the underlayment, and to correct the loose boards to ensure the weathertightness of the system.

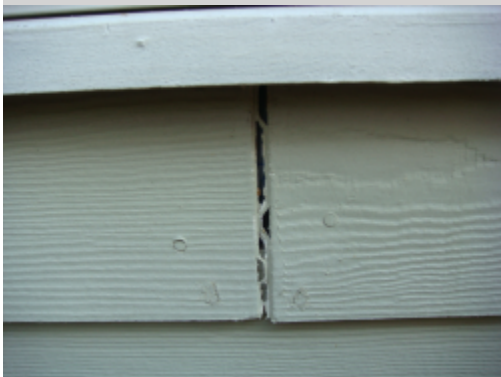
(B1 - 1.2) Main House

Additional Photograph: This a photograph of expanded gap between boards

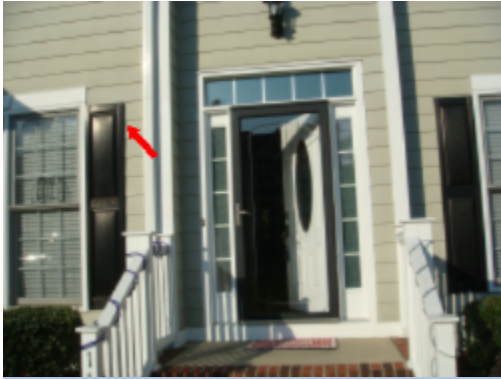
(B2 - 1.1) Windows ; Location: All Accessible

The window shutter was noted to be loose. If the shutter is not properly installed it will not prevent water penetration. A siding installation company or general contractor should be consulted to evaluate and repair the siding to ensure the integrity of the cladding system.

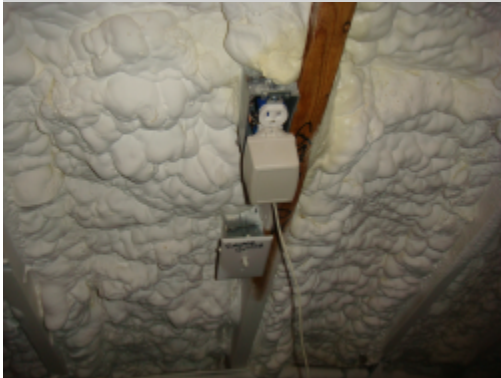
(E5 - 1.1) Attic

The receptacle located attic is missing cover plate. Missing cover plates could result in increased shock and fire hazards. A licensed electrical contractor should be consulted to make necessary repairs to ensure safe and proper operation and installation.

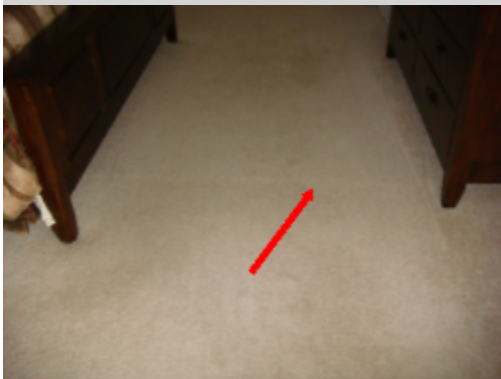
(H1 - 3.1) Bedroom: Master

The floor in the master bedroom has a raised seam. No related concerns were noted in the foundation area. The buyer should review the area of concern. If additional concerns or questions are present, an engineer should be consulted to evaluate the structure of the home to determine the significance of this concern and if repairs are necessary.

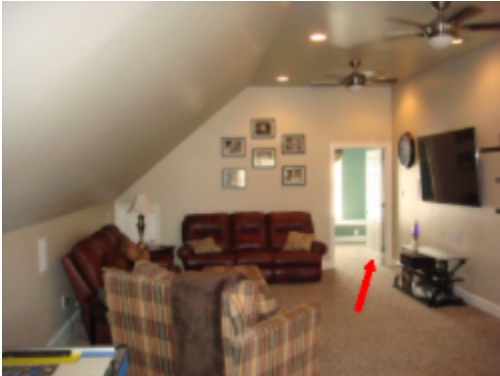
(H1 - 4.1) Bonus Room (3rd floor)

The door to the 3rd floor bedroom drags and is difficult to open or close. This condition could indicate improper installation. The door needs repair to ensure that the door closes securely and operates properly. A general repair specialist or licensed general contractor should be consulted for evaluation and repair.

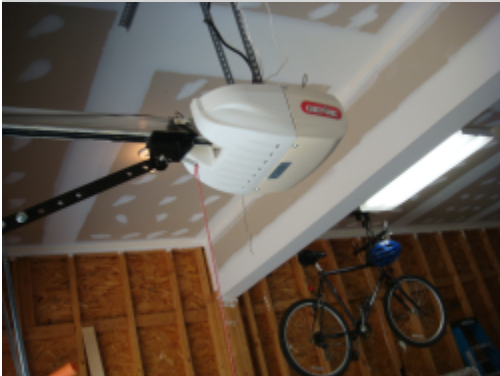
(H4 - 1.1) Garage

The garage door needs adjustment and repair. The door did not stop/reverse when the path was interrupted. A garage door installation company or a licensed general contractor should be consulted for evaluation and repair to ensure that the door operates safely and properly.

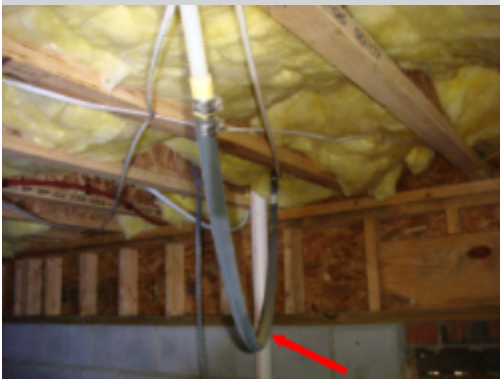
(J1 - 1.1) Dishwasher; Location: Kitchen

The drainage pipe from the dishwasher to the sink plumbing was not installed in manner to prevent sewer from backing up in the event of a plumbing clog. The dishwasher needs further evaluation and repair to ensure sanitary and proper operation. An appliance repair person should be consulted.
